The Kizhi Federal Museum of Architecture and Cultural History
Cultural Heritage Site of Special Value of the Russian Federation

The Detailed Report **on Preservation of Kizhi Pogost Monuments** **(Kizhi Pogost, C 544) in 2011**

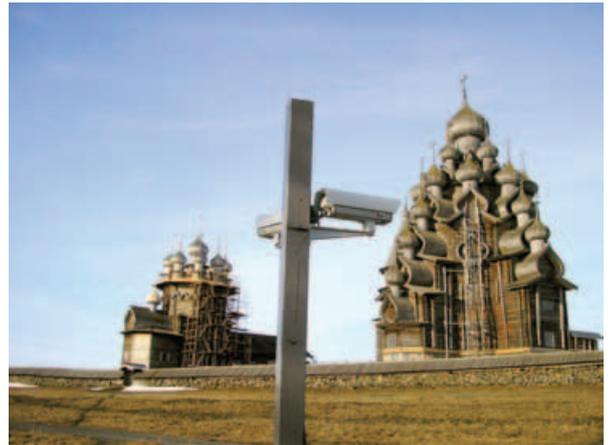
Fig.1. Sensors of infrared monitoring system mounted around the Kizhi Pogost

controls the Kizhi Pogost and surrounding areas and detects humans or heat source in any kind of weather day and night. This innovation greatly improved the protection of the site from unauthorized access, vandalism or ignition. Simultaneously, the security system with a radio-wave emitter «RADIY» was set in operation to control the Kizhi Pogost perimeter. It gives extra control from unauthorized access beyond the protected perimeter.

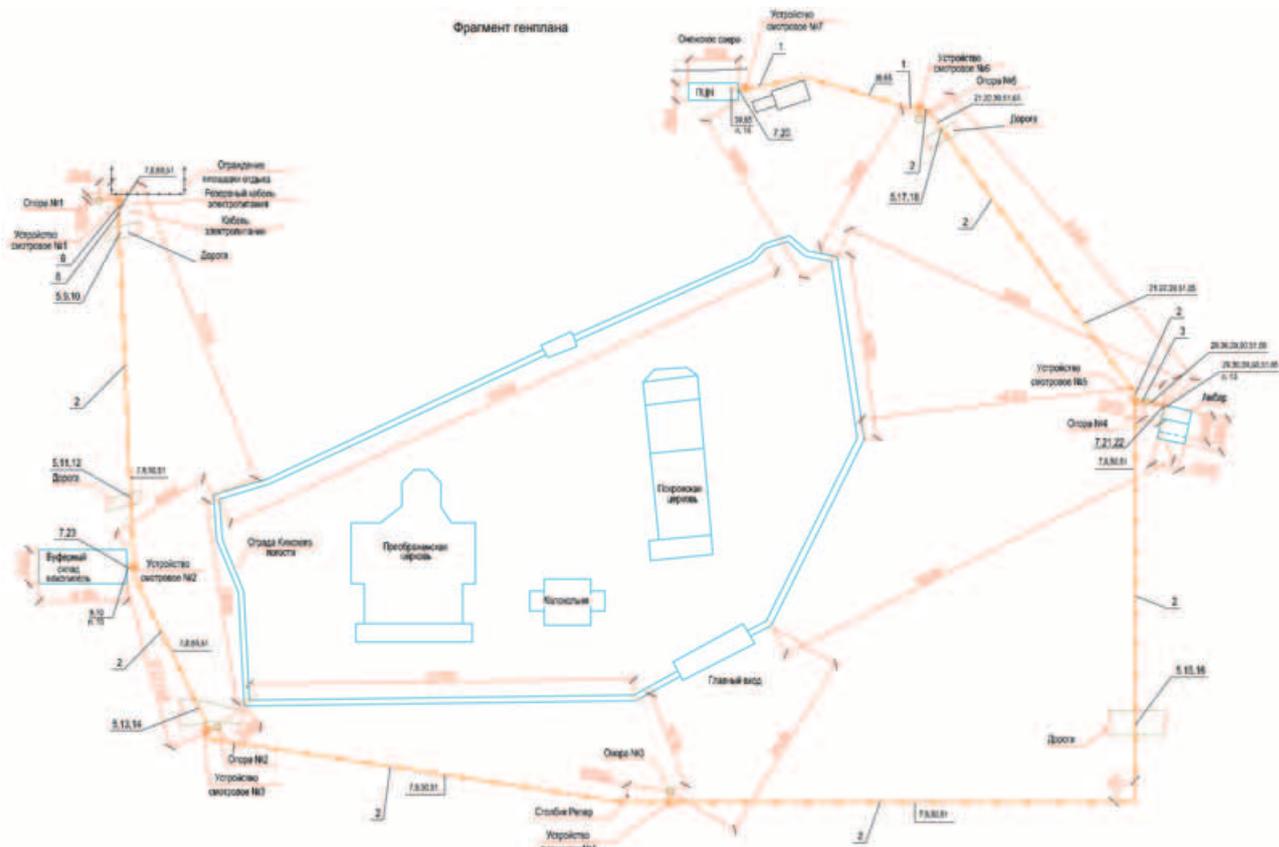
Fig. 2. System of the Kizhi Pogost perimeter guarding by the use of infrared monitoring sensors

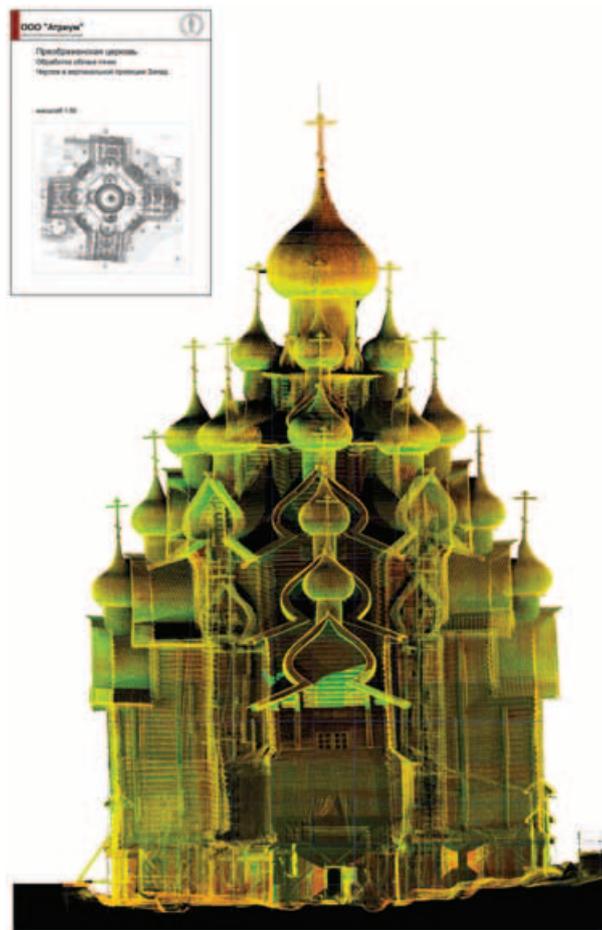
Fig. 3. 3D model developed as a result of laser scanning of the Church of the Transfiguration in 2010-2011

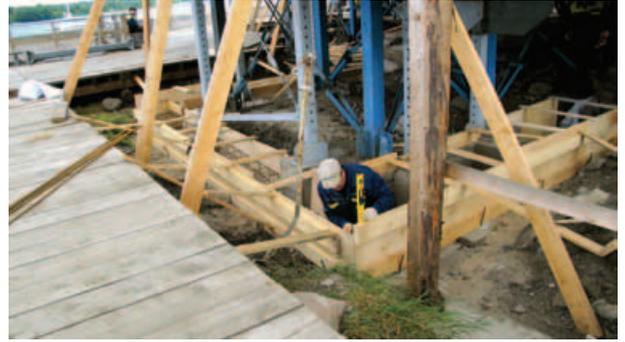
Fig. 7. Mounting of curb for underground part of the foundation

In 2011, «Alekon» Co ltd experts completed the underground part of the foundation in line with project №255/06-KЖ and with the authors' proposals developed by the experts of "Stroyreconstructsija" Co Ltd. The upper part of this strip foundation is made of reinforced concrete. The installation of three extra connecting beams of reinforced concrete was introduced into project №255/06-KЖ as the addition. These beams are located underground in three church annexes (northern, southern and western). Thus, they are concealed from sight and won't spoil the appearance of the monument. The installation of extra beams was caused by the necessity to make rigid connections in three annexes due to the change of geometry of the church basement part after it has been restored in the restoration complex. Consequently, the corrected geometry caused the necessity to introduce changes into the horizontal projection of the underground part of the foundation.

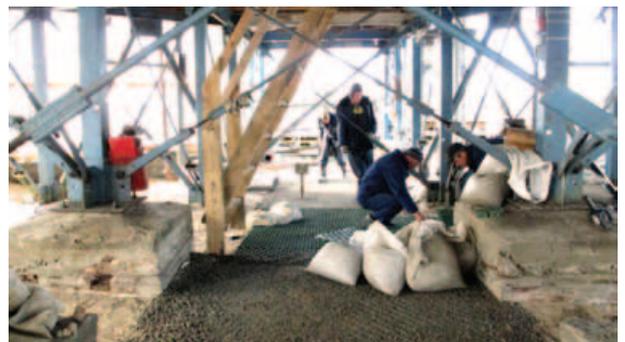
After major works on foundation were completed, the planning of bottom was performed under the whole church building: the bottom was made even; the holes, trenches and earthfills made during the repairs since the XIX c. were removed. «Dornit» material was laid on the evened bottom. This material separates the historical level from the temporary covering used for work purposes. This separation could be of great use for archeologists in the future. The finishing layer of planning is a macadam base laid in the polymeric mesh with the cell dimension 60x60 mm. This mesh reinforces the macadam base and secures density and rigidity. The design of bottom in the church basement gives the opportunity to perform restoration works in comfort, improves the appearance of the church basement and restoration site on the whole, and reduces dust impact on the church wooden elements.

Fig. 8. Ground leveling and laying of polymer mesh in the basement of the Church of the Transfiguration

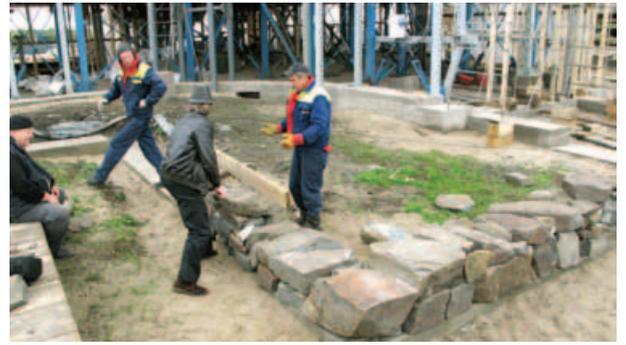
taken to build an experimental part of the overground rubblework. A part of original rubblework was laid dry on the foundation strip of reinforced concrete. This experiment gave the opportunity to visualize the rubblework, to evaluate its appearance and design features, and to get fully prepared for the finishing works on foundation in 2012.

Fig. 9. Pilot part of loose rock foundation (above ground)

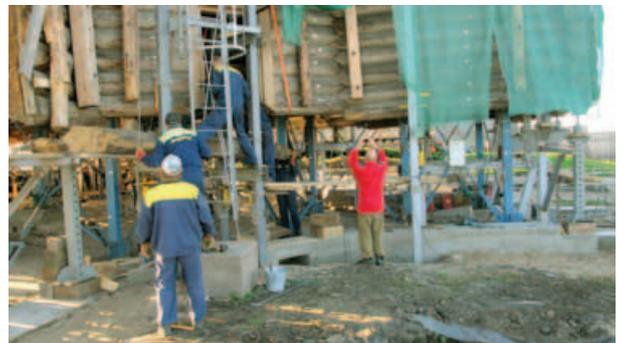
The gap of 5 meters appeared between the foundation and suspended log walls because more logs than expected earlier were dismantled from the western part of the church. The eastern side of the church remained in the same condition like in the end of 2010 because the dismantling has not been done yet.

Fig. 10. Dismantling of the VIIth restoration tier elements and fixing of lifted walls on lifting constructions

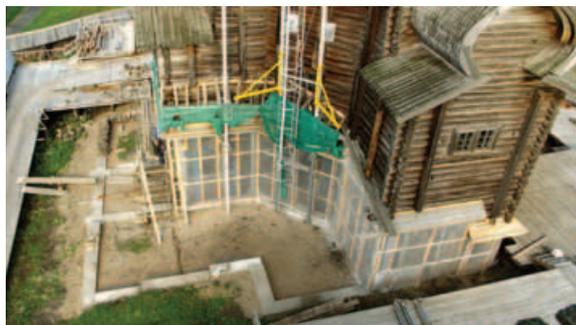
Fig. 11. Monument conservation for winter period

As in previous seasons, the church was prepared for winter period upon the completion of all main works. The dismantled part of the church was protected with shields of wooden framing covered with reinforced material. The work technique was fine-tuned in 2010. In addition to standard measures of conservation, the following works were performed:

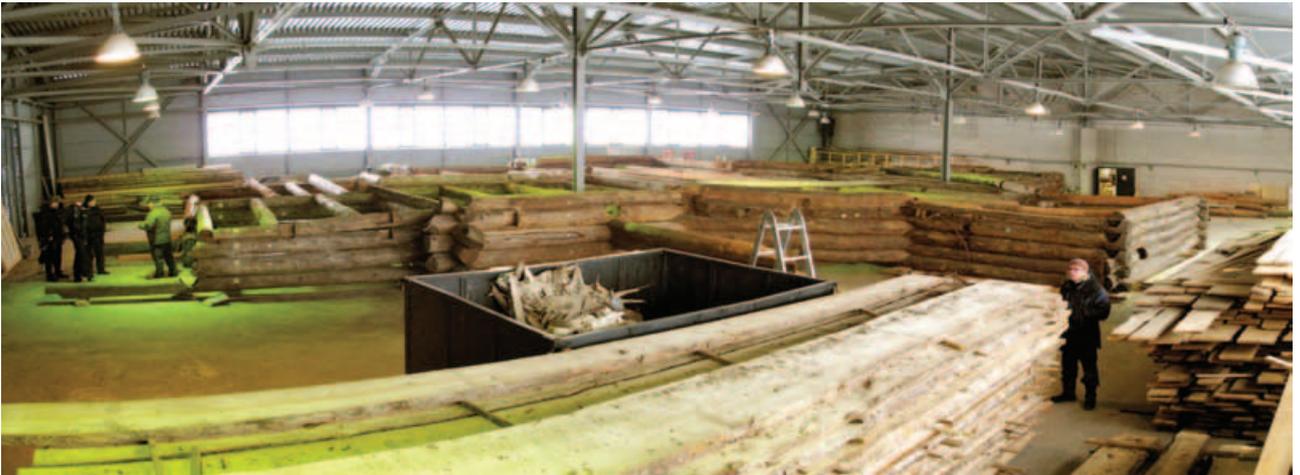
The correct position of church was already clarified on the stage of project development, and it is based on the thorough examination of the system of beam joints and the geometric position of church basement. The historical position of church basement (i.e. horizontal projection and vertical marks) that had formed by the time of dismantling (the middle of 2010) was corrected on the basis of the above mentioned examination and project proposal. As a result, restorers achieved the original geometry of log walls (i.e. the geometry as of the time of church building). All beams fitted into their slots, i.e. set to the correct position, and the floor level of XVIII c. was set horizontally. The analysis of a new geometry of the church basement revealed max. horizontal shifting to 25 cm, and max. vertical shifting to 40 cm. Actually, this church basement was shown to UNESCO mission in February, 2011.

Fig. 12. Framework of the basement (before the restoration) placed in new corrected outline. Beginning of the year 2011

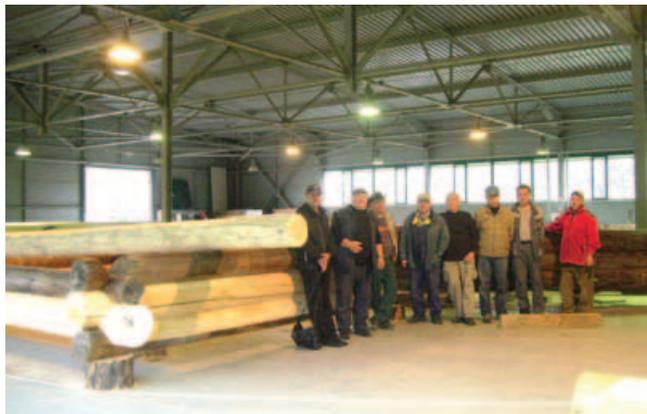
Fig. 13. Start of the basement framework assembly in the restoration assembly workshop

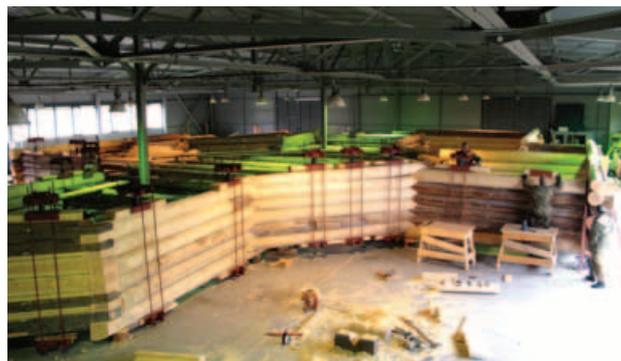
Fig. 14. The church basement framework under “Loading simulation” test

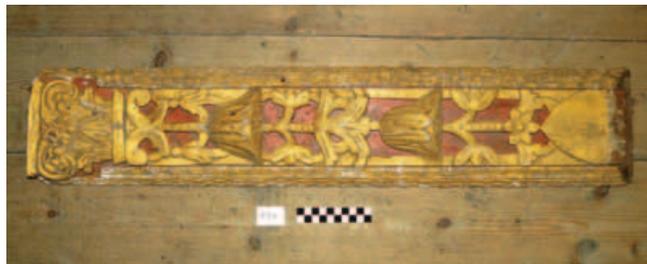
Fig. 15. A part of the fretted iconostasis frame

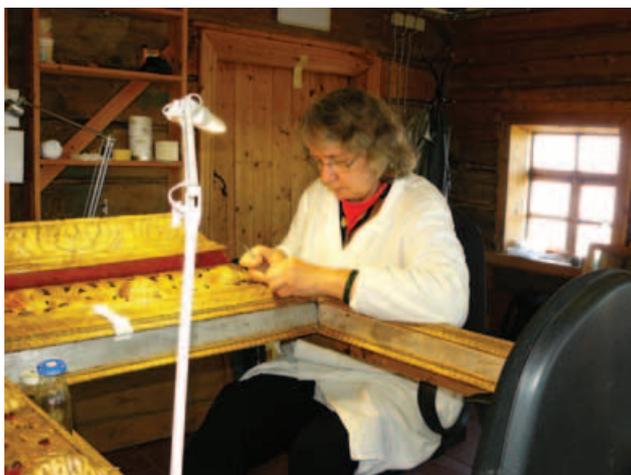
Fig. 16. Restoration of the iconostasis frame on Kizhi in the museum workshop

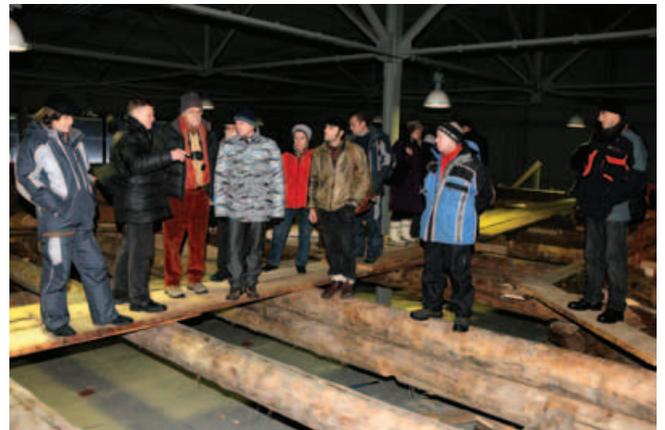
Fig. 20. Acceptance of the basement restoration by ICOMOS/UNESCO experts and members of the national Supervisory board set up by the Ministry of Culture of Russian Federation. December, 2011

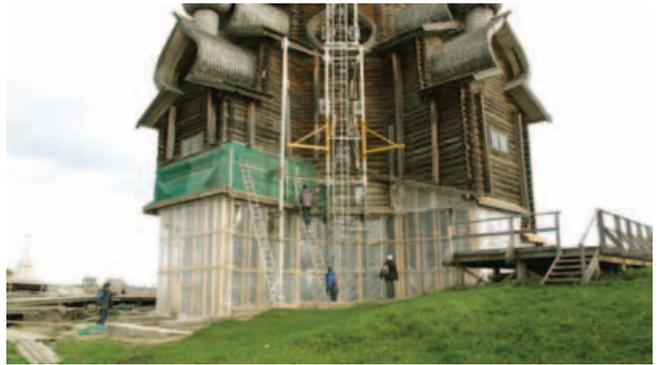
The second task was solved by constructing a wooden framing under the church walls and by covering this framing with reinforced material. The facade screen was used to cover refectory walls. The logs and other parts that were dismantled in 2010 were stocked (preserved) in the restoration complex and their condition is under control as well.

Fig. 21. Monument conservation for winter period

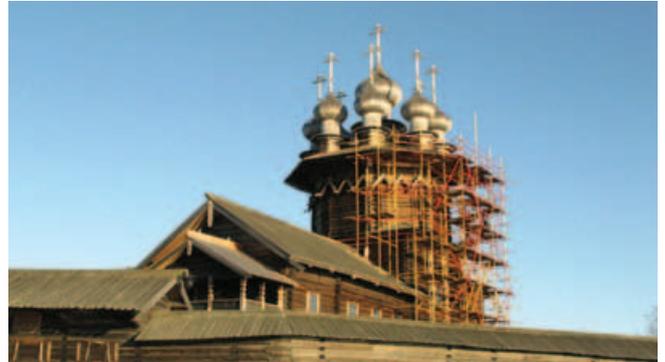
The shingles on the last altar dome were partly replaced in winter. The boarding on the northern, western and eastern roofs of the church proper was completed by spring. Building of scaffolds for restoration on the southern roofs of the church proper was started in autumn after the tourist season. The roof boarding on the south-western roof slope was completed by the end of 2011. The works on the roof are planned to be completed by the beginning of tourist season in 2012

Fig. 22. Scaffoldings mounted for completion of roof restoration

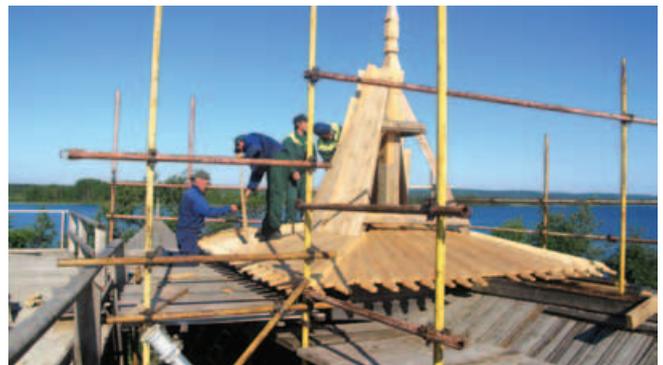
The northern tower and the fence part that adjoins the restoration site were reroofed. The cross on the northern tower was replaced with a new one.

Fig. 23. Restoration of the northern tower of the Pogost enclosure

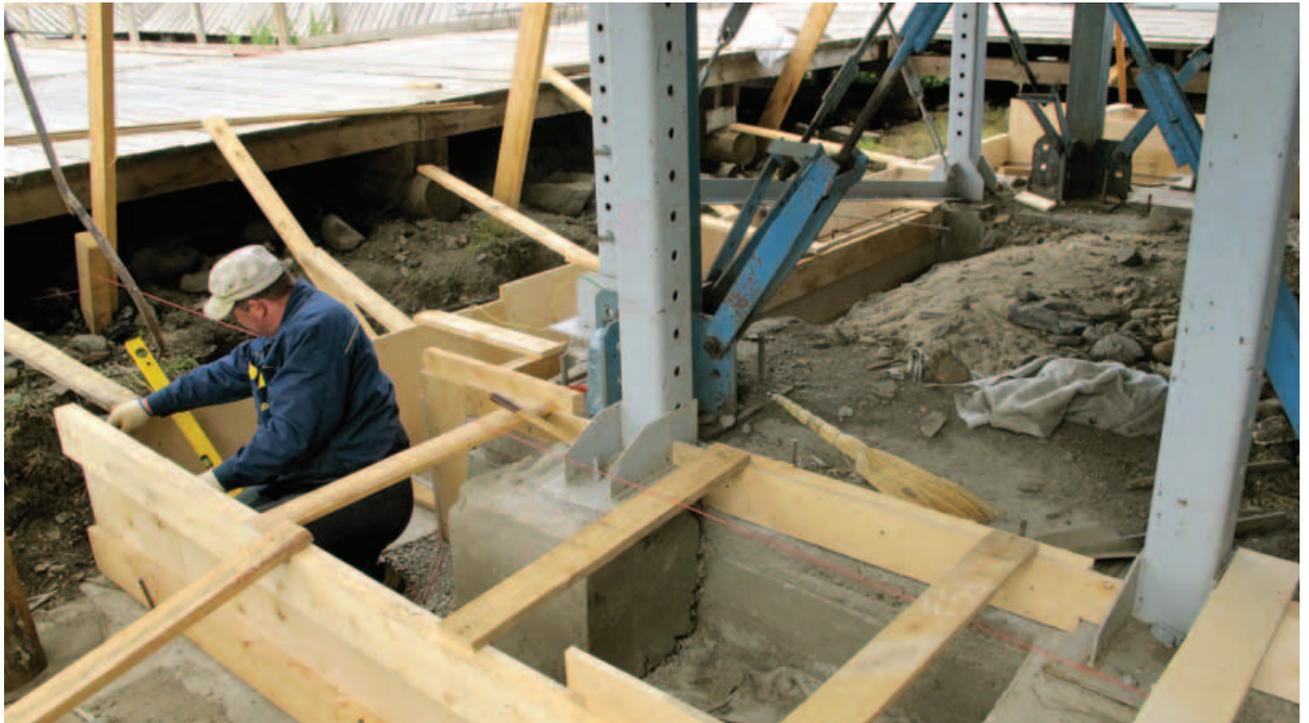
Fig. 1. Mounting of curb for grouting of reinforced concrete foundation (underground part)

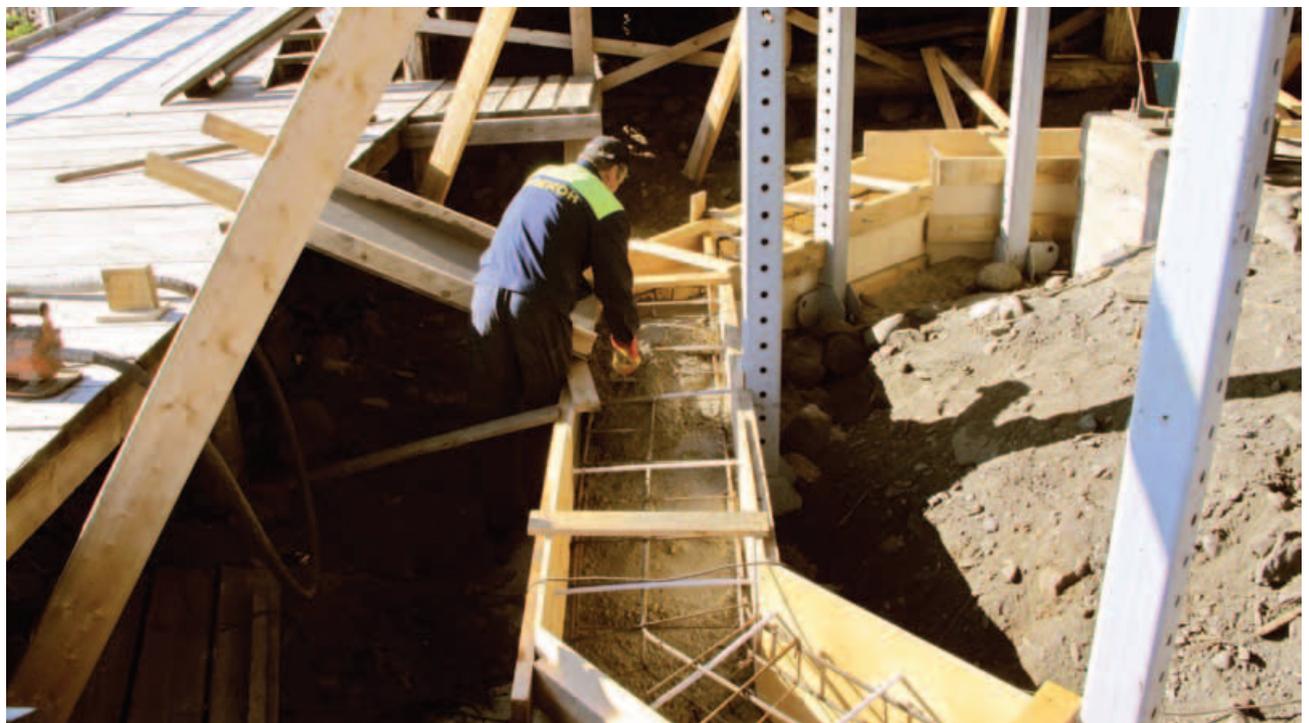
Fig. 2. Grouting of reinforced concrete foundation (underground part)

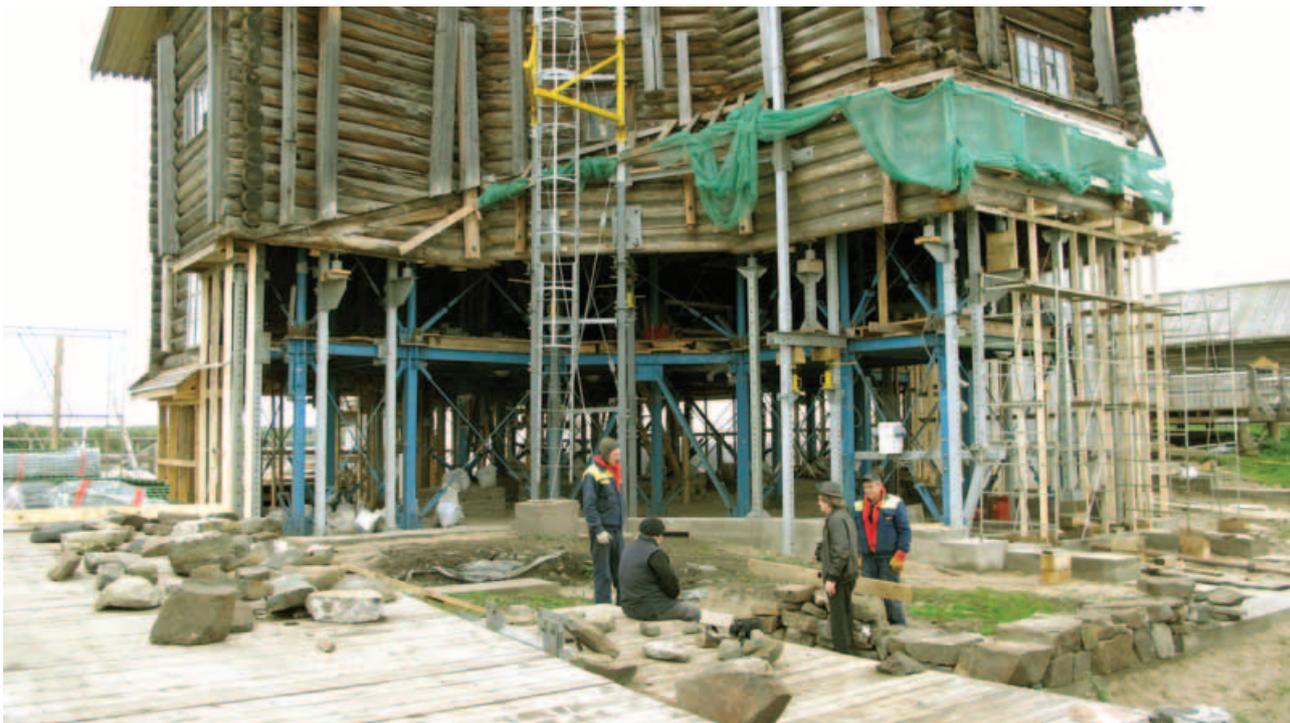
Fig. 3. Grouting of foundation and building of a pilot loose-rock foundation is completed. Dismantling of the Church of Transfiguration logs is completed.

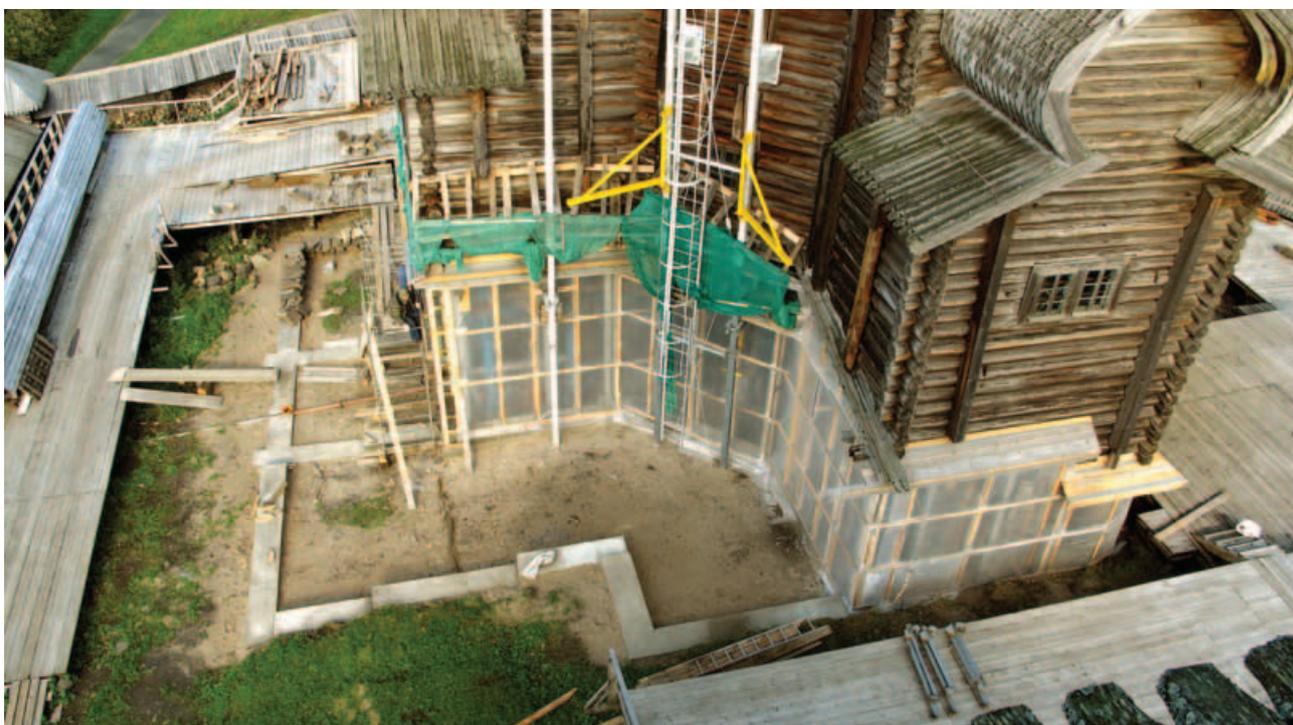
Fig. 4. Monument conservation for winter. Top view on the underground foundation part.

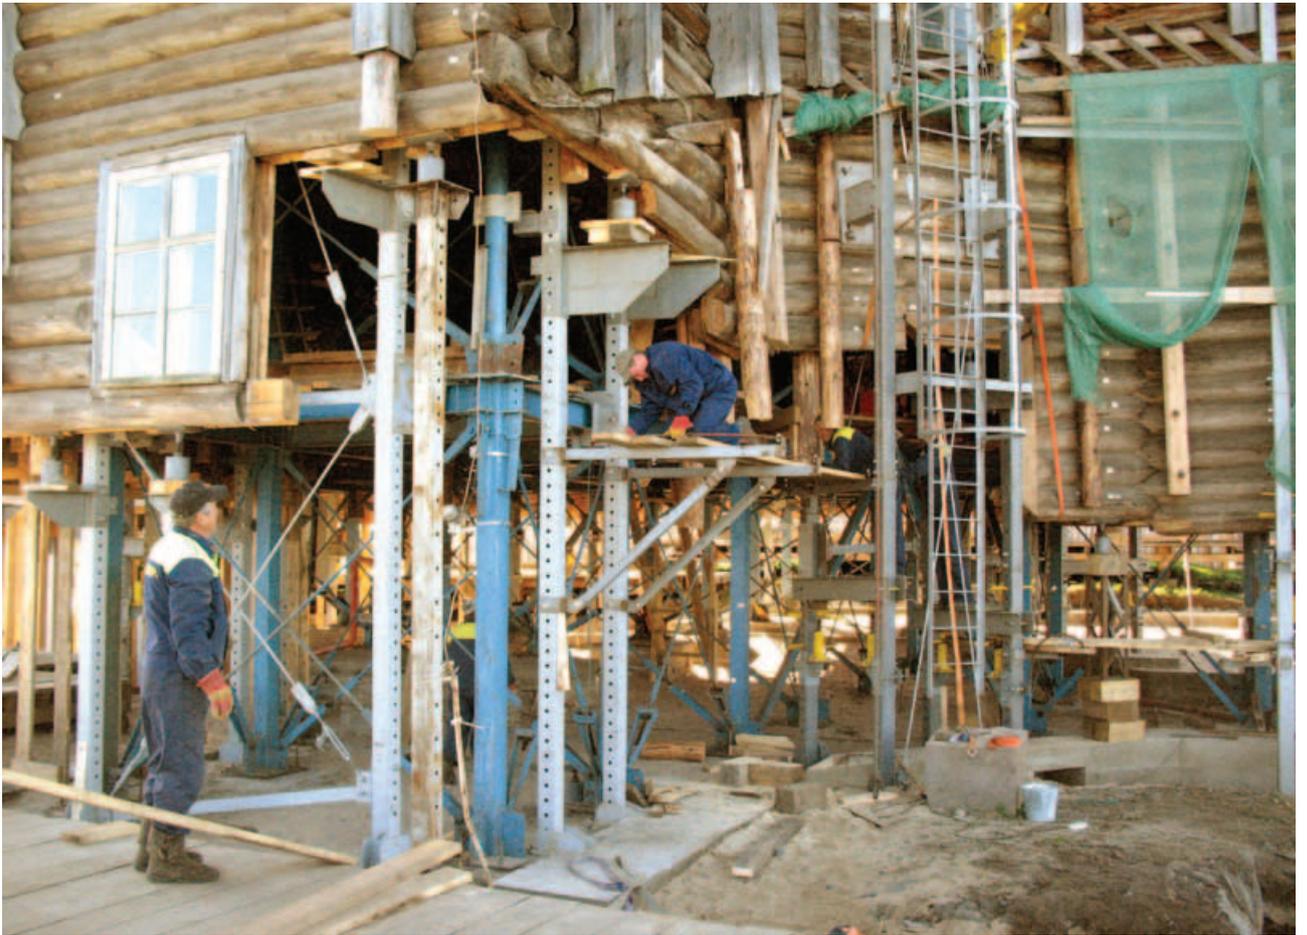
Fig. 5. Dismantling of logs from the Church framework by the use of lifting system.

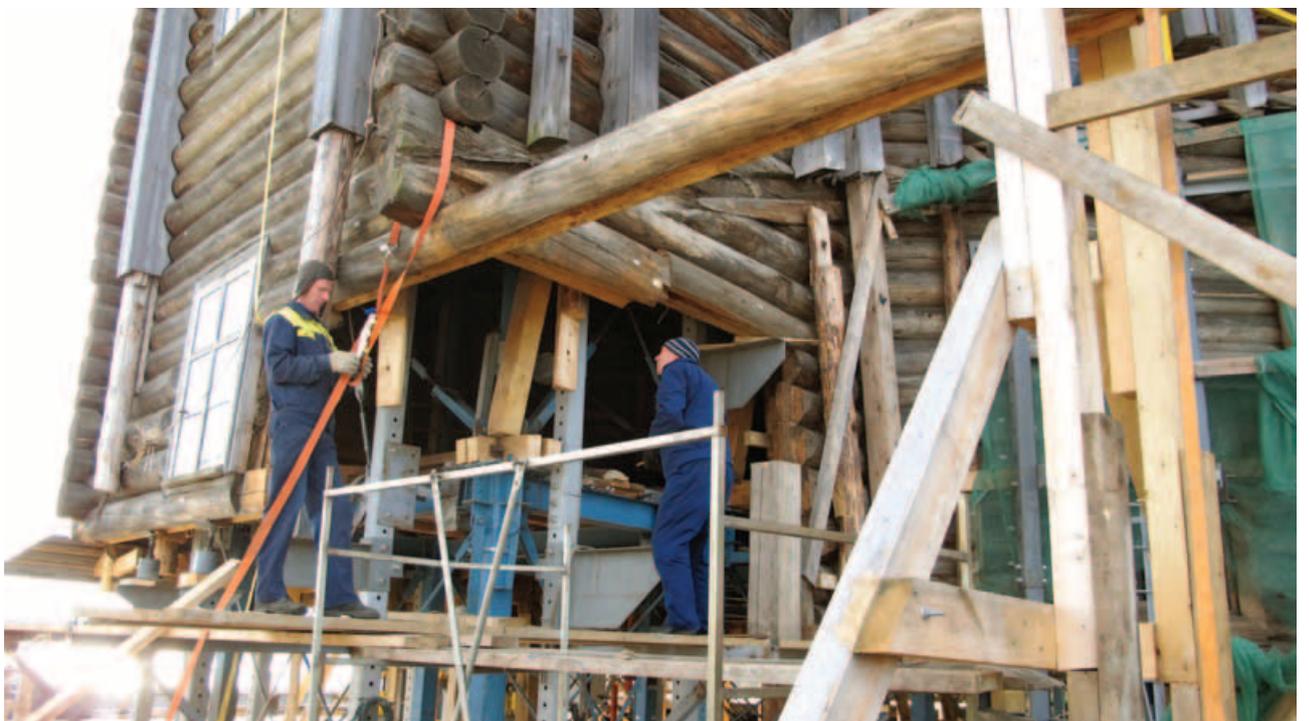
Fig. 6. Logs are dismantling by SKF "Alekon" company fitters. They have been working on the Church since 2004.

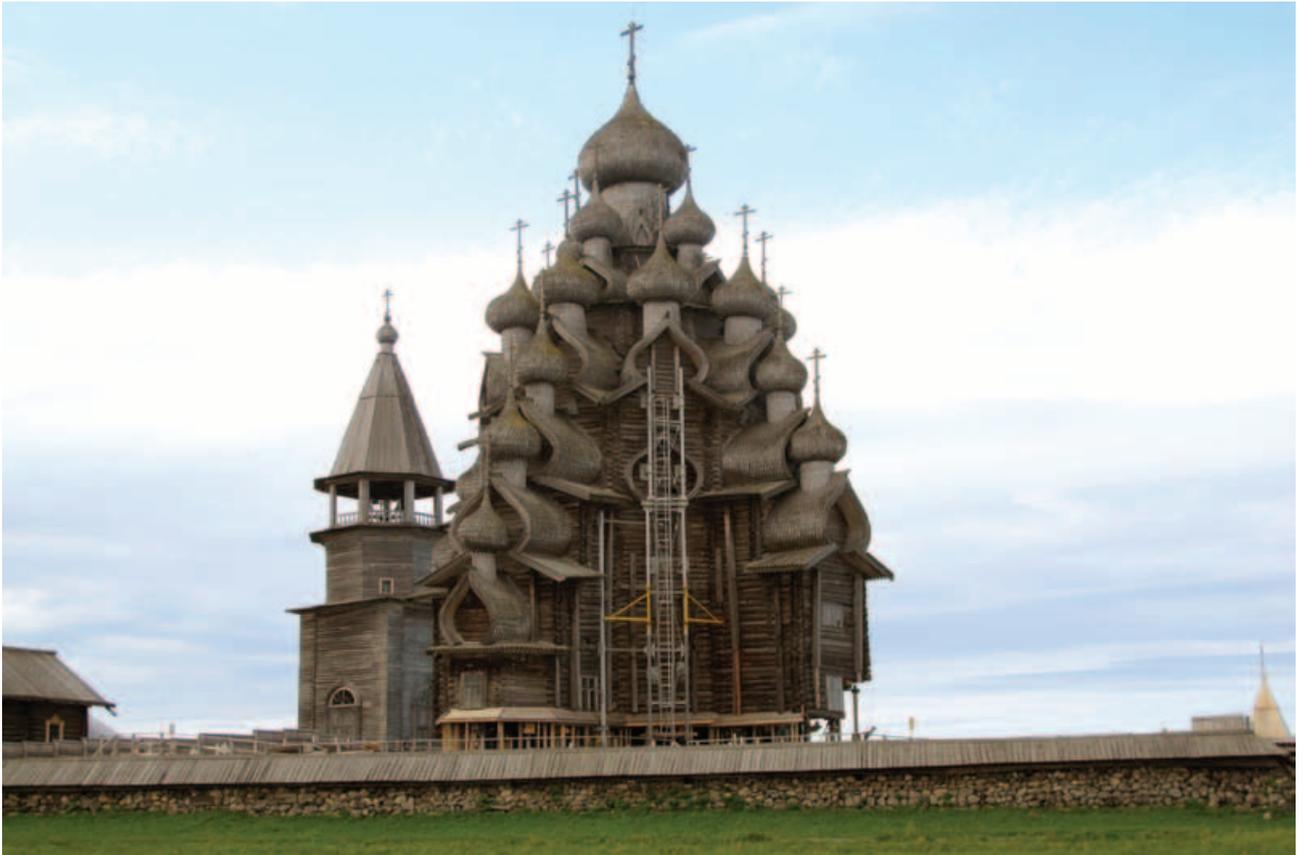
Fig. 7. The Church after logs dismantling. North-east view. Autumn 2011.

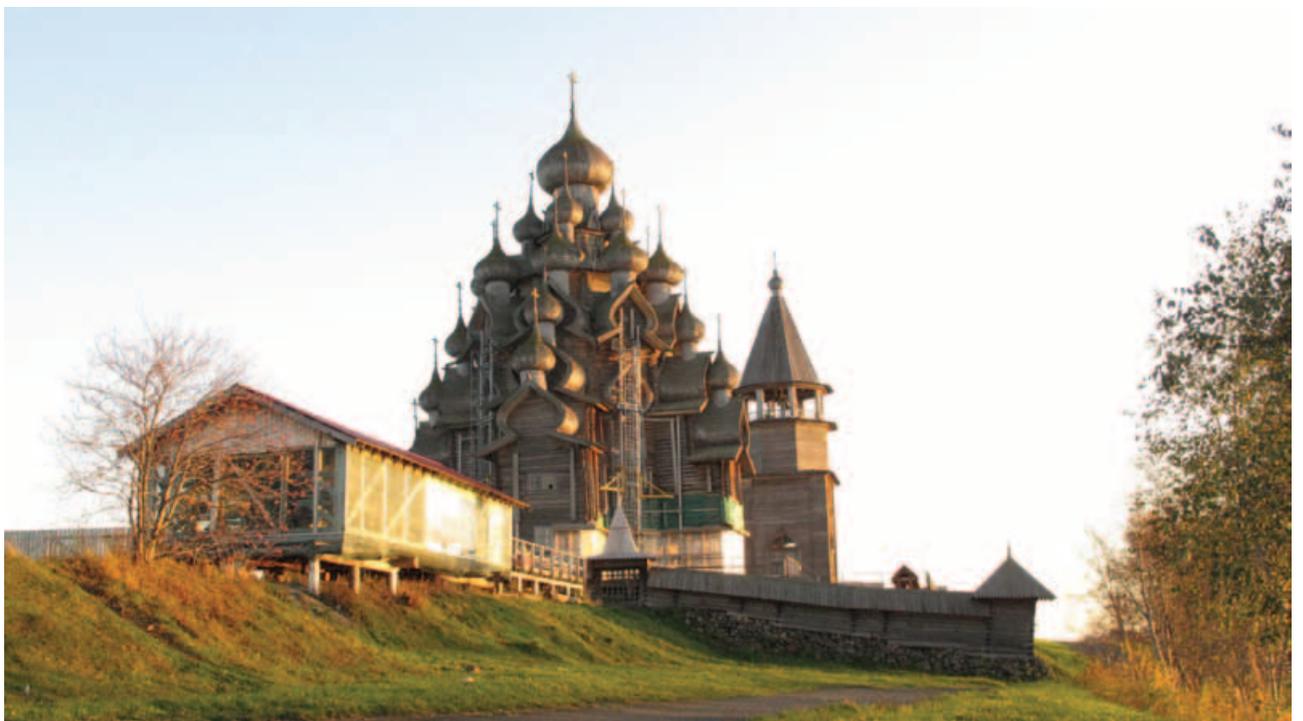
Fig. 8. The Church after logs dismantling. North-west view. Autumn 2011

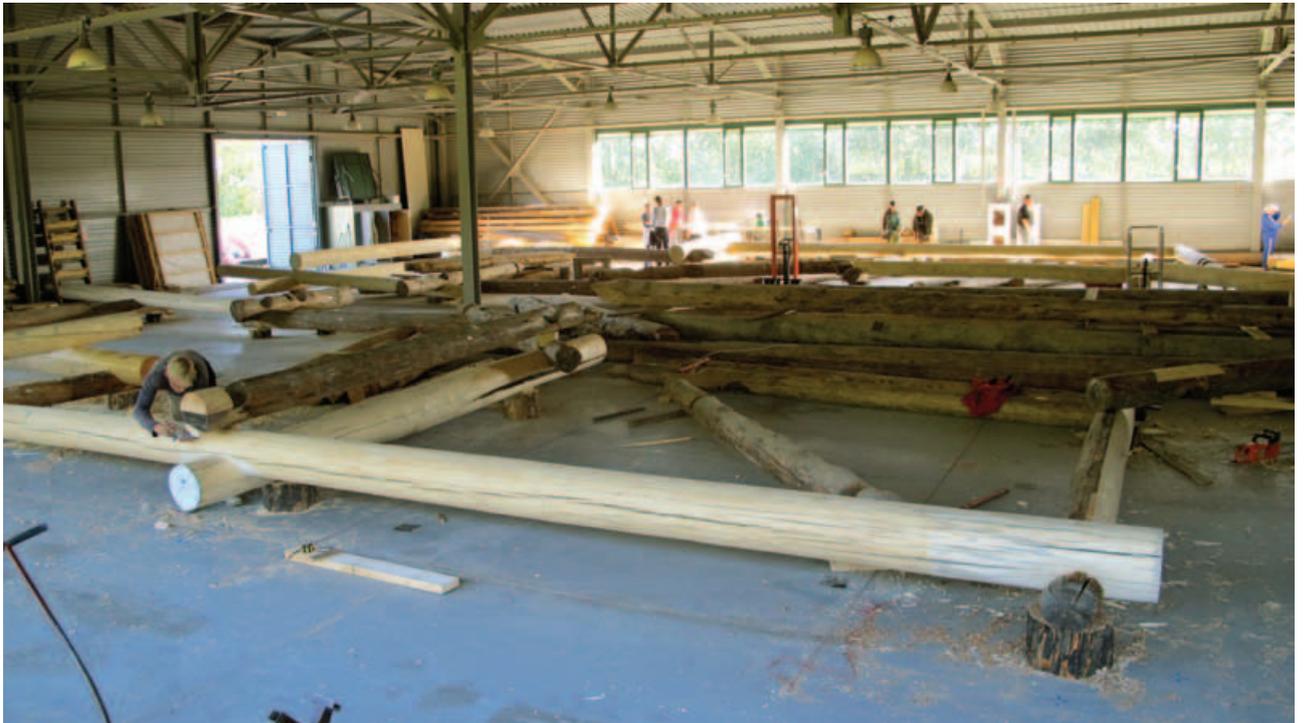
Fig. 9. Start of the monument framework assembly in new corrected outline

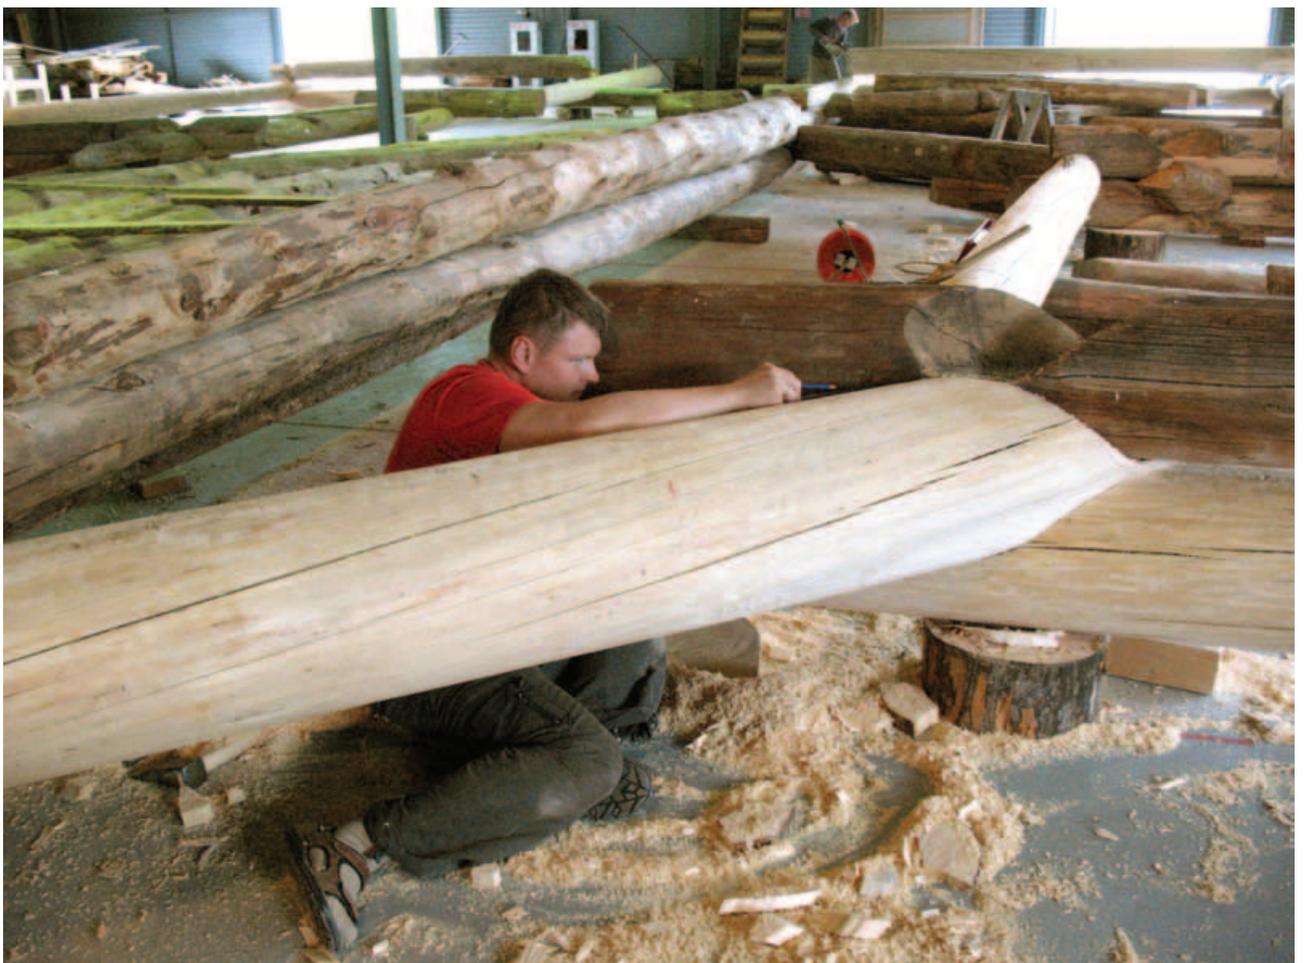
Fig. 10. Work on accurate superposition of historic and new wood in the monument framework

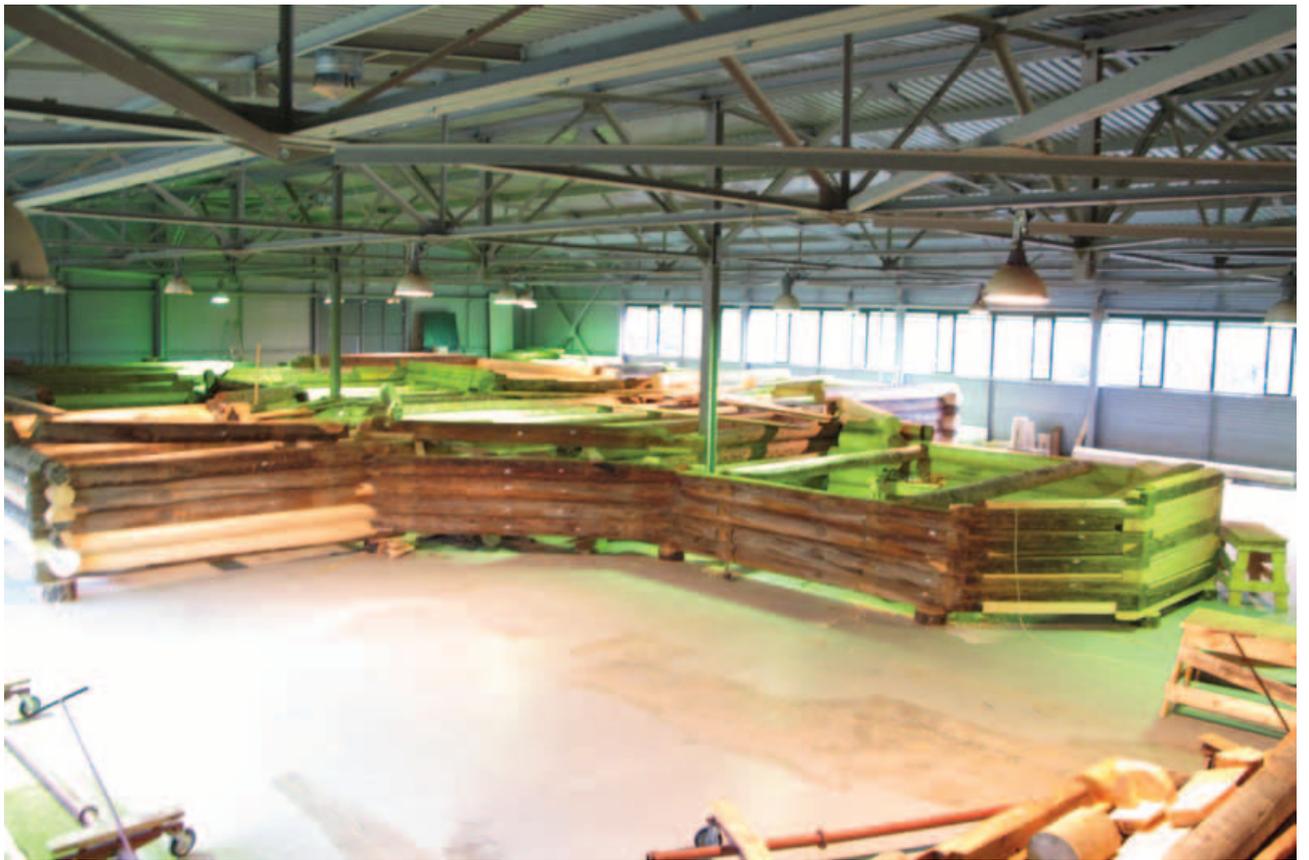
Fig. 11. Process of framework assembly

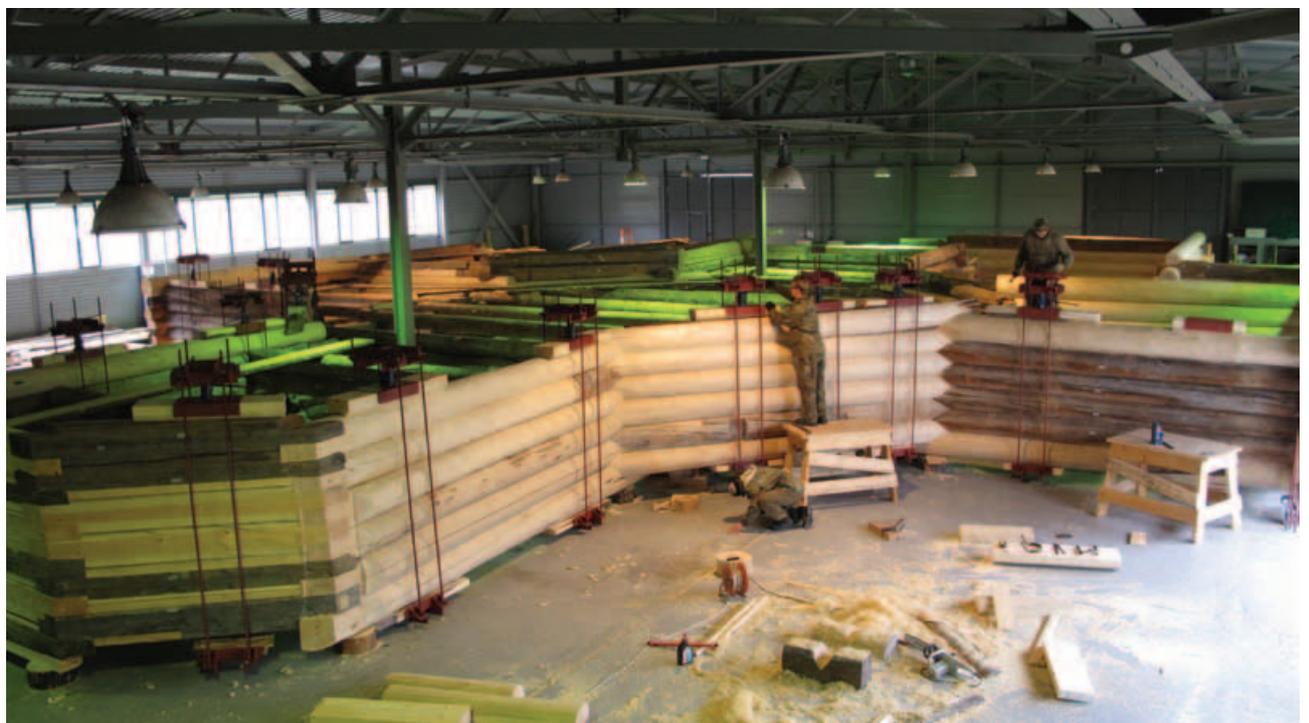
Fig. 12. Installation of metal constructions with jacks for simulation of loadings on the framework

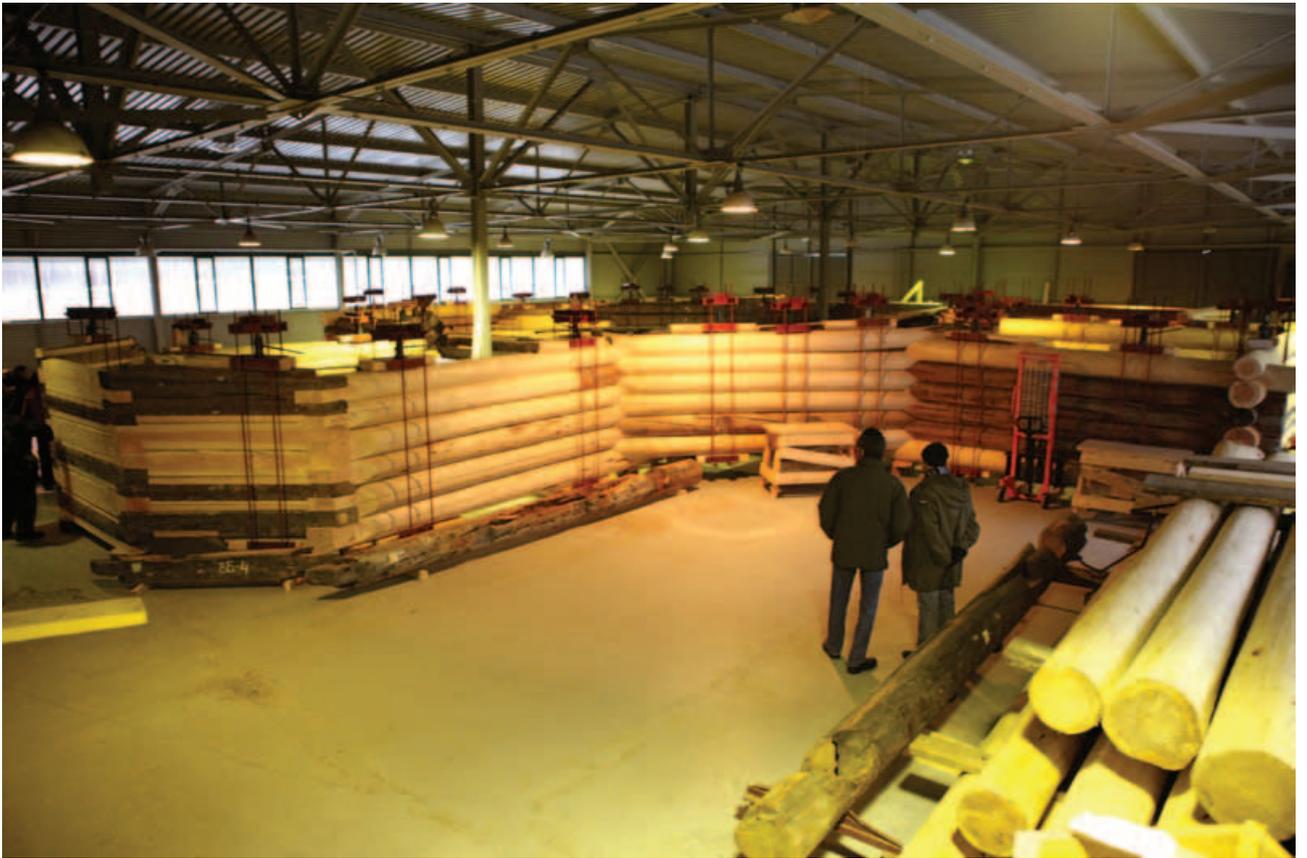
Fig. 13. Foundation after the restoration with applied load on the framework timber sets
