The Kizhi Federal Museum of Architecture and Cultural History  
Cultural Heritage Site of Special Value of the Russian Federation

## The Detailed Report

on Preservation of Kizhi Pogost Monuments  
(Kizhi Pogost, C 544) in 2012

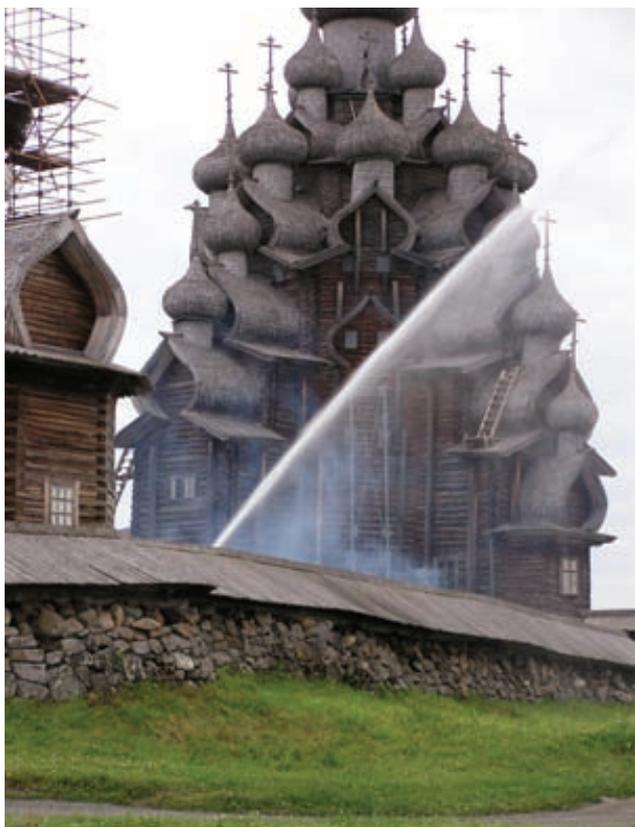
*Checking the fire-extinguishing system  
of the Kizhi Pogost*

One remote-controlled nozzle of the outdoor fire-fighting system of Kizhi Pogost was replaced; the configuration of protected zone around the Church of the Transfiguration was specifically revised for the security system with a radio-wave emitter «РАДИУ».

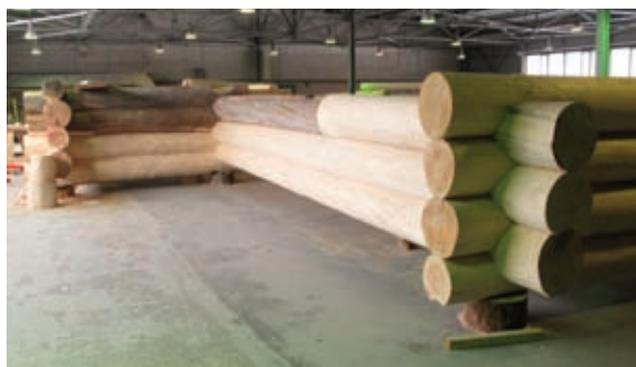
*Reconstruction of the lost lower logs of the Transfiguration Church*

The restoration and test-assembly of the 7th tier were started in 2011 in the Restoration Complex. Due to specific dimensions of the assembly department, the restoration tier was divided into two parts; the first one was restored and assembled in 2011, and the work on the second one was started in winter, 2012.

Special quality timber of the required trunk diameter was prepared and stocked in addition to the available stock, because only 25% of the original material was planned for complete replacement preliminarily but, in fact, as much as 40% need to be replaced.

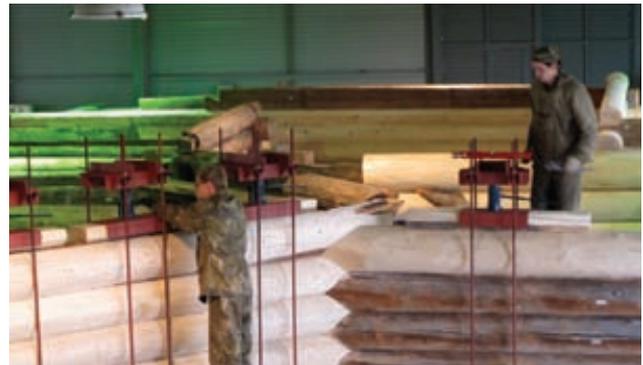
*Simulation of loadings on the restored walls*

The imitation of loads from the upper part of church on the assembled 7th restoration tier was performed likewise in 2011. Test-pressing of the assembled part was successful, no defects of restored logs found. This procedure will be applied for all upper tiers. In addition to that, the project documentation is prepared for test-pressing of the 7th restoration tier reassembled on the Pogost. It is necessary for eliminating micro deformations because the 7th tier at the moment is not loaded by the upper part of the building like usually.

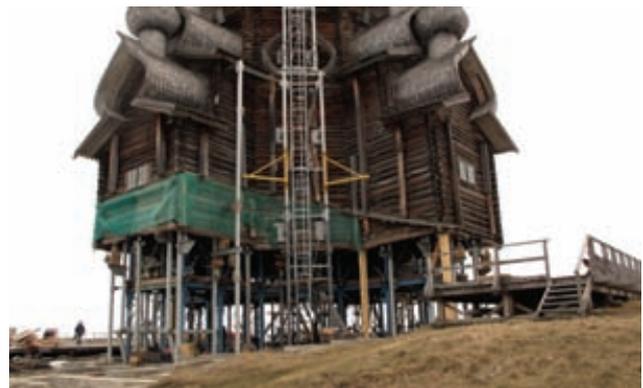
*The prepared space for the assembly of the restored tier on the foundation*

It was not any surprising situation for restorers, and it was foreseen in the production technology. This is why the first work task in spring was partial disassembly of the upper restoration tier to get enough space for the final reassembly of the 7th tier on the foundation.

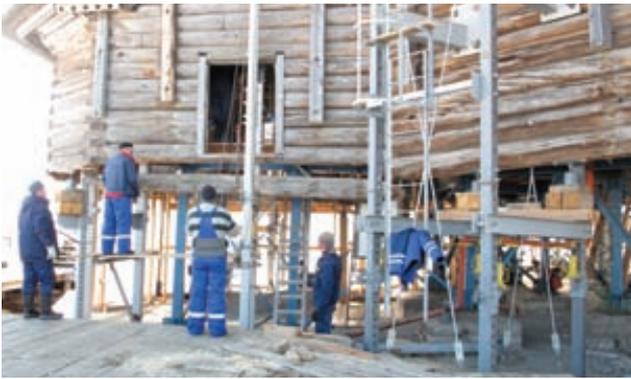
*Dismantling of the walls in spring 2012*

The process of disassembly was perfected in the earlier period. The disassembly of the dome and so-called ‘barrel’ roof above the altar was something experienced for the first time as well as the work on reassembling and disassembling performed simultaneously on the building.

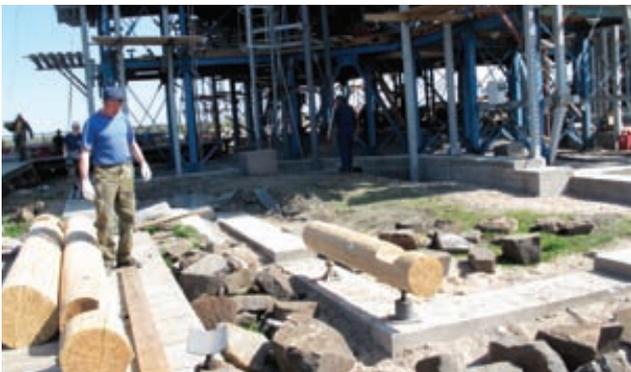
*Installation of the first log on the foundation*

In spring, at the end of May 2012 the assembly of the restored basement part of the monument (7th tier) started at its historic site. Long-term, and sometimes invisible, work of restorers started to take visible forms, the renewed Church of the Transfiguration started to grow upwards! The “empty” space started to fill with restored material that eventually formed a rather complicated in plan view (in plan, the church has 25 walls) and in elevation points (cascade construction of the walls adjusted for relief deviation) basement of the monument.

The first log-set (i.e. several logs notched with each other in their ends forming the perimeter of a building) started with the 5th row of logs. Consequently, the four lower rows of logs were not complete log-sets (did not embrace the whole perimeter) and were built in a cascade way according to relief.

In the process of the lower logs assembly it was decided to lay them exactly in the center of the strip foundations. Then, during placing the first complete log-set it was necessary to verify its geometry by checking it with the control points and, if necessary, correct it.

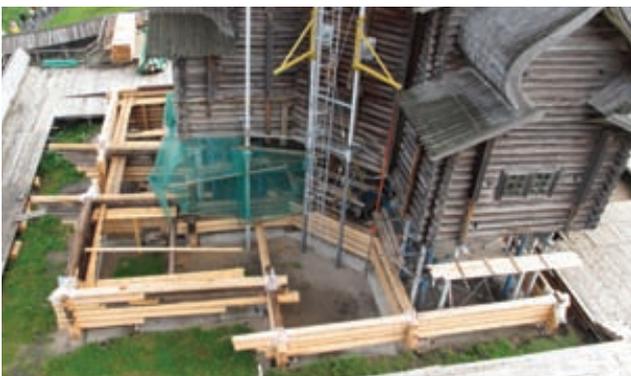
*The restored tier exactly fit the foundation of the church*

A very good result was received in the end of this stage of the work. The plan of the foundation of the church coincided with the plan of log walls within the allowable tolerances! It was not a random luck as it was carefully thought out and measured in advance on two construction sites (“Pogost” and “Restoration Complex”), where the same system of coordinates was used. The accuracy of the walls and the foundation was confirmed for the second time during the installation of the supporting beam system. All beams were nestled precisely, practically, without any gaps and discrepancies.

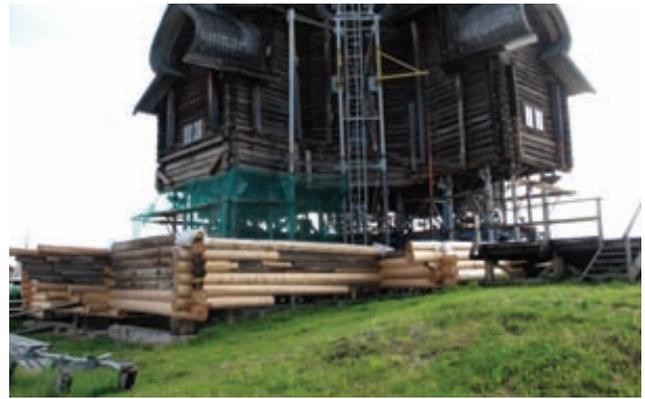
*Assembly of the restored 7th tier on the foundation*

In accordance with the working plan, jacks with special tool trays were installed around the perimeter of the foundation. Logs were placed on these movable bearings. During the walls assembly jacks were constantly lifted and lowered depending on the need until logs with the floor groove took strictly horizontal position. It is worth recalling that the difference between elevation points at the level of the floor groove was about 400 mm before the dismantling, and it made no sense to reconstruct such “uneven” floors.

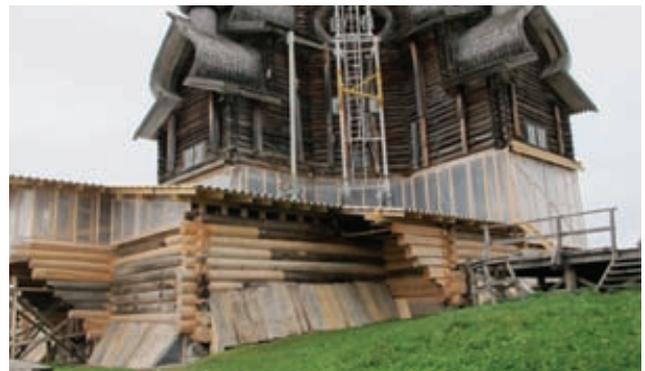
*The fully assembled 7th tier (without two upper layers of logs)*

After the walls of the basement part (7th tier) were completely assembled, the two upper log-sets were measured and taken to the Restoration Complex to base the next, upper tier during the restoration.

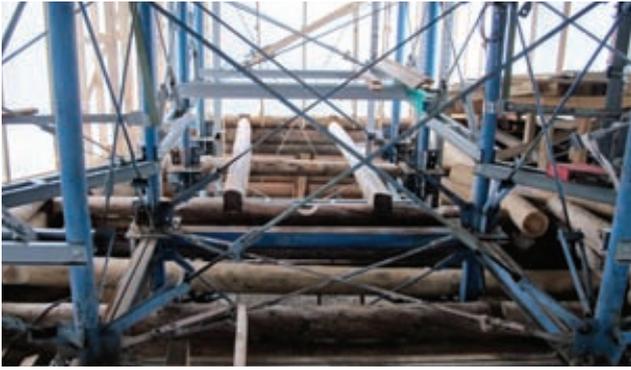
*Adjustment of the position of horizontal metal beams of the metal frame*

This experience was very useful as this situation (when wooden beams “overlap” with metal ones) can be repeated and it is quite possible that similar works will have to be done at other elevation points.

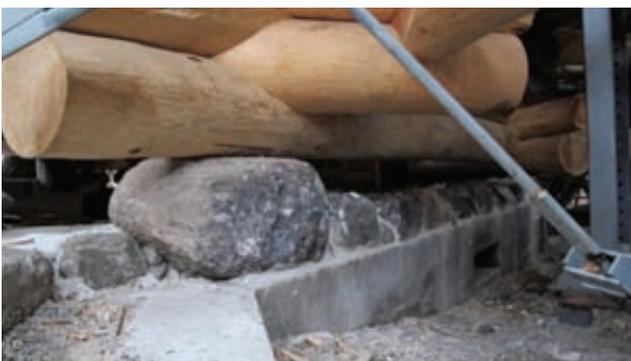
*Boulders under the corners of the walls and stone filling between the boulders*

Initially the lower logs of the basement were installed on jacks, during the summer all the movable supports were gradually replaced with stone boulders that were perfectly fitted to be placed between the foundation and the lower logs of the walls. 30 boulders were put under all corners of the walls and at the places of cascade construction of the longest walls.

Installation of large stone boulders under the corners of the walls of wooden buildings is a traditional method of foundation construction in the Russian North. The space between the boulders is filled with stones of smaller size. The original

foundation of the Transfiguration Church was made in this way.

Besides the 30 perfectly fitted stone boulders under the corners of the walls it was necessary to treat and adjust in size the stones used as a stone filling of the foundation. It is a thorough and painstaking work, which cannot be done fast. We can say that every stone in this foundation is a piece-work of stone-masons.

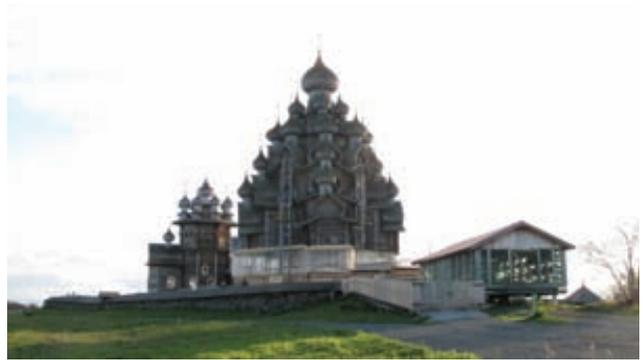
*Conservation of the Church of the Transfiguration for the winter period 2012—2013*

Besides the basic conservation works some measures were carried out to shelter the lower layers of logs and the foundation, to do preventive maintenance of the wooden flooring around the church, to test the system of lifting and fire and security perimeter alarm systems.

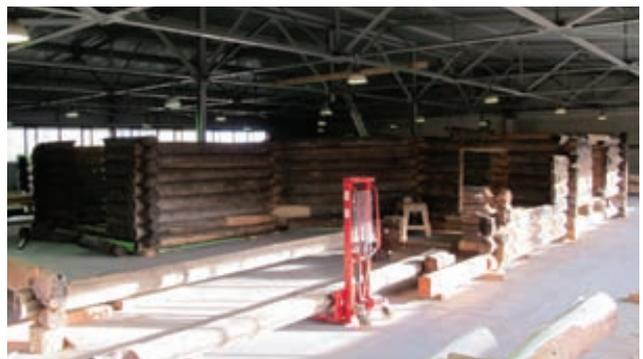
*The test assembly of the 6th tier in the Restoration Complex*

Restoration of the 6th tier started with a preliminary assembly of the unrestored walls in the workshop and the comprehensive assessment of its condition. As it was mentioned above the assembly of the restored tier is carried out on the basis of two layers of logs of the underlying tier that has already been restored.

Specific restoration decisions are made exactly at the stage of the preliminary assembly, when all deformations and defects of the logs can be seen at eye level. It should be said that the 6th tier of the monument is placed quite high and its detailed study from the outside of the wall was approximate.

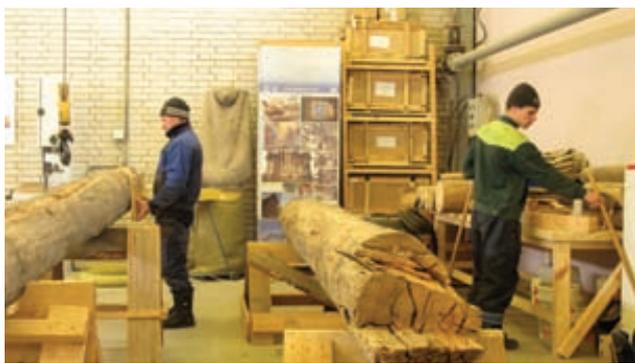
*Restoration of logs*

In accordance with the agreements concluded, contractor organizations rent the assembly workshop to perform the work (assembly of restored walls). The ‘Carpenter Center’ of the museum under the direction of A. Kovalchuk is engaged in restoring the original historical material all year round.

This approach on conservation of the historical material is very costly in terms of human and time resources. But the point of restoration is to do everything possible to preserve the element, to fight to the end. The last extreme measure is to make an exact copy of the worn out by time element.

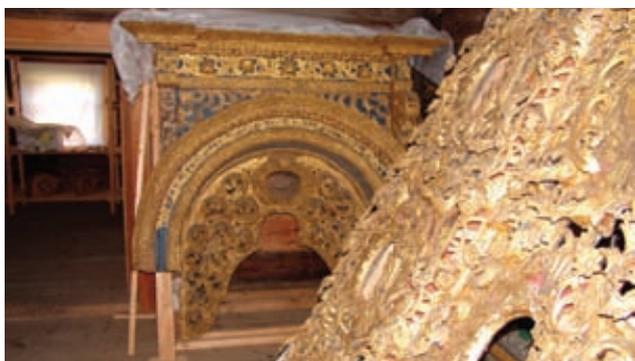
*Restoration of the iconostasis*

The works started in the second half of 2011. Removable parts of the Deisis tier were sent to the workshops of the contractor in Moscow to perform the works all year round. In the summer of 2012 the restored elements were returned. The basic tier structures could not be transported to the workshops of the Art Research and Restoration Directorate because of their considerable size and the emergency state of the gilt covering and had to be restored on Kizhi Island. The only premises that could accommodate large fragments of the Deisis

The conservation technology of the damaged gilt covering requires a temperature not lower than 18 °C.

Due to unfavorable weather conditions, by the end of the summer the temperature in restoration premises on Kizhi Island was not higher than 12—16 °C. It significantly slowed both the process of the gilt covering conservation and the restoration of the tier.
