INTRODUCTION

The following broadened report concerns measures of maintenance of Kizhi Pogost, and it is made within the bounds of recommendations announced on the 32-33 sessions of ICOMOS UNESCO.

PART I «Measures of Kizhi Pogost Maintenance»

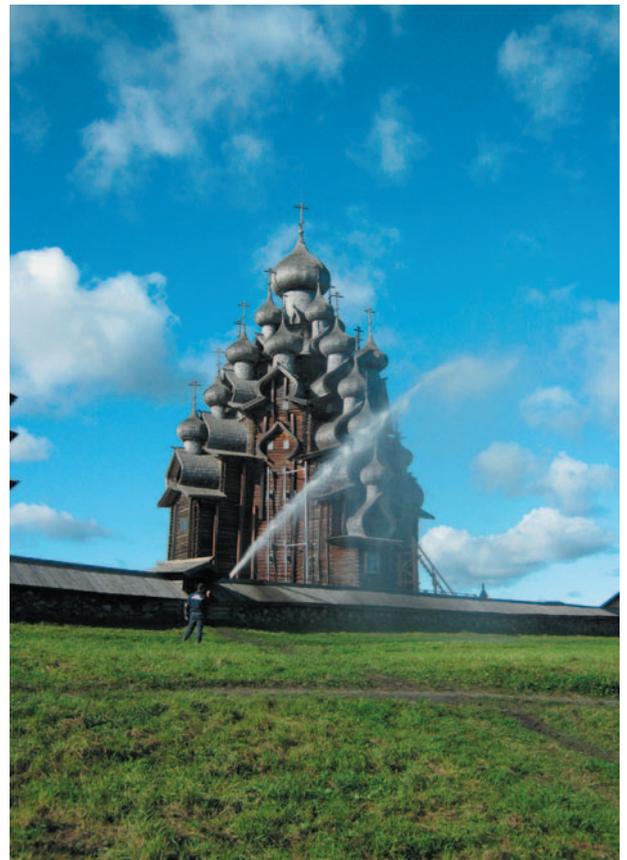
photo 1. Fire-fighting equipment tested.

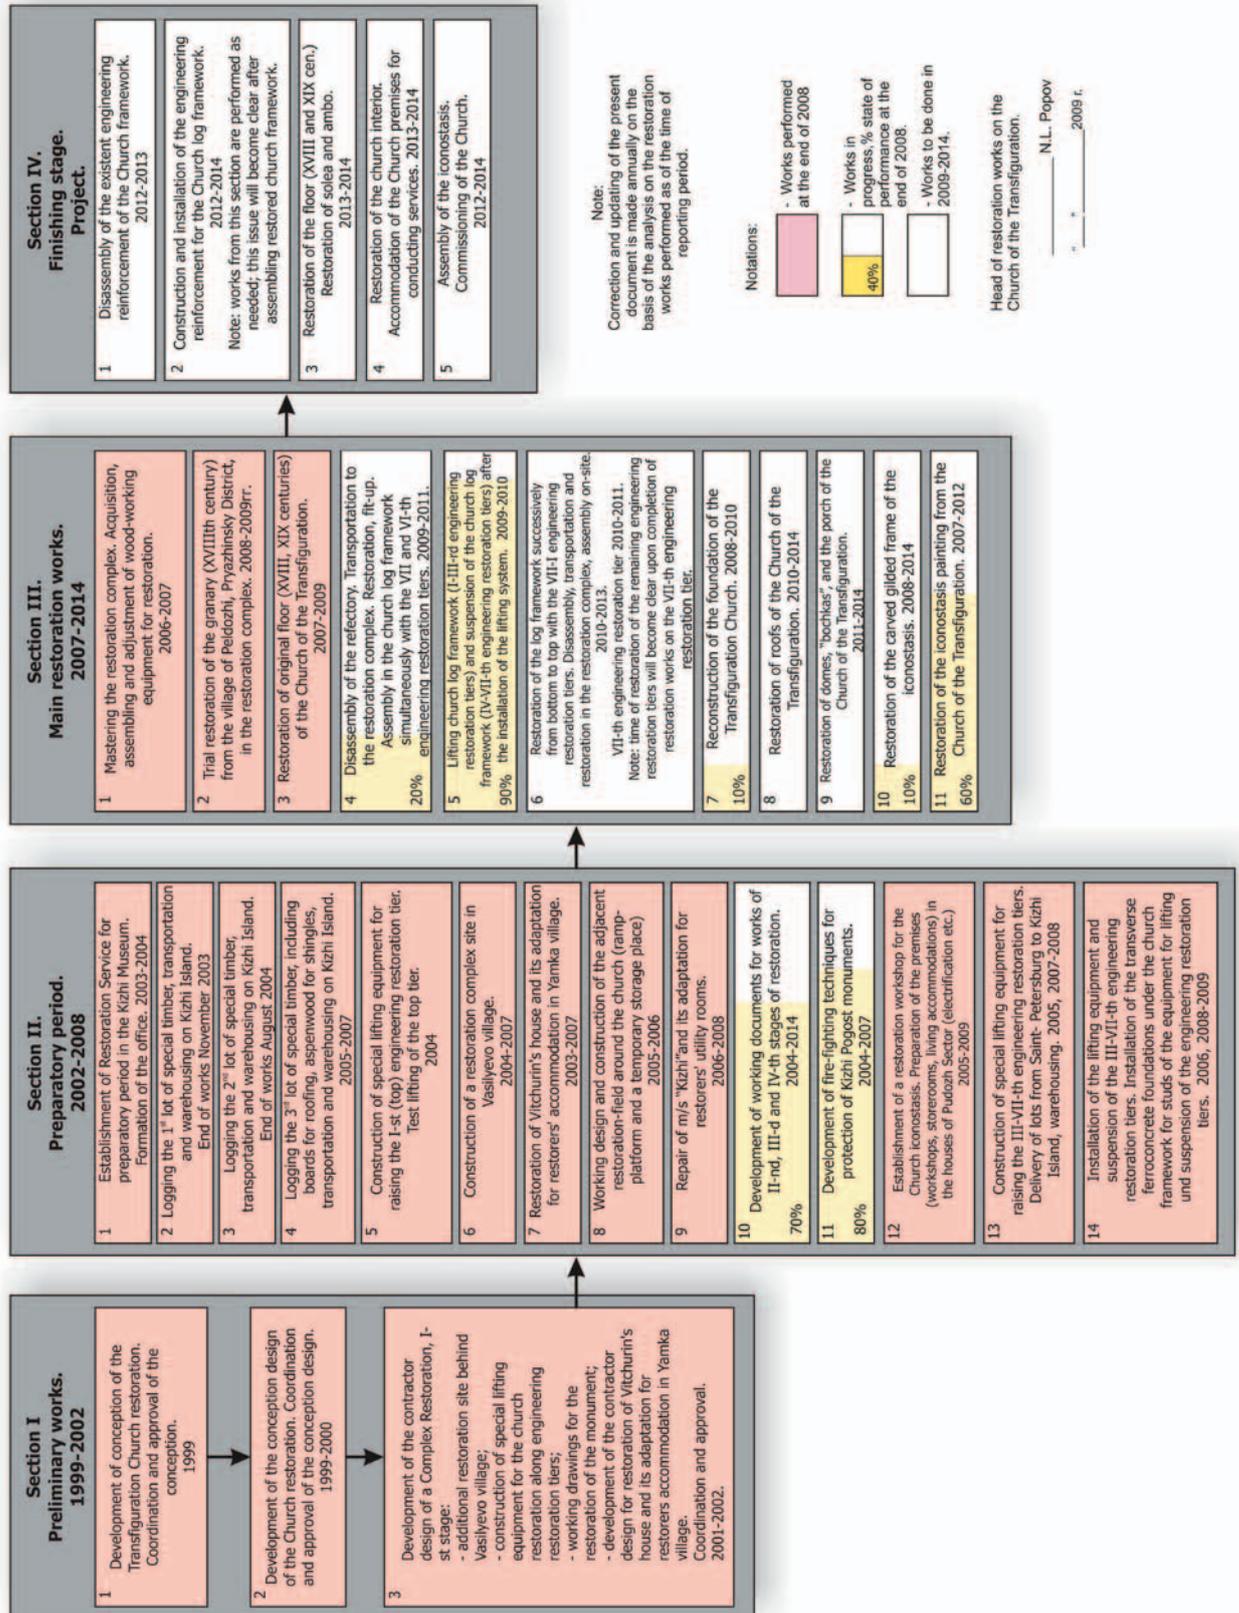
fig. 1.

Main Stages of Works on the Restoration of the Church of the Transfiguration on Kizhi Island and their Fulfillment vs. Time. 1999-2014.

The situation described as to the end of 2009.

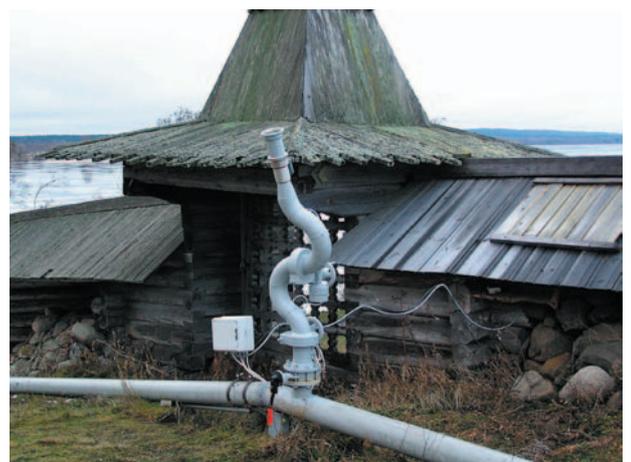
photo 2. Remote-controlled nozzles.

Two remote-controlled nozzles on the Kizhi Pogost have been replaced this year. Besides that, a year-round maintenance of fire-protection system, alarm system and video surveillance has been performed. All of the monuments on the Pudozh exhibition sector were equipped with fire alarm systems. These systems use a radio channel to inform Central round-the-clock guarding post on Kizhi Pogost about emergency situation. These buildings on the Pudozh exhibition sector were adapted for restoration workshops to restore the iconostasis of the Church of the Transfiguration.

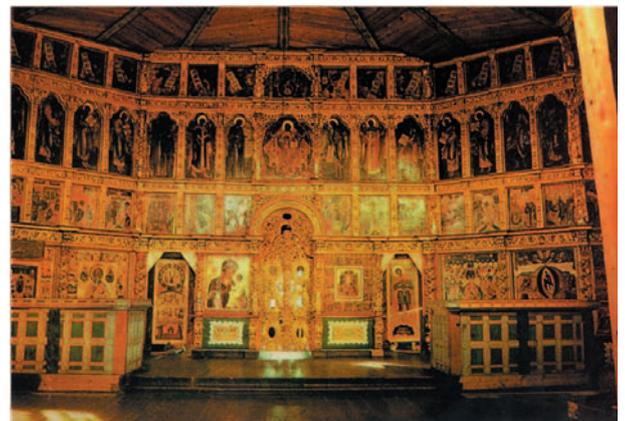
photo 3. General view of the Church iconostasis before the disassembly.

As a result, it is possible to say that the conditions for restoration of the iconostasis have been ensured, and there are no obstacles to their implementation. Restoration works have been going on in 2009. The contract was made, and a team of restorers from Moscow was successfully working in the premises of the Pudozh exhibition sector in summer. They were restoring a carved gilded frame of the iconostasis. Planned work was completed. A part of restoration works is planned for winter 2009-2010; some small parts of a carved gilded iconostasis were taken to Moscow (15 containers).

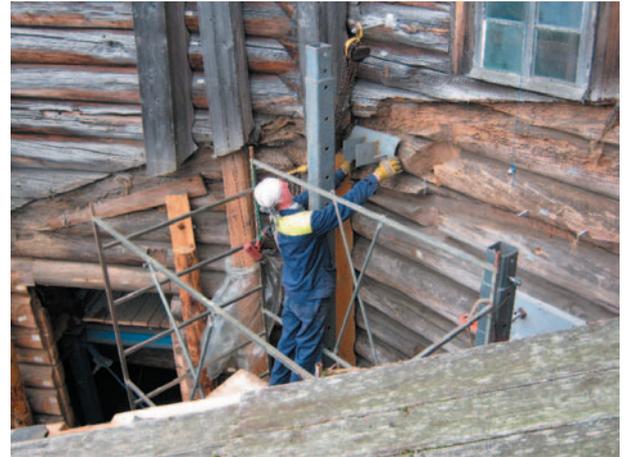
photo 4. Installation of lifting equipment.

- mounting metal constructions for suspending log walls of the main i.e. lower octagon and log annexes both outside and inside the church, with the whole metal construction resting on the prepared transverse concrete foundations (basic ones in 2008, 10 pieces, and additional ones in 2009, 20 pieces) under project 286/06-KM;

At the same time, similar constructions for holding log walls were installed symmetrically on the exterior diagonal walls and some exterior walls of log annexes, which defined a final position of transverse foundations for supports of the lower octagon. Twenty transverse beams for concrete foundations under projects 81/09 КЖ and ППР 151/08 have been produced during this summer. Supports of the equipment for lifting and suspension of log walls of the lower octagon were mounted atop foundations after 7 days of curing according to technological requirements.

Upon the completion of installation works, the system was adjusted and put into operation with the assistance of project developers. Then, the upper three engineering restoration tiers were lifted successively, which made it possible to unload the lower octagon to 150 tons. After the lifting procedures, church log walls were fixed in a new position. Thus, the volume of work planned for SKF "Alekon" Co Ltd in 2009 was fulfilled, although the commencement of works was seriously delayed (until July, 20) due to late preparation of the permission to start restoration works.

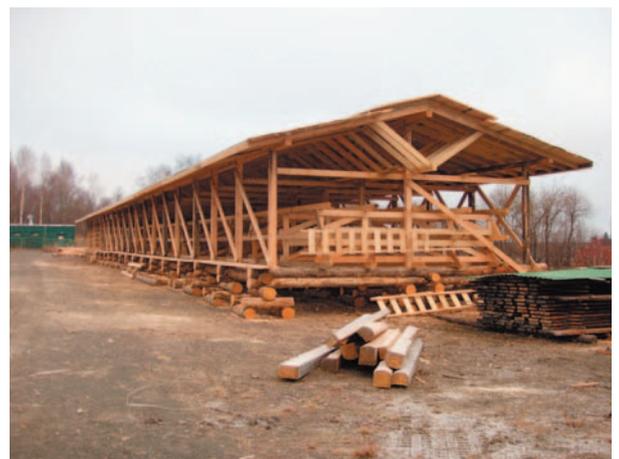
photo 5. Storage facility for the restored elements of the Church.

The production project of improvement of power supply for all the consumers of 1st rank (i.e. those of primary importance) within the Restoration Complex has been developed during last years. Electrical equipment was purchased and installed on the site. After the adjustments, round-the-clock power supply was provided for woodworking equipment, crane, resistance heating of personal service rooms, fire-fighting equipment of workrooms, and electric lighting. This is a power supply that works independently from of the primary power which is located on the mainland and works unsteady. Thus, the restoration works may be performed in the Restoration Complex twenty-four-hours and all year round. According to the work production plan, the roofed storage for the restored logs of the Church of the Transfiguration was built on the territory of the Restoration Complex between the assembly department and pumping station for fire protection in 2009. This storage facility will make it possible to use the area of Restoration Complex in the optimal way, i.e. relieve departments and storehouse of the Complex from the intermediate storage of the parts that has just entered for the restoration or has been restored before they are used in the further stages.

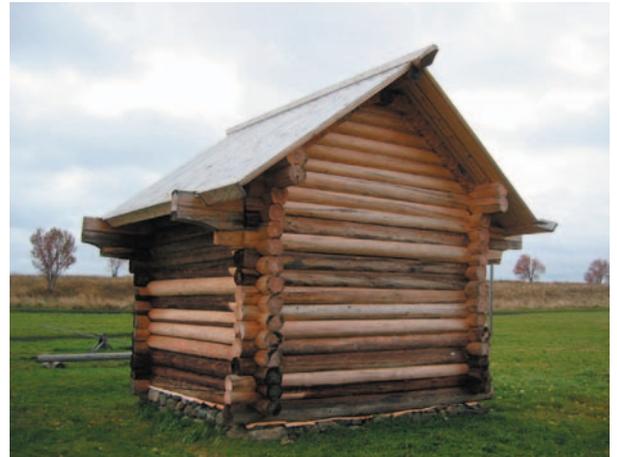
Log walls of the granary built in the XVIII-th century and included in the list of Kizhi Museum monuments is almost identical in age, method of cutting, degree of preservation and condition of joints to the log walls of the Church of the Transfiguration, especially 2nd and 3rd octahedrons.

Logs in both of the buildings are noted for a good state of preservation on their inside surface (i.e. facing the interior of the monument), meanwhile their external surface is almost disrupt or even ruined in some parts. The external surface of logs located in the south-eastern portion is especially damaged because these logs are most liable to sousing from the rainwater that trickles down the walls and to slanting rains during cross winds, and besides that, they are exposed to intensive solar irradiation. As the result of all the reasons mentioned above, sapwood on the external log surface started to crack, water penetrated into the cracks and rather deep tubular mould generated in these parts of the logs; this is quite often the case that water was running all along the logs penetrating into the log joints and the log ends protruding from the corners which increases logs rotting.

photo 6. The granary from the village of Peldozi after restoration.

The granary was disassembled, the logs were carefully inspected, and afterwards restoration techniques were developed for each of the logs. The conditions of the Restoration Complex made it possible to use different approaches to methods of restoration. At the same time, various well-known and new technologies of woodworking applied in log restoration were used and tried: lengthening, assembly on long connectors (wooden rods), putting insertion pieces and grooves applying glue junctions of phenolresorcin glues, preliminary assembling of the log walls inside the assembly department of the Restoration Complex.

The experimental restoration of the granary proved in practice the correctness of the chosen restoration technique for logs and reassembly of the log buildings. Besides that, it gave the opportunity to gain work experience of performing such tasks, and this experience helps to prepare for the restoration of log walls of the Church of the Transfiguration and have well-prepared, qualified carpenters-restorers at hand. The process and results of the restoration done on the granary from the village of Peldozi are stated in the report on the restoration which is available in the archives of the Kizhi Museum. In April 2009, the restored granary was set back on the exhibition.

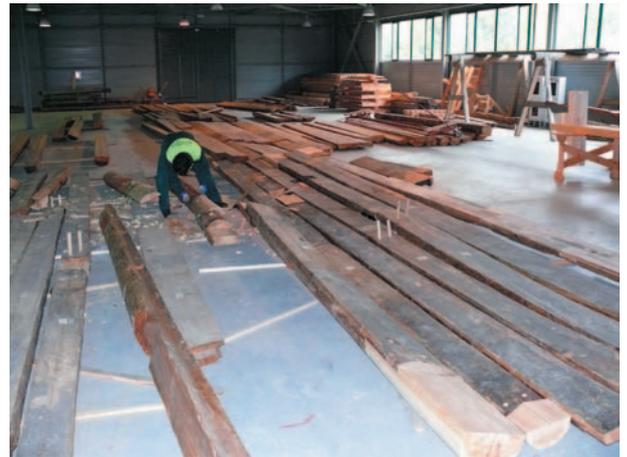
photo 7. General view of the assembly department with the Church floor components being spread and prepared for restoration.

1. Cleaning the altar, church proper, refectory and solea portions of the floor from dust and surface contamination with a high-pressure apparatus. The cleaning was done during frost-free season by air-drying. An average water discharge was 35-40 liters per component. Moist factors before and 7 days after the cleaning did not vary in more than 2%.
2. The restoration works were done on some elements of altar and solea floors, northern and southern log annexes, central portion of the church proper and included the following:
 - extracting defected elements;
 - producing and fixing insertion pieces.

3. Manufacturing, adjusting and fixation of insertion pieces for joining sawed elements and structural timber lengthening for the components that have losses. The fixation of insertion pieces on the restored elements was done with adhesive composition "КАККОСИНОЛ 1714/2520" using additional pegs of birch wood. Insertion pieces for lengthwise fixation were produced for the elements that are supposed to be jointed and their total length is more than 7 m; these insertion pieces were fixed from one side of the defected elements.

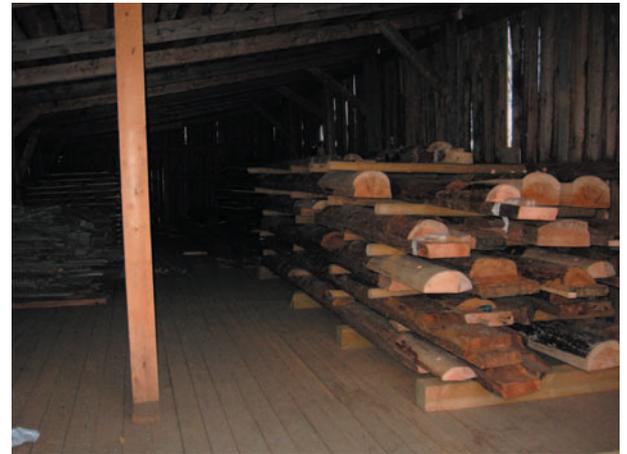
photo 8. The restored floor components are stockpiled before the restoration on Pogost.

8. The restored elements of the floor are stocked in the storage area, detailed tables and maps of stacking are made. The lower tier is set on the antiseptically treated beams 15x15 cm. placed with 1m spacings; The rows were interlaid with antiseptical poles (diameter 7-9 cm) treated

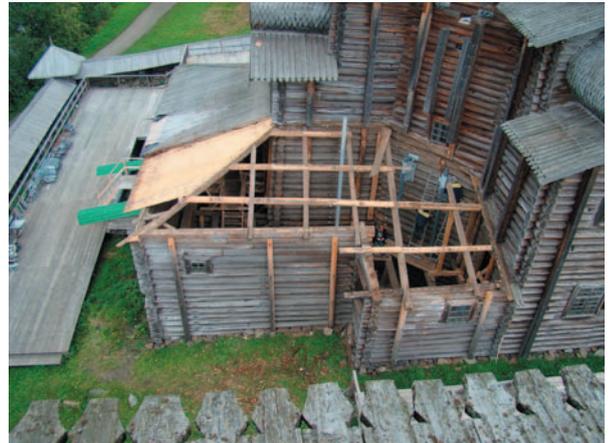
photo 9. The disassembly of the refectory in progress.

Disassembly of the refectory was done in September-October 2009 according to the work production plan developed by "Spetsprojectrestavratsiya" Institute: «Disassembly of the refectory of the Church of the Transfiguration. I-st stage of work». The work was done by a team of restorers (8 persons) from Karelia, «Restavratsiya» Co Ltd, the town of Sortavala. Permission to start works (Nº 05-4/141 as of July,1, 2009) was acquired in advance on the basis of tender; Government Contract Nº 29/09 as September, 3, 2009.

- removing upper logs of refectory walls, window and doorcases;
- removing floor beams of the refectory;
- removing stone infillings of the foundations and adjusting lifting jacks under the lower rows of logs;

- removing lower logs of refectory walls;
- transportation, cleaning and storing removed parts in the Restoration Complex;
- ground leveling operation and construction of drainage pipes from under the foundation of the refectory;

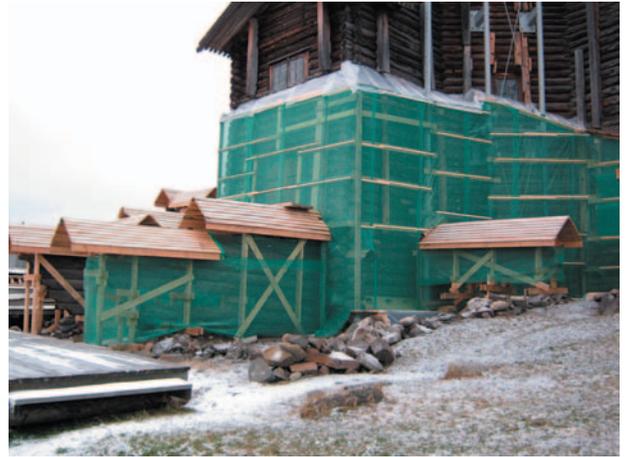
photo 10. The refectory after the disassembly.

All of the works were done in compliance with the developed project; daily engineering supervision was implemented by the experts of the Kizhi Museum, field supervision was done by the project developer. The opportunity to remove some more wall logs presented itself in the course of works. These works were done by the contractor. All the parts that have been removed are stored in the Restoration Complex in a special storage and prepared for restoration which will be done by the «Carpenter's center» of the museum in wintertime.

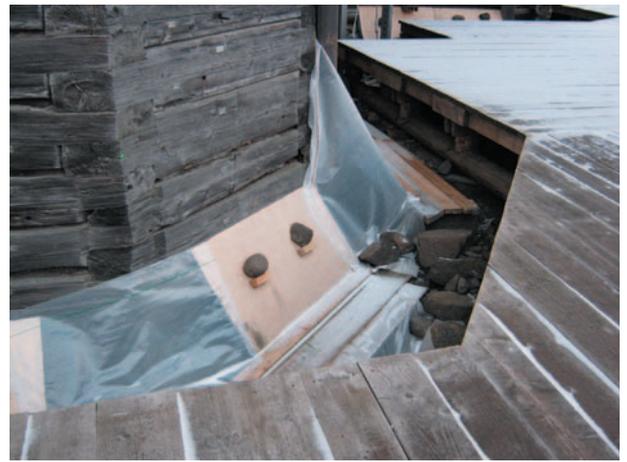
photo 11. Conservation of the foundation posts.

(supports) of suspension equipment was developed in 2009 by «Stroyrekonstruksiya, » Co ltd, under the contract with the Kizhi Museum. These foundations were laid, and supports for suspending church log walls were installed. The total amount of the foundations laid in 2008-2009 equals to 32. (See draft «The layout of foundations for the studs of suspension equipment, » 2009, the as-build).

Thus, works on transverse foundations is the first stage of the reconstruction of original strip foundation, and it continues in 2010. Date for sections III.8-III.9 is not due yet.

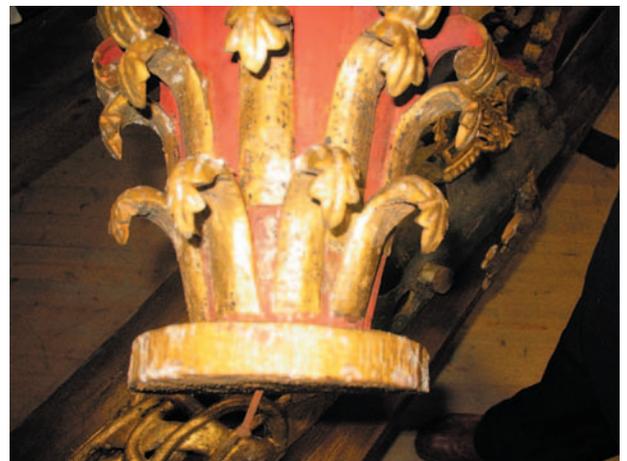
photo 12. Gilt cap of the iconostasis of the Church of the Transfiguration.

In 2009, the Kizhi Museum has completed a long period of preparatory works and started the restoration of the golden frame of the iconostasis of the Church of the Transfiguration.

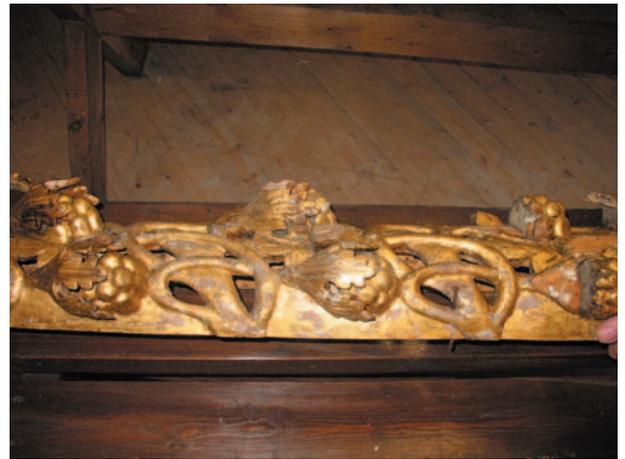
1. During the restoration, it turned out that the condition of gilding requires much more complicated methods of restoration than it was supposed. Thus, it is necessary to take into consideration the increasing volume of works and their cost as well as the prolongation of restoration period.

photo 13. Carved gilt element of the frame of the iconostasis.

2. The experts of the Kizhi Museum had stressed the importance of restoring carvings and woodwork more than once before the restoration works actually started. However, the necessity of wood restoration and work of restorers were not taken into consideration in preliminary calculation of works done gratuitously by the Regional Department of Restoration (MHPXY) in 2007 - 2008, and thus funds have not been allocated. The very essence of the problem is that skilled experienced carvers are missing in many of the restoration centers in Russia and the Regional Department of Restoration (MHPXY) as well. Some measures were taken in this connection. Three wood restorers of the Kizhi Museum have been studying in the State Institute of Restoration, The Russian Museum of Cultural History, in Grabar's All-Russia Restoration Center during last five years and were admitted to restoration works. Their trial work has been approved by the Regional Department of Restoration (MHPXY). Museum restorers of paintings developed damage statements for the lower and local tiers of the iconostasis frame during 2009; the damage statement for the festive tier is almost completed. Thus, museum restorers of paintings can take part in current restoration works and the subsequent monitoring of the iconostasis condition since 2010.

3. The restoration of a gilt carving is quite a complicated work, and the schedule of works is very strict, the first of the two mentioned points implies that more restorers are needed, and the second one that these works must be done all year round; The accommodation for five persons was arranged in the annex to Belyaev's house, and in the smithy of the Pudozh exhibition sector. However, total accommodation area is 20 sq.m. which is hardly enough for five experts in summer time and cannot be used all year round. The only way to solve the problem of insufficient living area is purchasing at least two accommodation modules. Otherwise, the restoration may last decades or more.

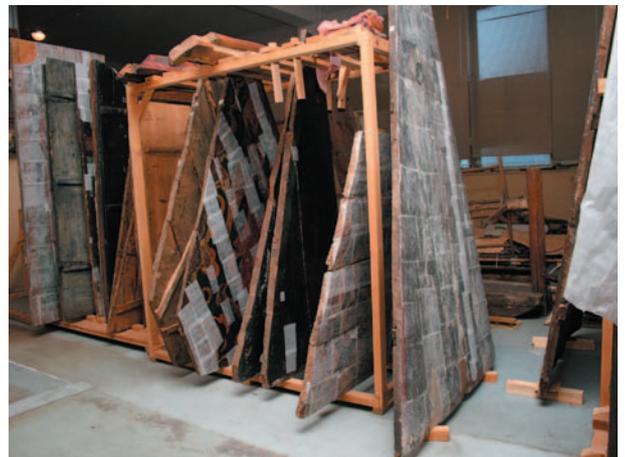
The icons were removed from the iconostasis of the Church of the Transfiguration for storage in 1980; their condition is controlled by the museum custodians. The icons are restored when needed, and this guarantees their safekeeping; in some cases, only measures of preservations will be needed to keep icons in good condition. The volume and nature of these measures will be clear in the mid-term of the restoration i.e. closer to the very moment of placing into the iconostasis frame.

photo 14. The icons are stored and protected.

For reference: it is obligatory that works on conservation of icons of such a value are performed once in 10-15 years or, even oftener for some of the icons. Icons of the Local tier obviously need some restoration. Museum restorer Kuusela N.S. completed a study course of "Restoration of the Old-Russian Paintings" in Grabar's All-Russia Restoration Center in November, 2009, and this event opens up the opportunity to raise the level of attainments and performance quality of promising young specialists, who are ready to help in restoration of the iconostasis paintings in the Church of the Transfiguration when the time comes.

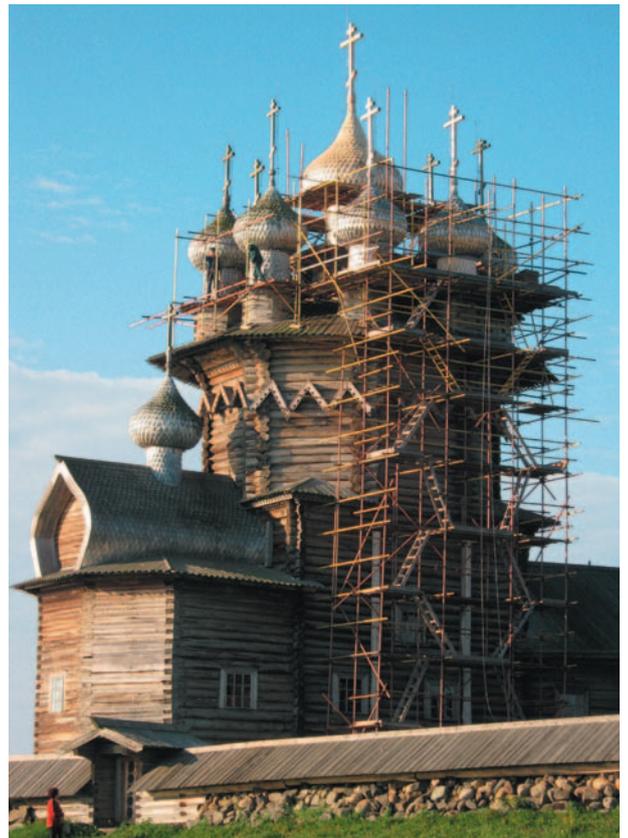
photo 15. The restoration of the domes and roof of the Church of the Intercession in progress.

Restoration of the roof of the Church of the Intercession has been performed during this year and is still in progress. These works are implemented according to suggestions on preventive and maintenance work developed by the Kizhi Museum and in compliance with permission № 11 - 14/647 issued by the Ministry of Culture of the Republic of Karelia on the 22 of October, 2008. The conservation works, on the condition that they are done in time, may protect the monument from leaks.

The restoration of the central dome and two eastern satellite domes of the octagonal part of the church was accomplished in 2009. The tightness of roofing and joints was restored; part of shingles and crosses was replaced.

The next stage of heat treatment of lesion focus of wood-boring beetle has been implemented. Thus, up to date all of the most serious lesion focuses of wood-boring beetle on the church log walls have been treated with heat. Treatment of the roofing of the church proper is planned for 2010. In 2009, "Spetsproiectrestavratsiya" Institute (Saint-Petersburg) accomplished the complex inspection of the church constructive elements and I-st stage of the restoration in line with the contract with the Kizhi Museum, which implies restoration of the roofing, domes, log walls of the church proper, and the church porch. These works will be done by the "Carpenter's center" of the Kizhi Museum.
