The Kizhi Federal Museum of Architecture and Cultural History  
Cultural Heritage Site of Special Value of the Russian Federation

# The Detailed Report

## on Preservation of Kizhi Pogost Monuments (Kizhi Pogost, C 544) in 2010

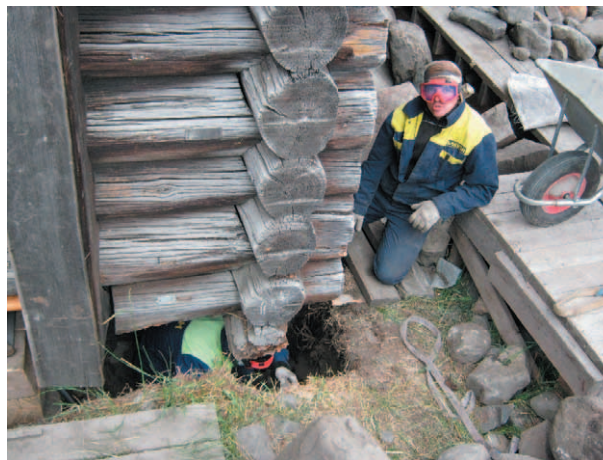
Fig. 10. Reconstruction of foundation

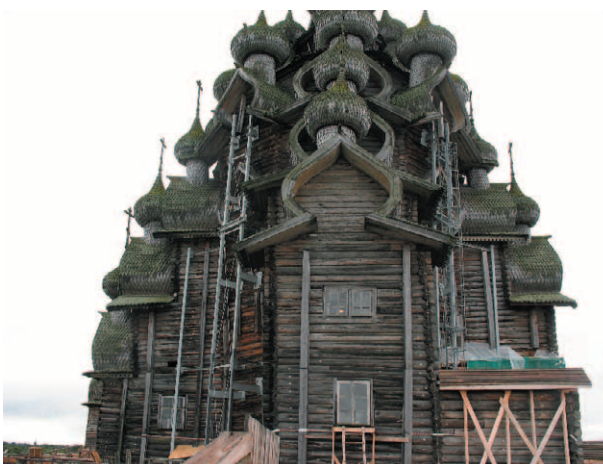
Fig. 11. External lifting uprights, general view from north

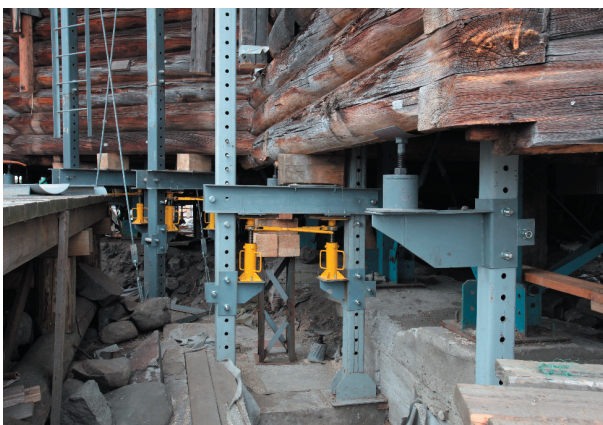
Fig. 12. Movable lifting mechanisms of lifting system: a console, beams and two types of lifting jack

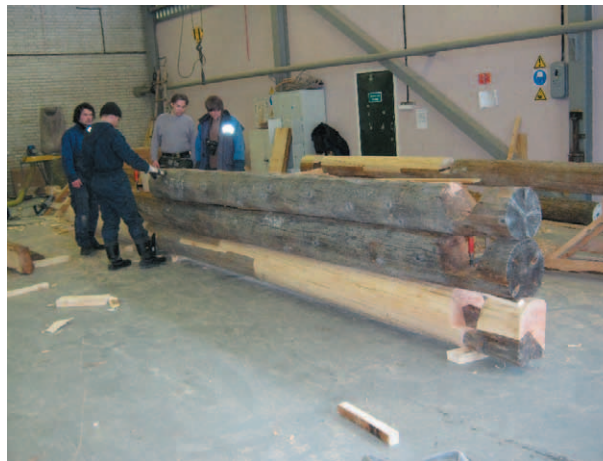
Fig. 14. Restoration of the Church refectory logs

3. The complicated problems of repair and restoration of logs were discussed. The refectory logs were restored in advance, prepared and demonstrated to the mission experts. Having examined and analyzed the restored logs, the experts not-

ed the excellent workmanship of the restorer carpenters and nevertheless mentioned the shortcomings, stipulated by insufficient knowledge about the natural dynamics of repairing large timbers, large number of patches in one log and recommended the limitation of using the glued wood patches. According to their opinion, the number of patches in the log must be less than two (three patches as an exception).

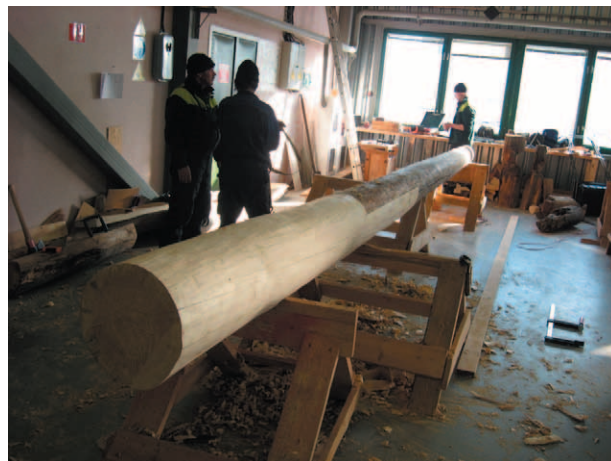
Fig. 16. New wood insertion in a log from the refectory – preservation of a destroyed structural element

The material for the insertions was selected from the sound part of logs dismantled from the refectory in 2009 in case the whole log had unsatisfactory quality and could not be re-installed to the structure or from special timber stocked in 2004. When selecting material, they took into consideration wood moisture content, physical characteristics and condition of the wood surface.

All pieces, inserted in refectory structural elements were marked by «ПЦ» label (Carpenter Center) with index, date and carpenter's name. The label was burned or written by special pencil.

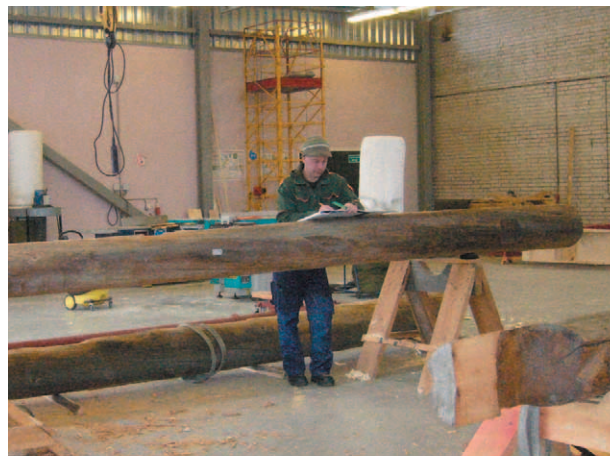
Fig. 18. Inspection and fixation of the refectory structural elements

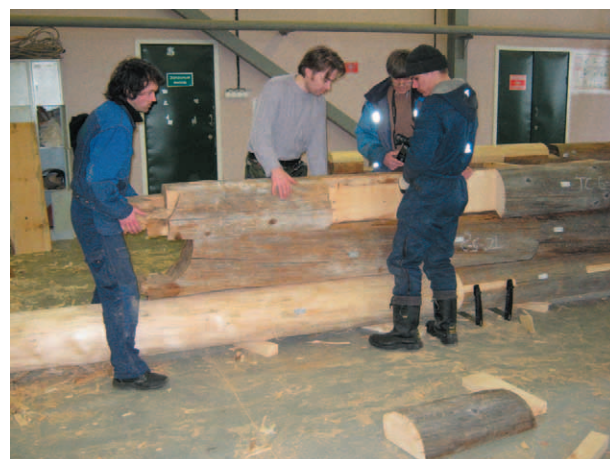
Fig. 19. Restoration of the refectory structural elements with due regard to location of contiguous (upper and lower) elements

About 21% of the structural elements (52 of 242 elements) had been restored as of the 1st of December, 2010. The work is going on. In future restoration of the refectory structural elements will be continued simultaneously with the logs of the VIIth restoration tier dismantled in 2010.

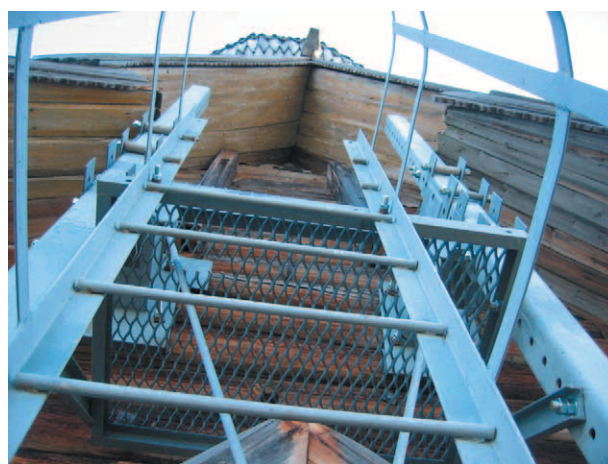
Fig. 21. Elongated posts mounted on diagonal Church log walls

Lifting and fixing of the I – III engineering restoration tiers was implemented in 2009 and revealed the necessity to upgrade the lifting equipment so that to improve the restorers working conditions and fire safety of restoration. The designer put forward the proposals and developed technical documentation for production and installation of additional posts with staircases and crossing platforms on diagonal log walls from +9,40 to +15,90 levels (Fig. ). Manufacturing and installation of the equipment was done by SKF “Alekon” Co Ltd in August 2010. The similar metalwork on north-east wall was installed in 2009.

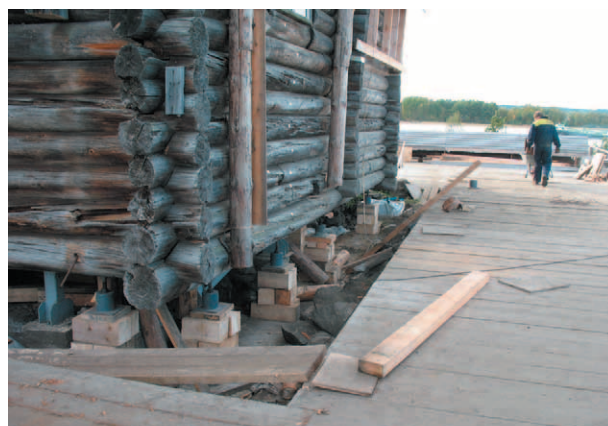
Fig. 22. Initial stage of the dismantling – the Church is supported by jack posts with crawls along the perimeter

According to the technological project, the dismantled logs had to be set successively on the constructed belt foundation under the ground level in order to disassemble log sets of the lower restoration tier. 65 adjustable legs installed along the Church perimeter between the foundation and lower logs with gaskets were used for this purpose. After the dismantling of 2 or 3 lower log sets the weight of log walls is shifted to the transverse beam of suspension system, and then adjustable legs are removed.

When the underground part of rubble concrete belt foundation was built and strengthened, adjustable legs were installed on the foundation along the perimeter and brought to the lower log set. After that adjustable legs were removed in consecutive order starting from the altar giving a chance to remove logs from the wall through the opening. Then logs were removed from the wall and delivered for restoration. When the lower log was removed from the wall, the adjustable legs were brought to the log in the upper log set.

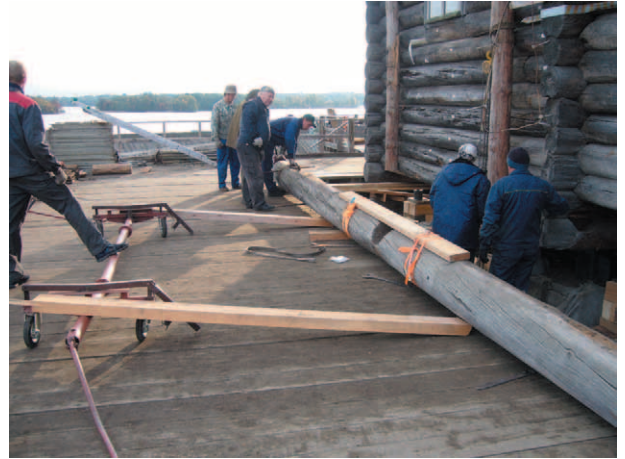
Fig. 23. Dismantling of 12-m long log from northern wall of the Church

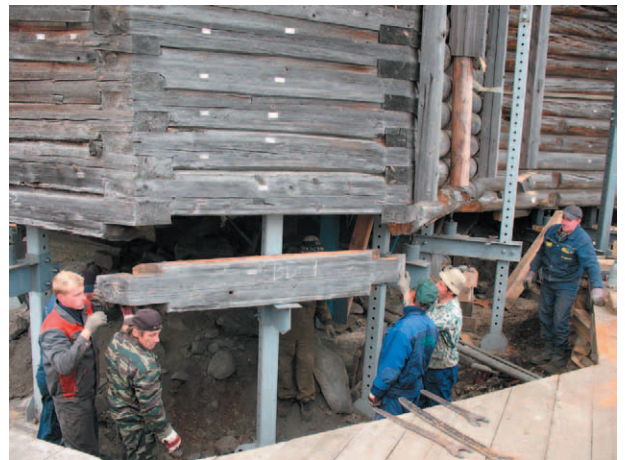
Fig. 24. "Wave" dismantling of the Church framework with the use of lifting system and jacks

These manipulations were repeated until the lower part of the tier could be placed on the transverse beam and console of the system for the log wall suspension. Since that time the weight of the intact part of the restoration tier was shifted to the suspension system. The other log sets of the VIIth restoration tier and ground floor beams were removed by rearranging movable cross-beams of log walls in consecutive order. 250 logs were dismantled and delivered to restoration workshop. The height of the dismantled part is 2,5 m in average. The remaining log walls were securely adjusted on the existing supporting structure and systems for lifting and suspension.

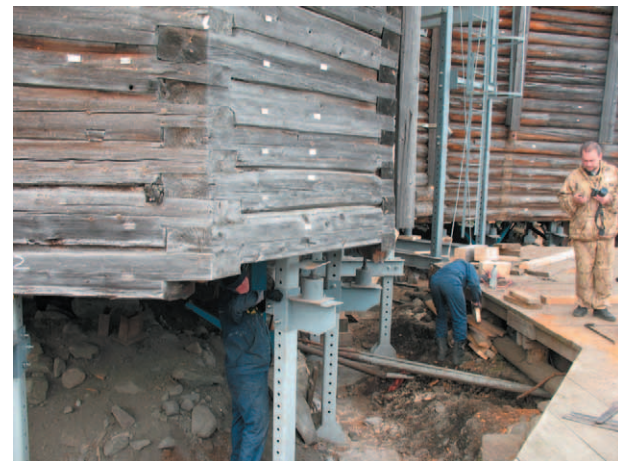
Fig. 25. Fixing of walls after dismantling of an element

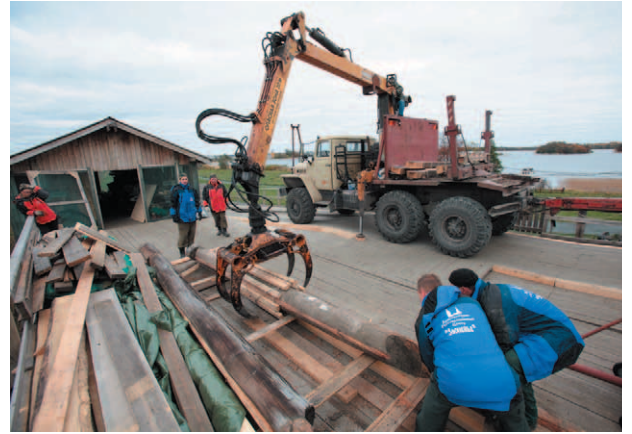
Fig. 26. Loading of logs with the use of special band for transportation to the Restoration Complex

Dismantled logs were placed on the site platform, then put on a special transporting carriage and transferred to the temporary storehouse by wooden technological bridging. Then they were carefully moved to the Restoration Complex by timber lorry with a hydraulic manipulator. In order to prevent the damage of historic timber during the transportation, loading and unloading, the timber lorry trailer was equip-

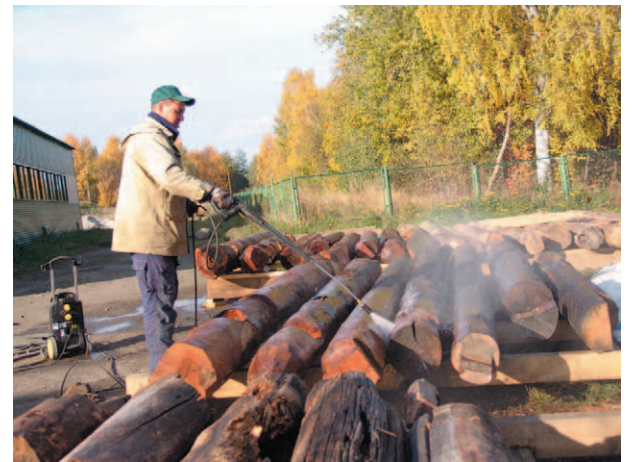
Fig. 27. Washing and air-drying of logs before stacking

Logs delivered to the Restoration Complex were unloaded to a washing ramp, then they were washed by water jet from high-pressure device "Karcher" and air-dried during 2 or 3 days (depending on weather conditions). After washing and air-drying logs were transported to the indoor store-house of the Restoration Complex for temporary storage on special single-layer stacks equipped with felt-covered cradles.

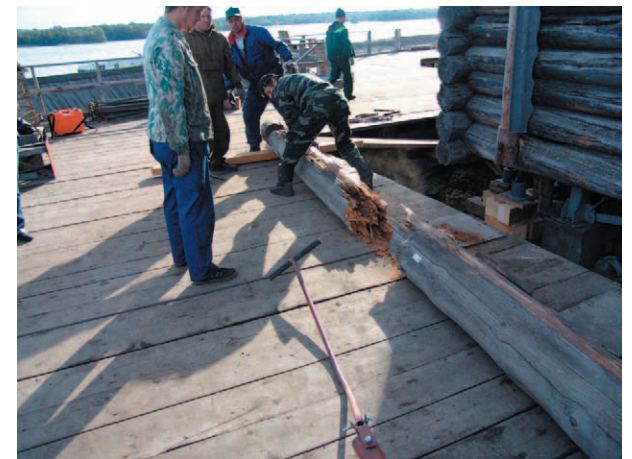
Historic logs were carefully inspected, photofixed and measured during storage. Inspection of logs removed from the VII restoration tier was made during the dismantling and storage and this **inspection revealed extremely bad condition of the majority of the logs**. The obtained results were much different from that obtained before the dismantling and were unexpected for restorers. The logs protected from environmental factors (located in the refectory shade or beams in the basement) were in better condition.

Fig. 28. Inspection during dismantling revealed extremely bad condition of some logs

This fact supports the validity of the restoration method used because the disassembly of a structure tier by tier enables to restore historic logs with high efficiency provided that the quantity of those logs being restored at a time is not large; and also this method enables to select the restoration technique that suits best to preserve maximum historic material.

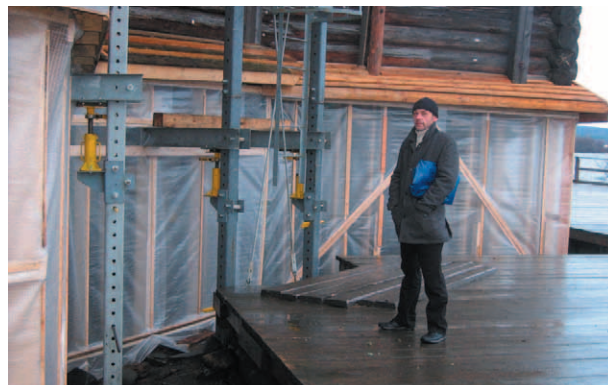
Fig. 29. Conservation of the object for winter. The SKF “Alekon” director A.A. Savelev

The cover made of reinforced poly-film mounted on a wooden frame was made in line with working project on completion of restoration in 2010. It was done to protect the reconstructed rubble concrete foundation, structural openings that appeared after the dismantling of lower logs as well as electrical equipment, remote control and fire-alarm systems installed in the Church from snow and rain. Small roofs were built along perimeter of the log walls to protect them against melted snow and rain-water.

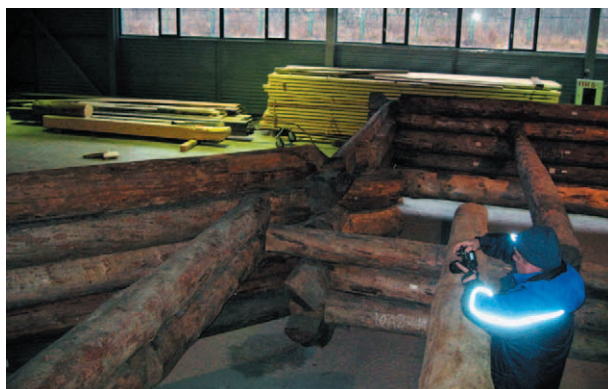
Fig. 31. Installation of beams to historic places – determination of original (XVIII c.) framework geometry

The log walls of the Church of the Transfiguration have been exposed to different factors for nearly 300 years and got significant deformations. This affected its present outline. The research made before and during the Church disassembly revealed declinations from the original location of log walls on the historic foundation. The lower log sets were moved from their original places as shown by the beam ends shifted considerably (more than 10 cm and up to complete dislocation). Significant deformations are observed in a vertical section of log walls, which results in the declination of the Church vertical axis to north-west and defect of the historic indent up to 40 cm in height.

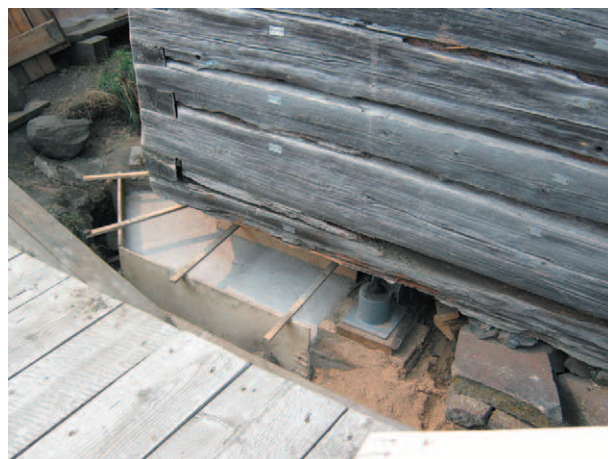
Fig. 32. Pouring of the underground foundation part in parts

The upper part of the foundation was leveled for 40 cm below daylight surface along the perimeter, at the same time anchors were set for connecting the reinforced concrete belt. When the foundation strengthened up to the designed values, boxing was removed and pockets were filled with consolidated sand.

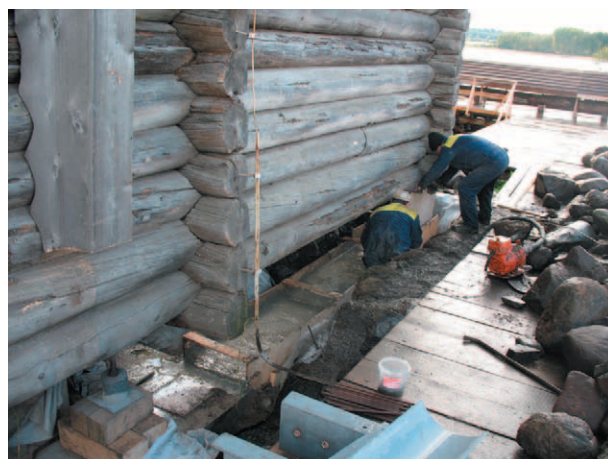
Fig. 33. Pouring of the foundation below lifted Church framework

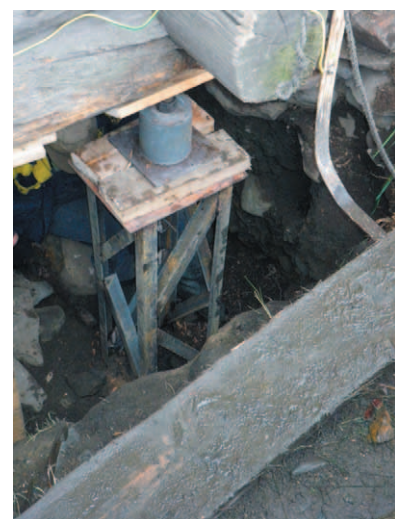
Fig. 34. Additional support during foundation pouring

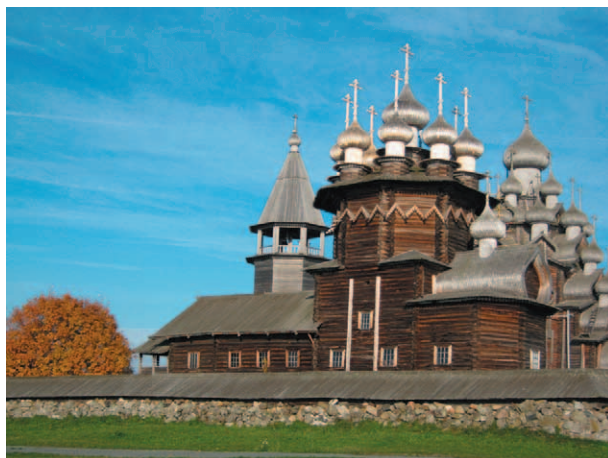
Fig. 37. Restored onion-domes of the Church of the Intercession. Fall 2010.

Shingles on onion domes were restored and northern slope of the roof of Church proper was changed in 2010. The completion of roof and porch restoration is scheduled for the year 2011. Restoration was done by the museum Carpenters Centre.

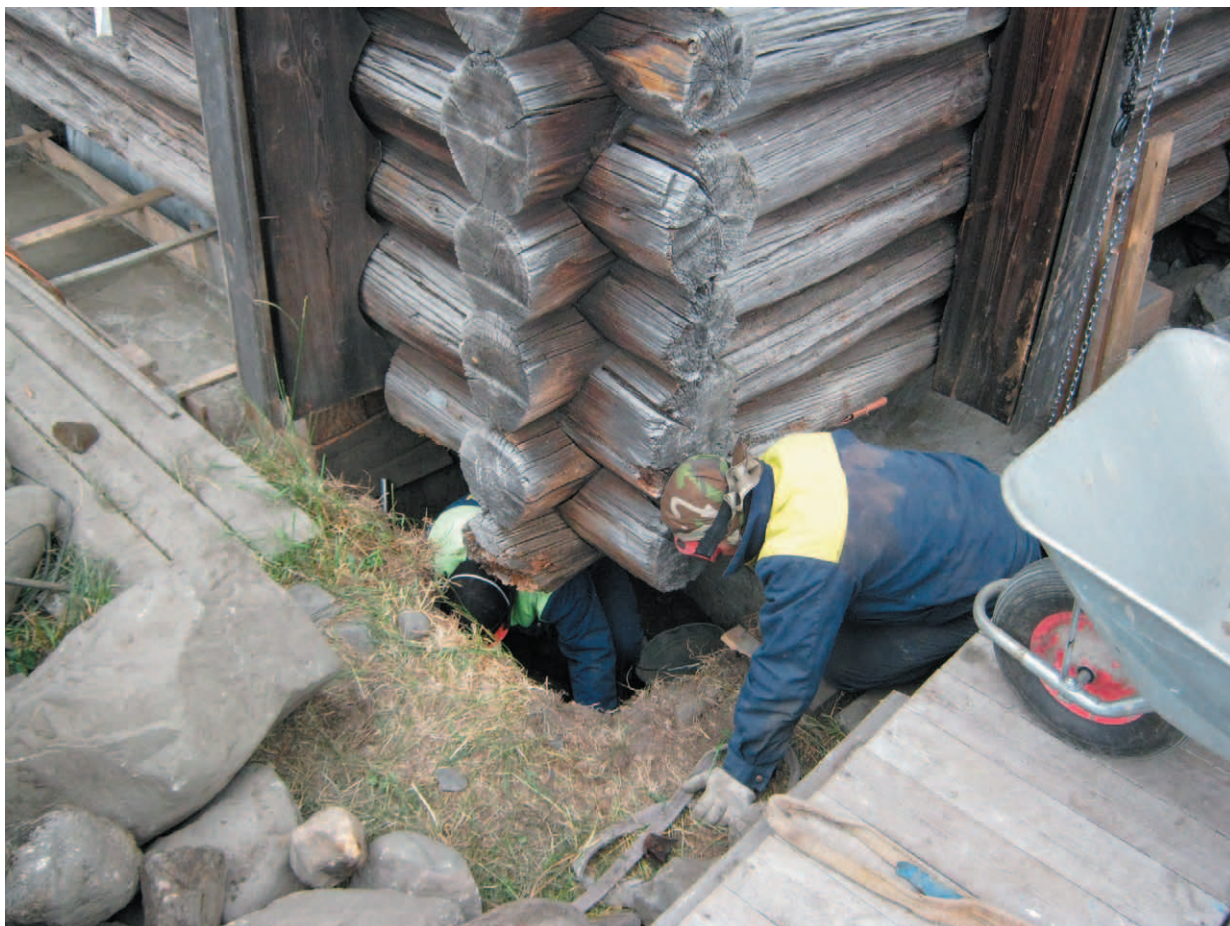
Fig.1. Ditch digging for belt rubble concrete foundation under lifted Church framework. Work of people in narrow conditions.

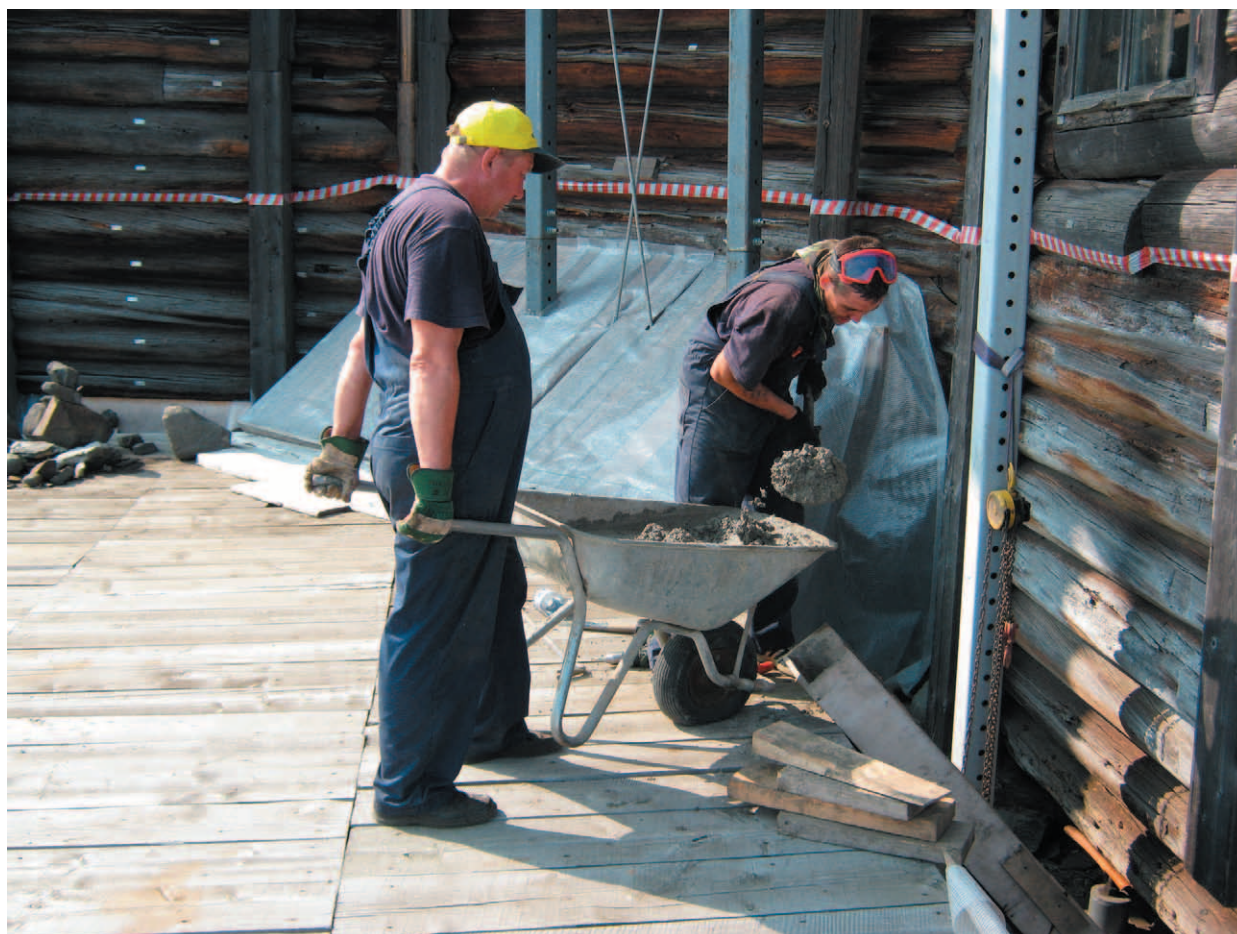
Fig.2. Pouring of lower part of rubble concrete foundation (underground part)

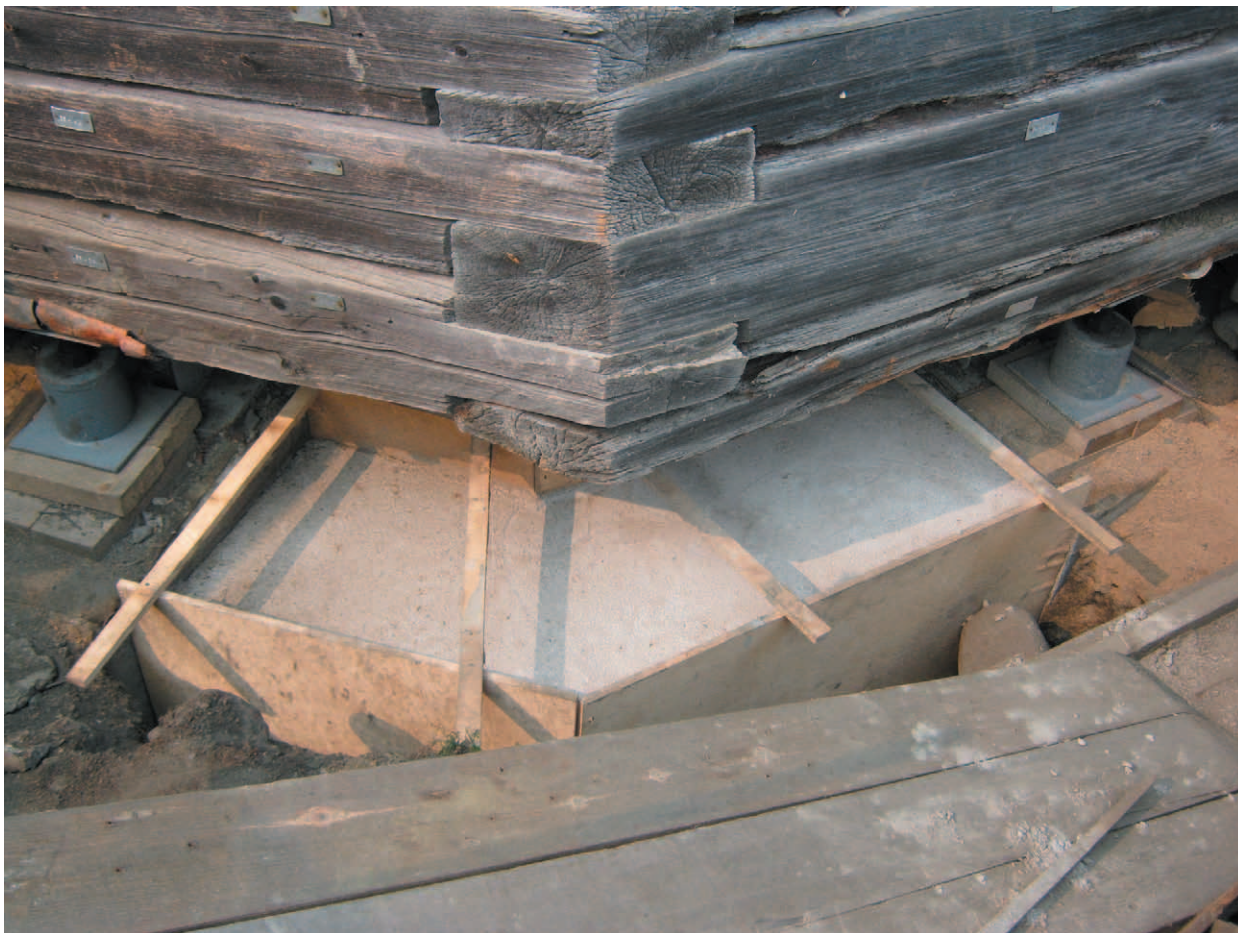
Fig. 3. Poured foundation in boxing; boxing is removed after 7 days of exposure

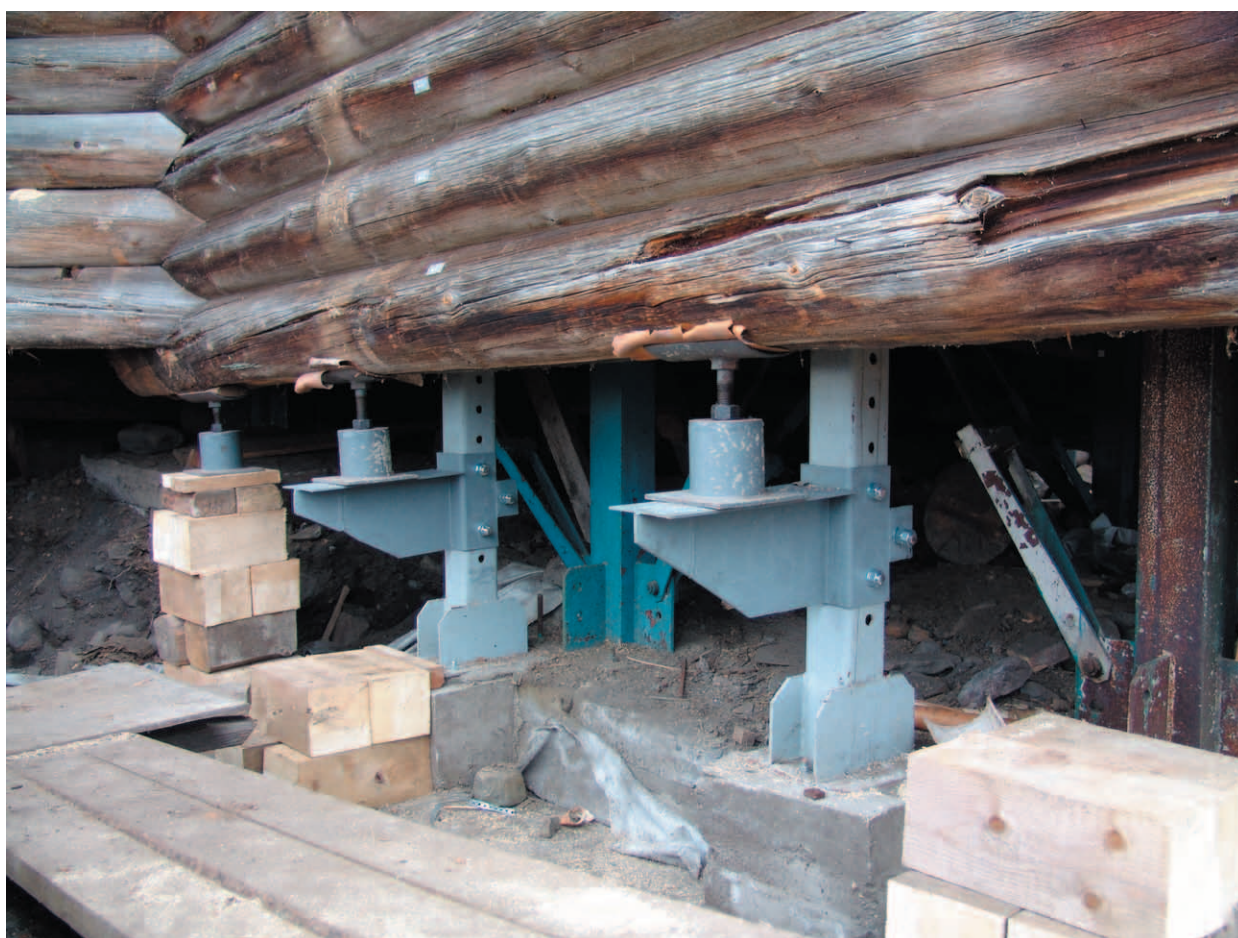
Fig. 4. Initial stage of dismantling. Birch bark is placed between jacks and monument timber

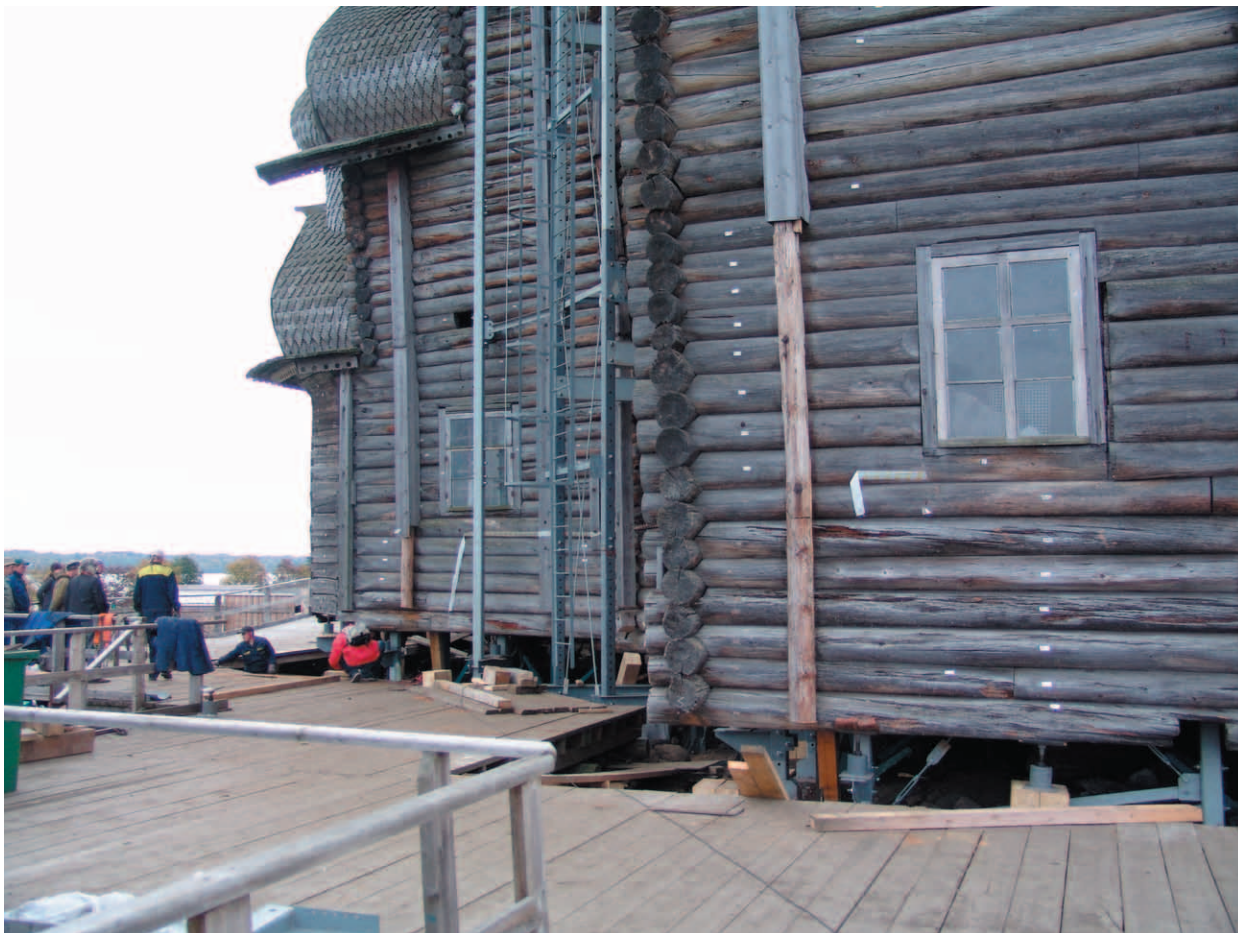
Fig. 5. Initial stage of dismantling. Logs are dismantled along the perimeter in consecutive order

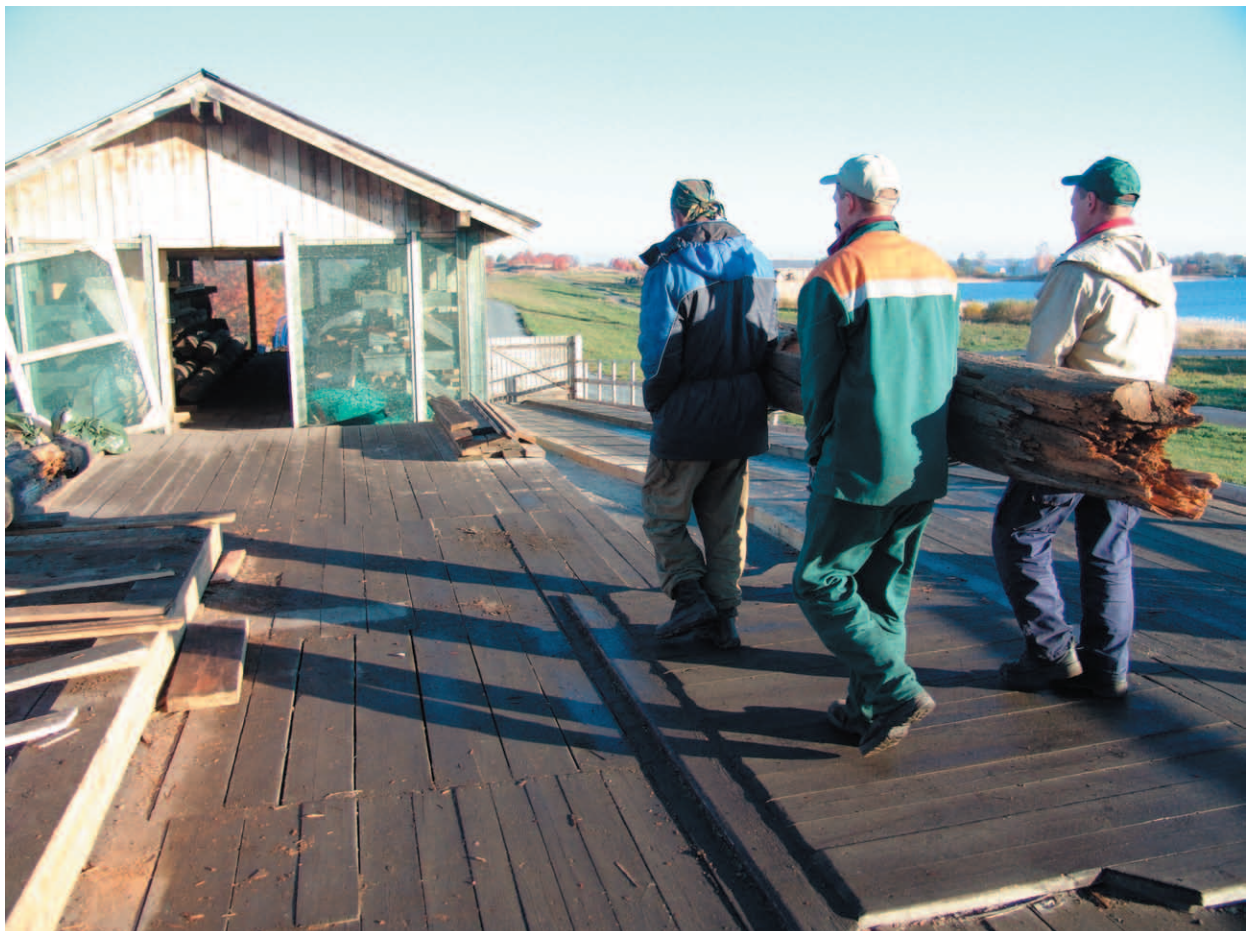
Fig. 8. Transferring of a log by hand to temporary storehouse. Extremely bad condition of a log

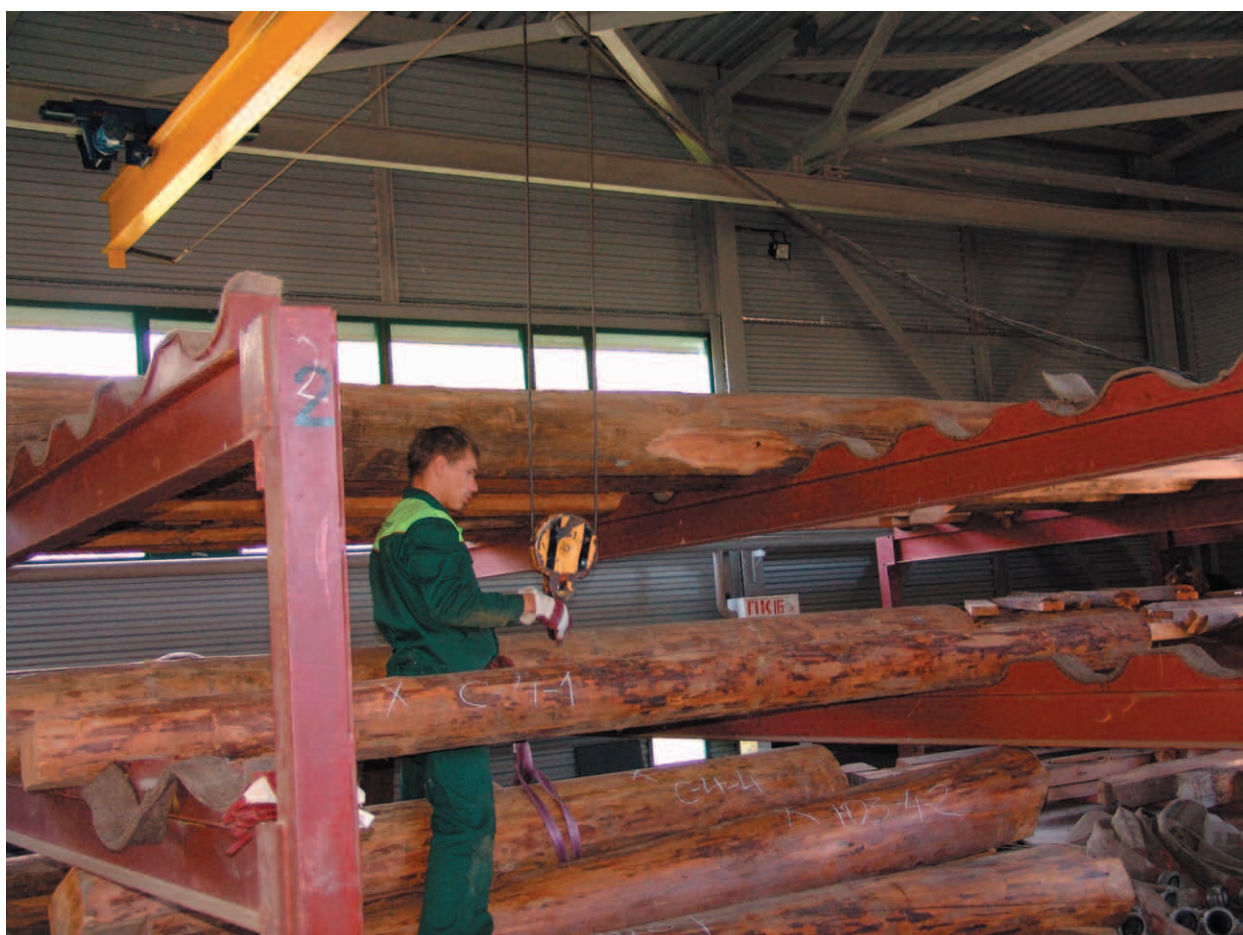
Fig. 10. Stacking of logs on stacks equipped with felt-covered cradles in the Restoration Complex

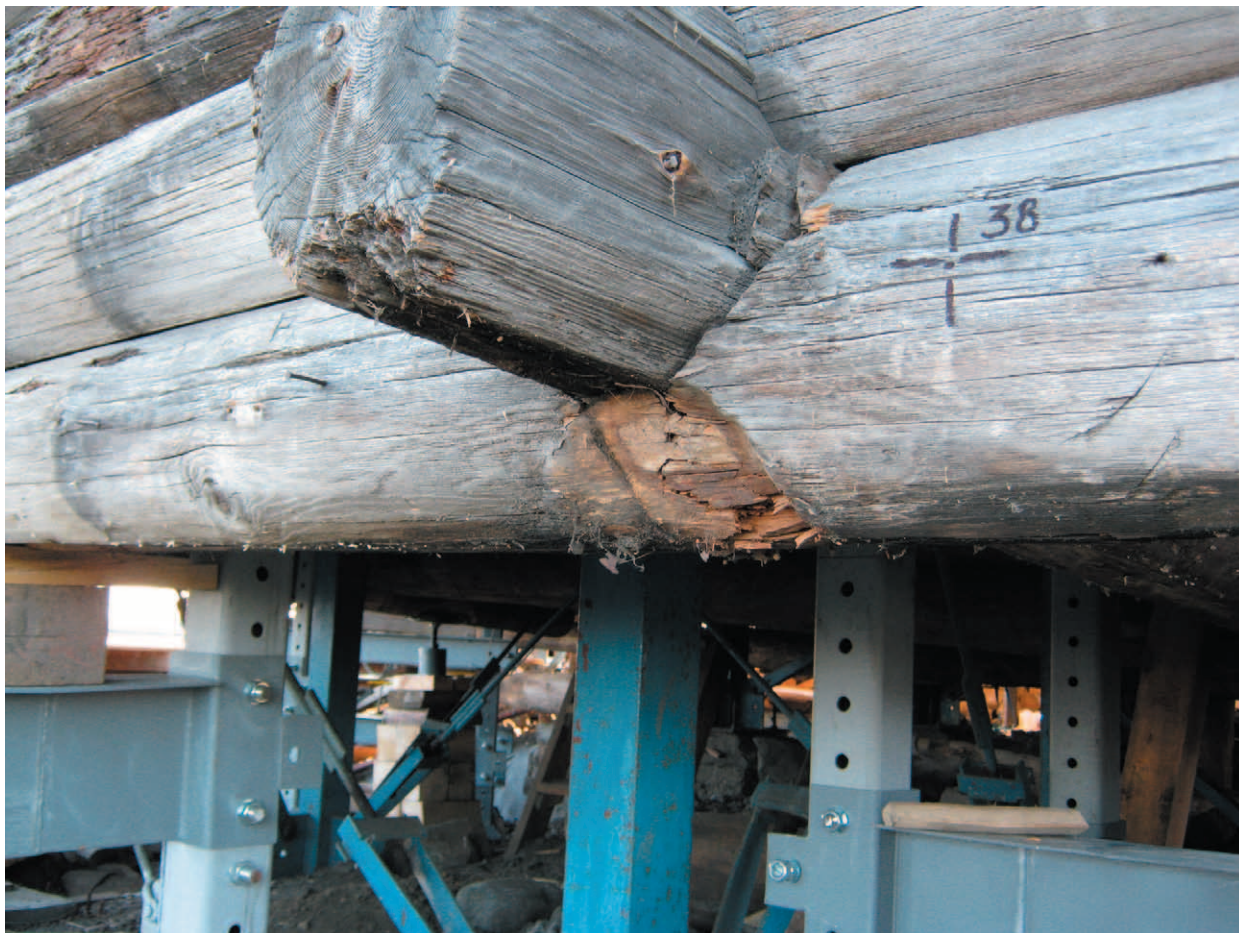
Fig. 11. Invisible defects of logs. The log notch is completely destroyed

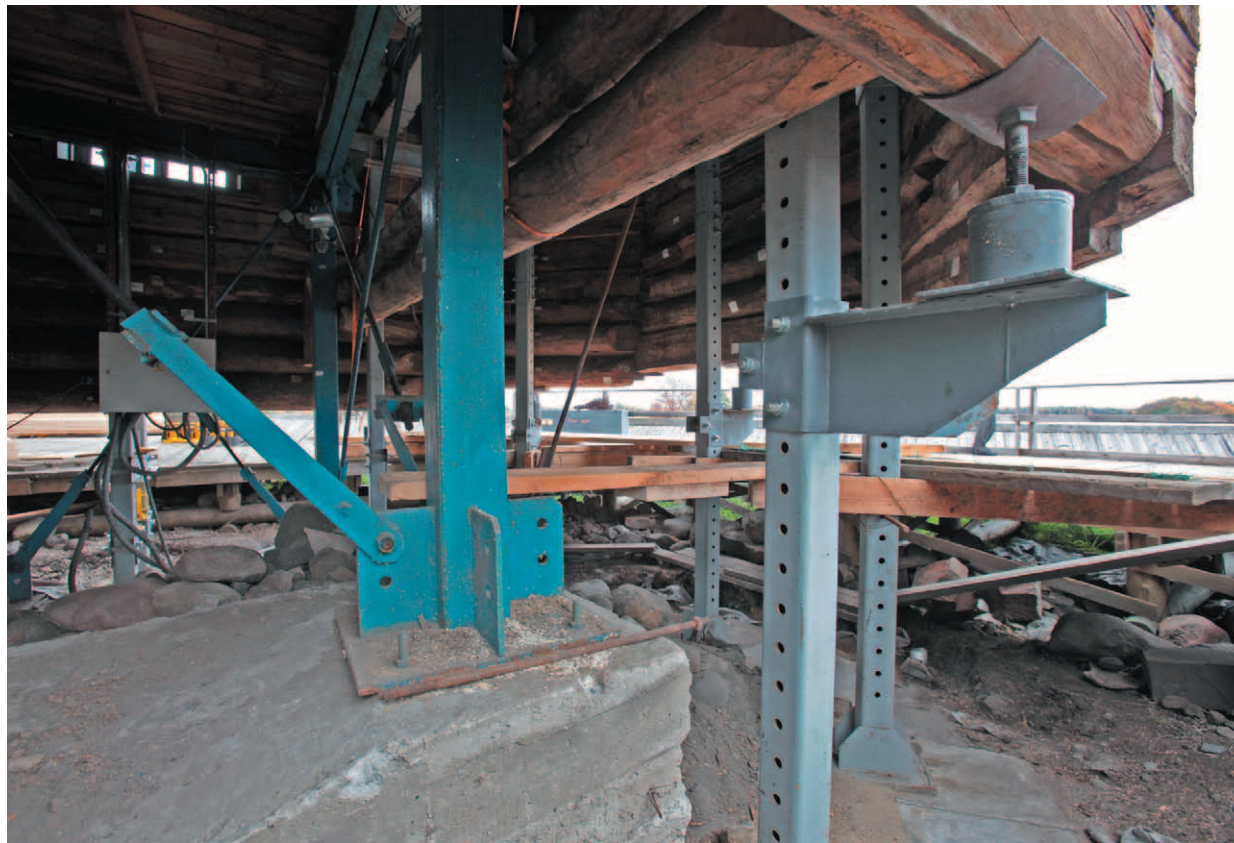
Fig. 12. Sequential dismantling of the Church framework upwards. Regular observations show stable condition of the framework

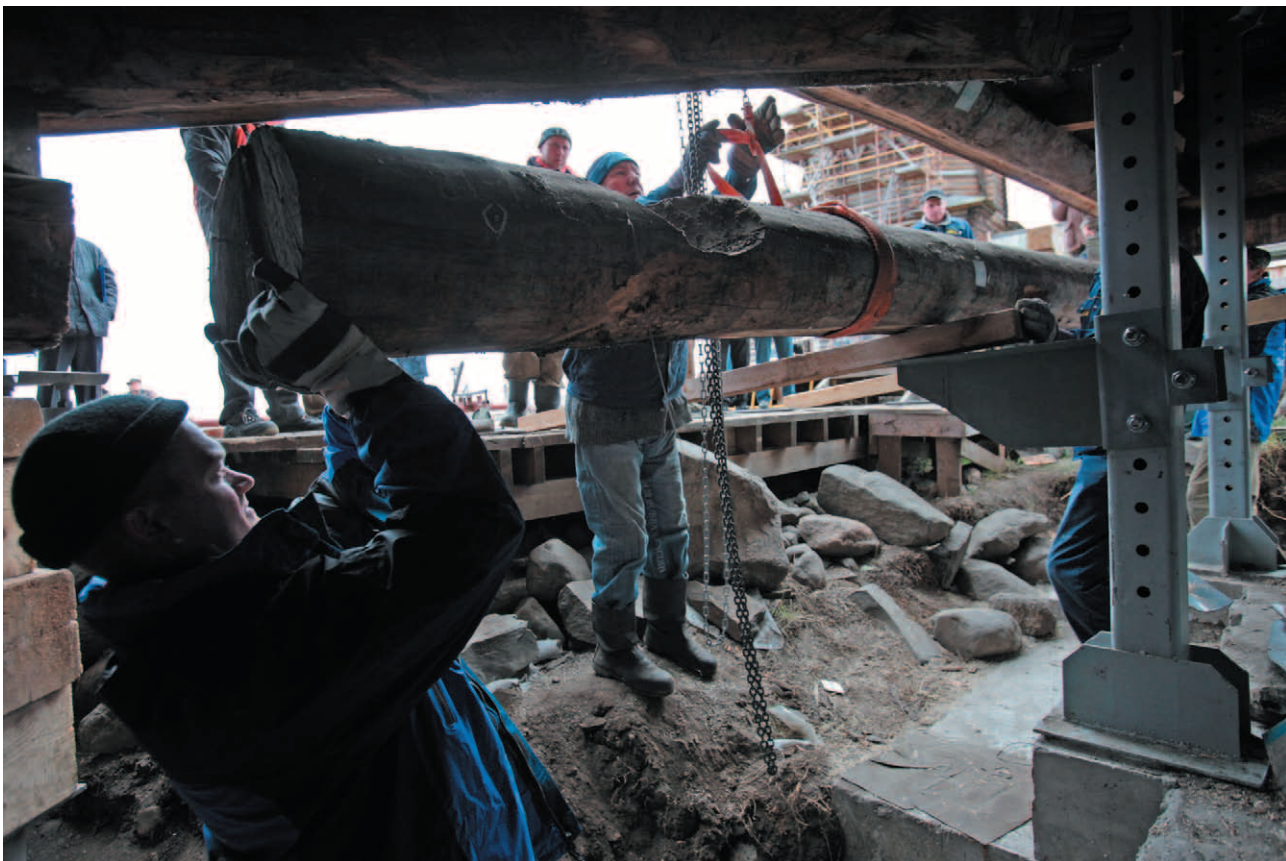
Fig. 13. Final stage of dismantling. Mechanisms of lifting system located along the monument perimeter start to work

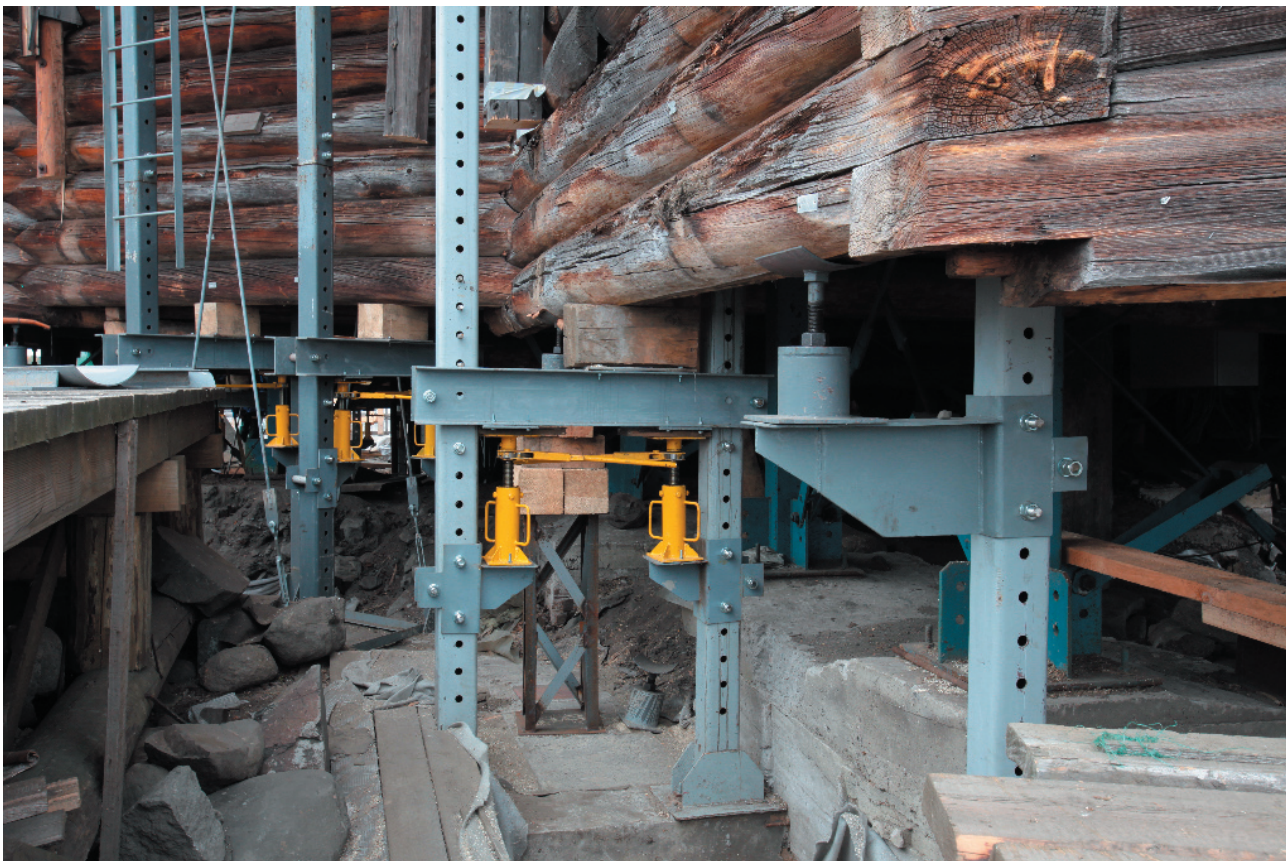
Fig. 15. Movable lifting mechanisms of lifting system: consoles, beams, jacks

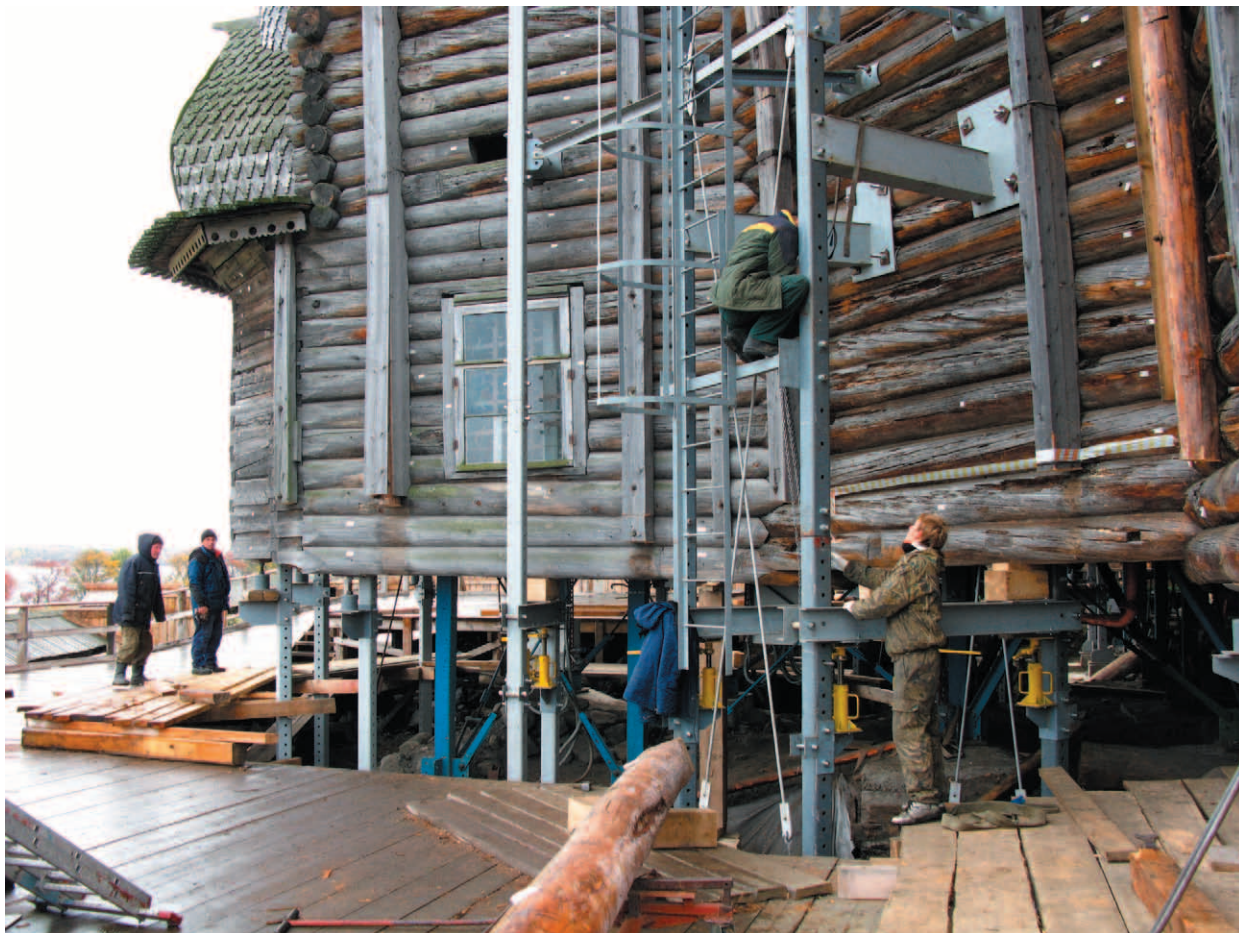
Fig. 17. Final stage of dismantling. General view. 2 timber sets are left along the perimeter
