The Kizhi Federal Museum of Architecture and Cultural History  
Cultural Heritage Site of Special Value of the Russian Federation

# The Detailed Report

## on Preservation of Kizhi Pogost Monuments (Kizhi Pogost, C 544) in 2010

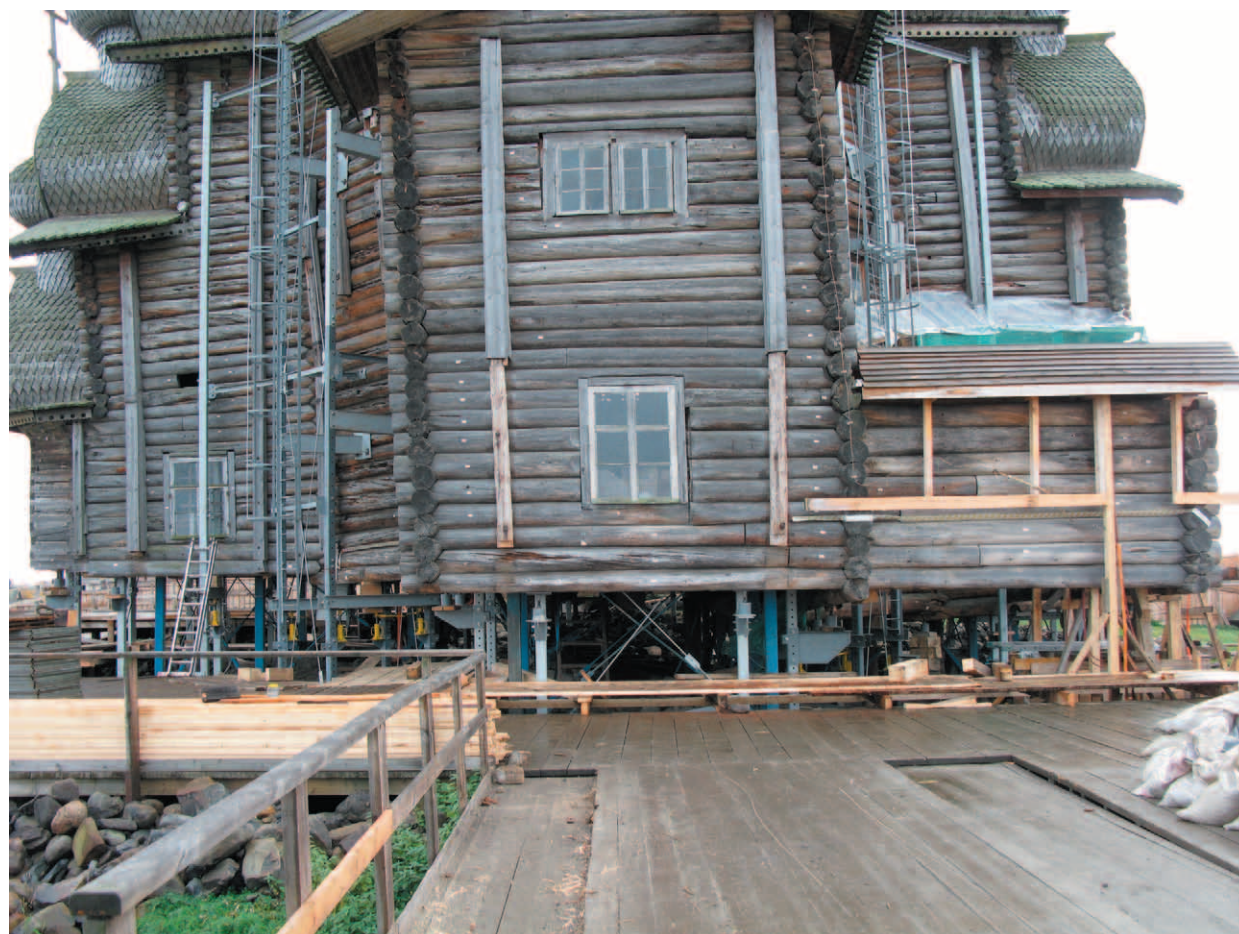
Fig. 18. Final stage of dismantling. General view. 1 timber sets is left along the perimeter
