Subject : **Transmission of the report of the ICOMOS advisory mission to the
World Heritage property "Kizhi Pogost"**

Report on the ICOMOS Advisory Mission to Kizhi Pogost (C 544)

28th September – 1st October 2015

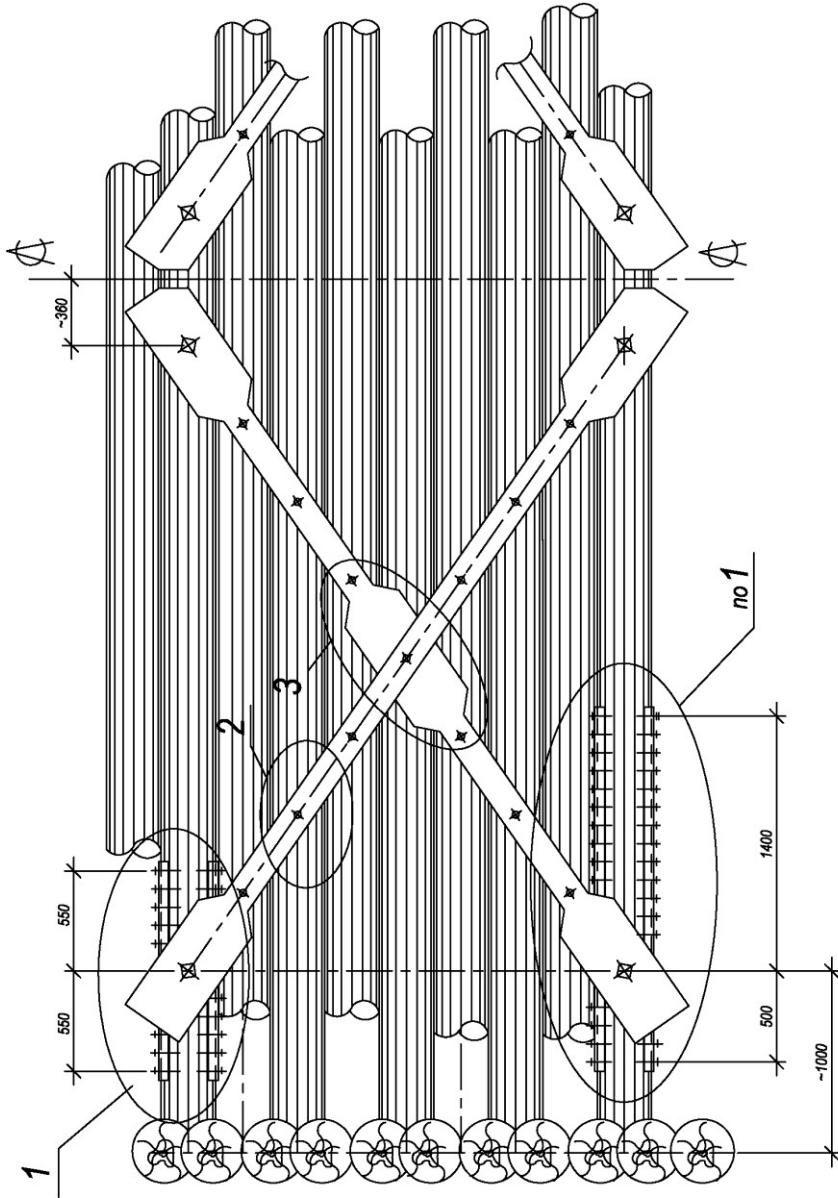
Suggested reinforcement of quadrangle

Усиление стенки четверика.

Mr. Iosif Rasha, chief engineer of the project expressed the need for a physical load test of the construction before a reinforcement system is introduced. He has also made a suggestion for reinforcement, based on filling the open gaps of the quadrangle construction with new logs, and bracing the walls of the quadrangle with an x-shaped cross of wood laminate (ANNEX E). Several of the mission participants pointed out that the existing quadrangle had no visible damage, and that the existing construction already had proven its abilities. Some participants also expressed concern that a test might be based on an excessively estimated load.

To carry out a physical test is a good idea, and it would undoubtedly give knowledge of interest both for this project and for other restoration projects. However, it is very important that the test be carried out on a model and not on the original construction from the Church of the Transfiguration, as this would imply a risk of damage. Like the rest of the building the quadrangle beam construction is very flexible, and reinforcements should not hinder this flexibility. Reduction of flexibility in the construction could alter the load forces, leading to overload in other parts of the construction. The flexibility of the construction must be considered an important factor for its durability, and it should not be disturbed.

The mission recommends to trust the old construction, and to re-establish it in its original state in the building. If there are very strong indications that reinforcements are needed, this must be conducted in the simplest possible way, and reduced to a minimum.

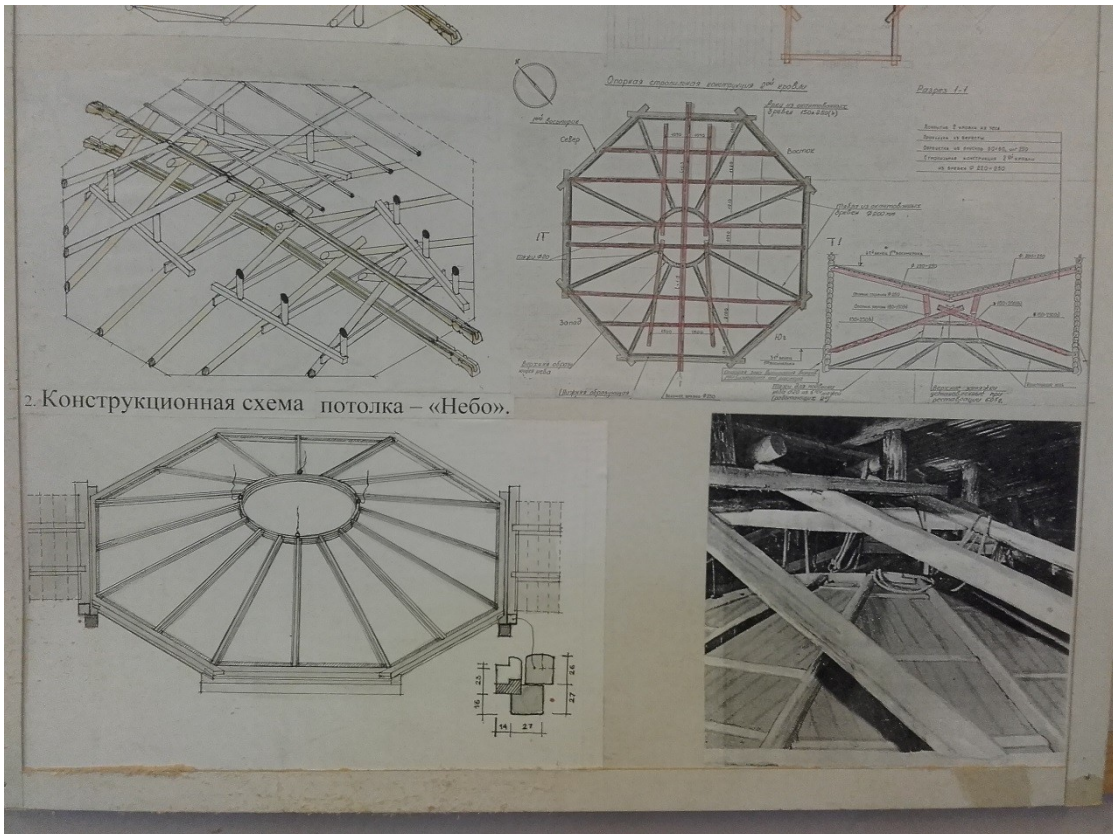
The «heaven» ceiling – «Nebo».

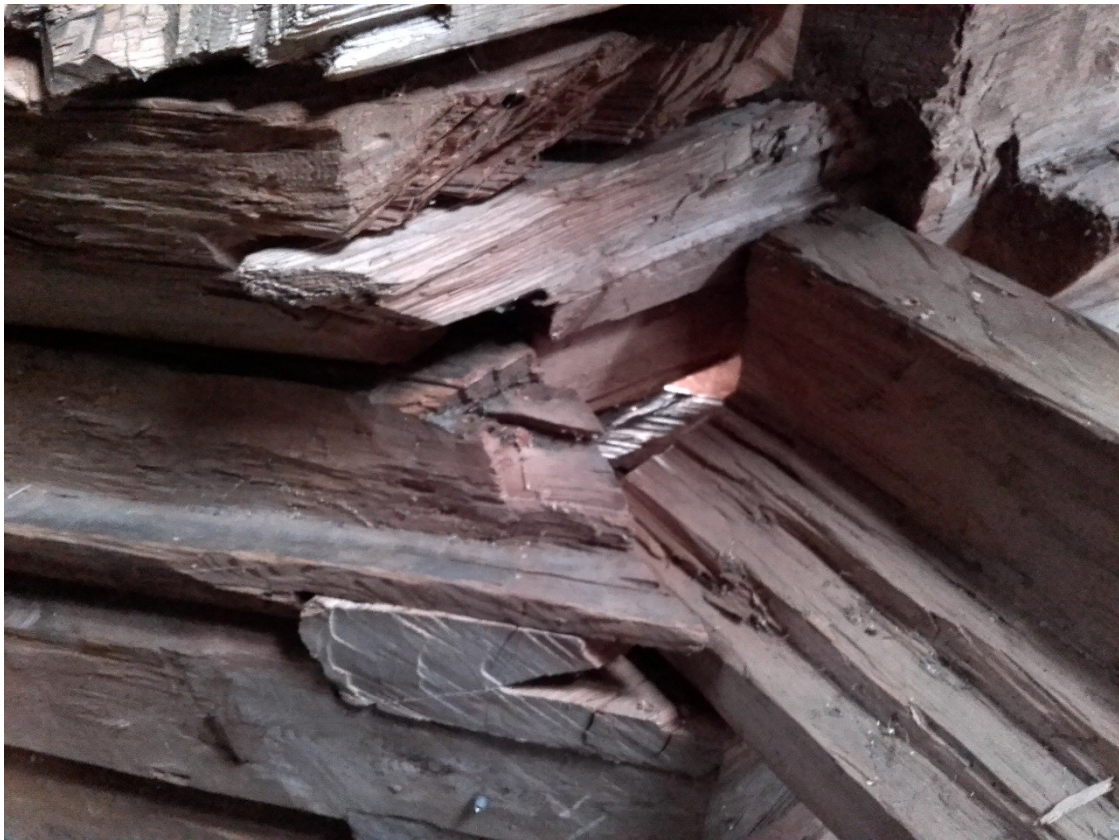
The supporting ring of the «heaven» ceiling. The joints of the beams spanning across the top of the annexes are broken, and have lost their function. The screw in the lower log is a point for monitoring.

It is also important to consider whether it is certain that the opening of joints has been caused by horizontal pressure from the ceiling “heaven”, or if it also could have been caused by the spreading of the octagon.

The mission reiterates the recommendations of earlier missions, to reduce added reinforcement interventions to an absolute minimum, and to resist introducing state-of-the-art modern materials and technology. The possibilities to support the ceiling by attaching it to constructions above should be investigated, in order to reduce the need of reinforcement as much as possible.

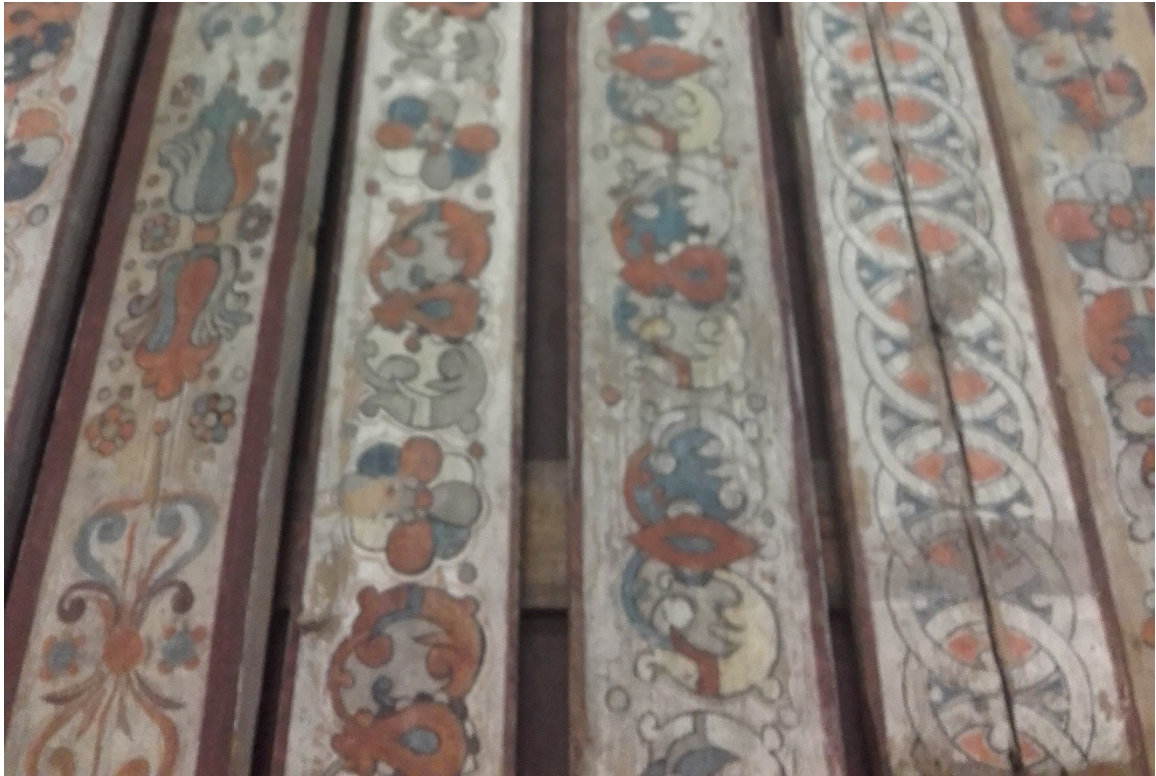
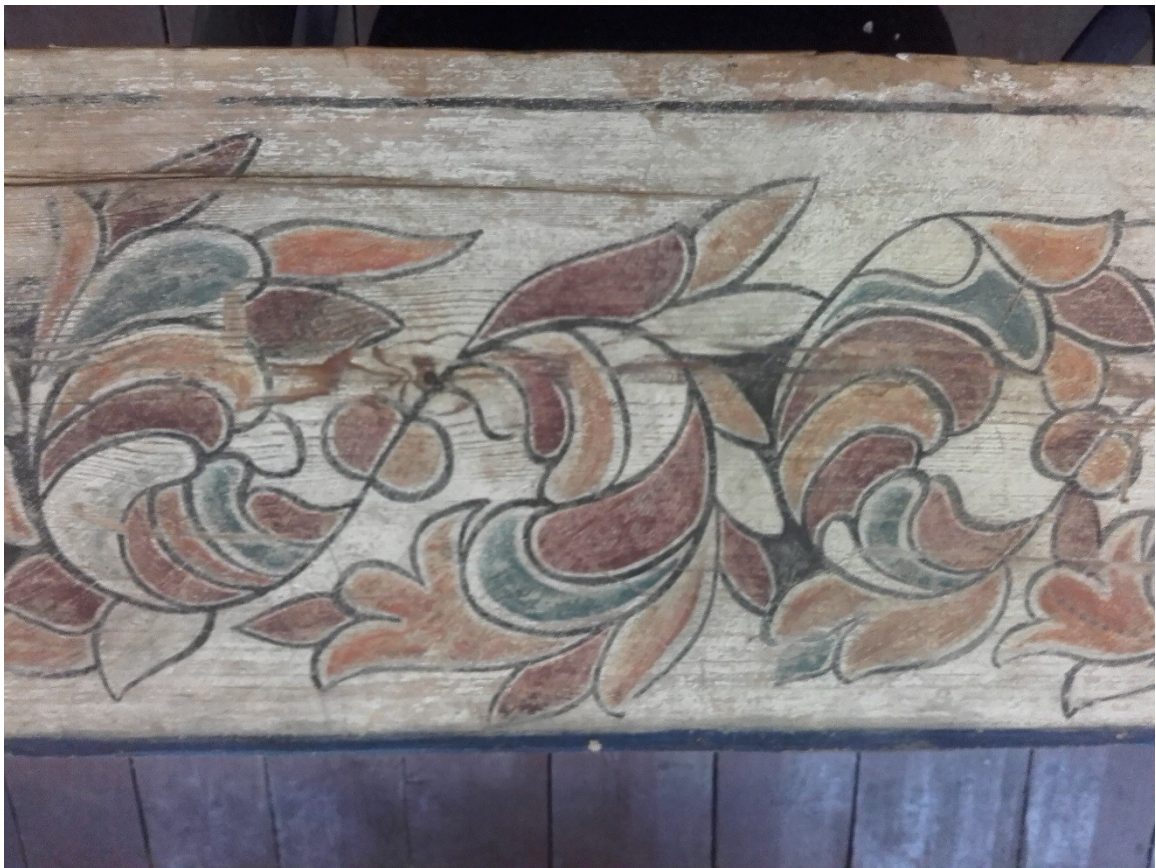
- e. **Potential loss of interior due to conservational challenges:** There has been some discussion on the conditions of the beams of the “heaven” ceiling from the church interior. The Russian paintings conservators, working with these interior parts, are very clear in their view that the beams should be kept in a museum, and that an exact copy should be made for the Church of the Transfiguration.

The mission recognizes the great challenges of putting the beams for the heaven ceiling back into its original positions in the church, including loss of decoration paint over time. Nevertheless, removing the original ceiling beams, which is both part of this almost complete church interior as well as part of the original construction, would cause loss of authenticity and integrity. This would affect the Outstanding Universal Value of the church in a negative way.

The decorated beams of the interior «heaven» ceiling.

Recommendation: The mission recommends that the goal of the restoration work should be to re-establish every part of the church, including the construction and the interior, in a state as close to the original as possible. All conservation work should be done according to this.

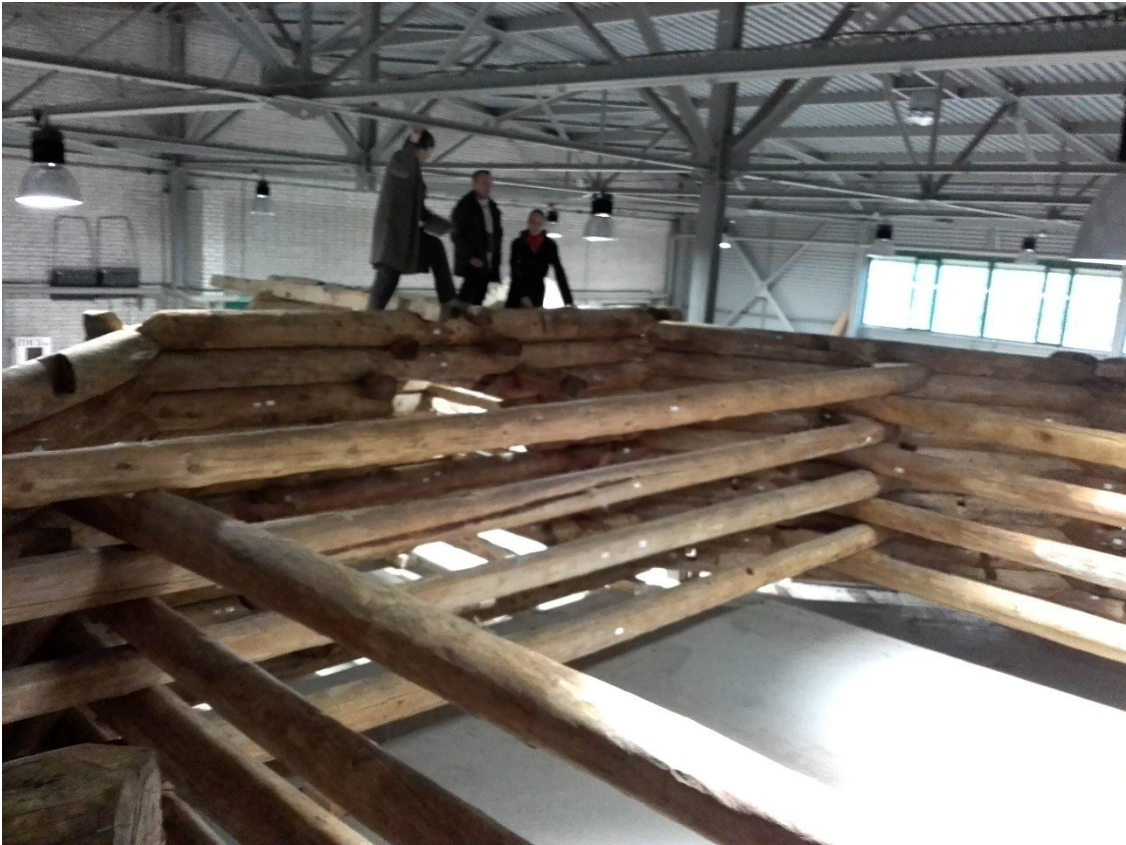
The quadrangle beam structure.

The safest information available on the construction of the Church of the Transfiguration is the empirical facts from the building. As pointed out by several Russian experts, the quadrangle beam construction has carried the upper part of the church for more than 260 years before the supportive steel framework were installed. There is no visible damage on the beams, and this indicates that there should really be no danger in putting this construction back into the church without any further reinforcement. However if there are strong indications that the logs have weakened, or wind forces will be bigger than before, a simple compromise is to install only one more layer of logs on the top or the bottom of the quadrangle. If this is carried out, it should be made with as little intervention with the original construction as possible.

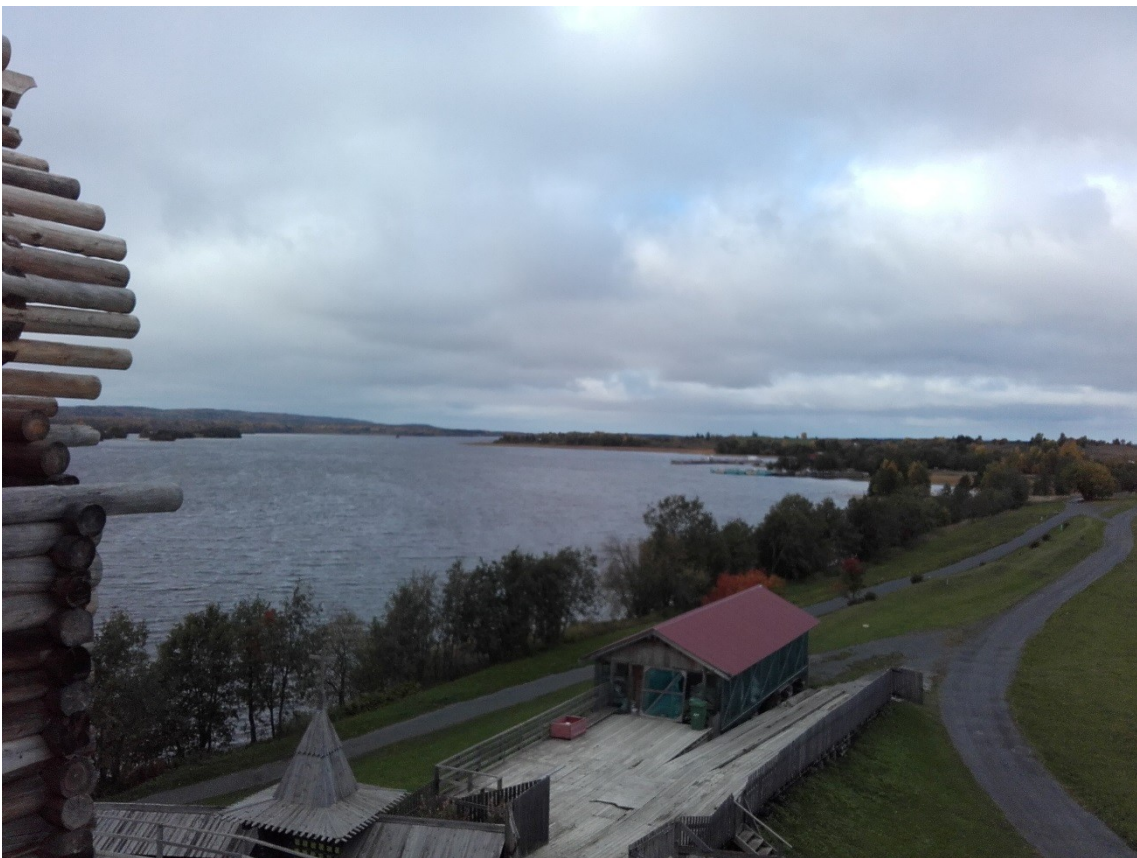
There has also been some positive development of the Island, as a response to the recommendations of earlier missions. The floating restaurant, which was in a very exposed location, has now been moved further north along the shore of Kizhi Island, and has now less visible influence on the pogost site. In addition to this, the smoking area by the entrance zone has been moved, and it is now located by the shore of the lake, away from the wooden floor and the kiosk area. There is little vegetation there, and this is a much better solution according to the risk of fire.

The big floating restaurant has been moved and is no longer visible from the pogost.

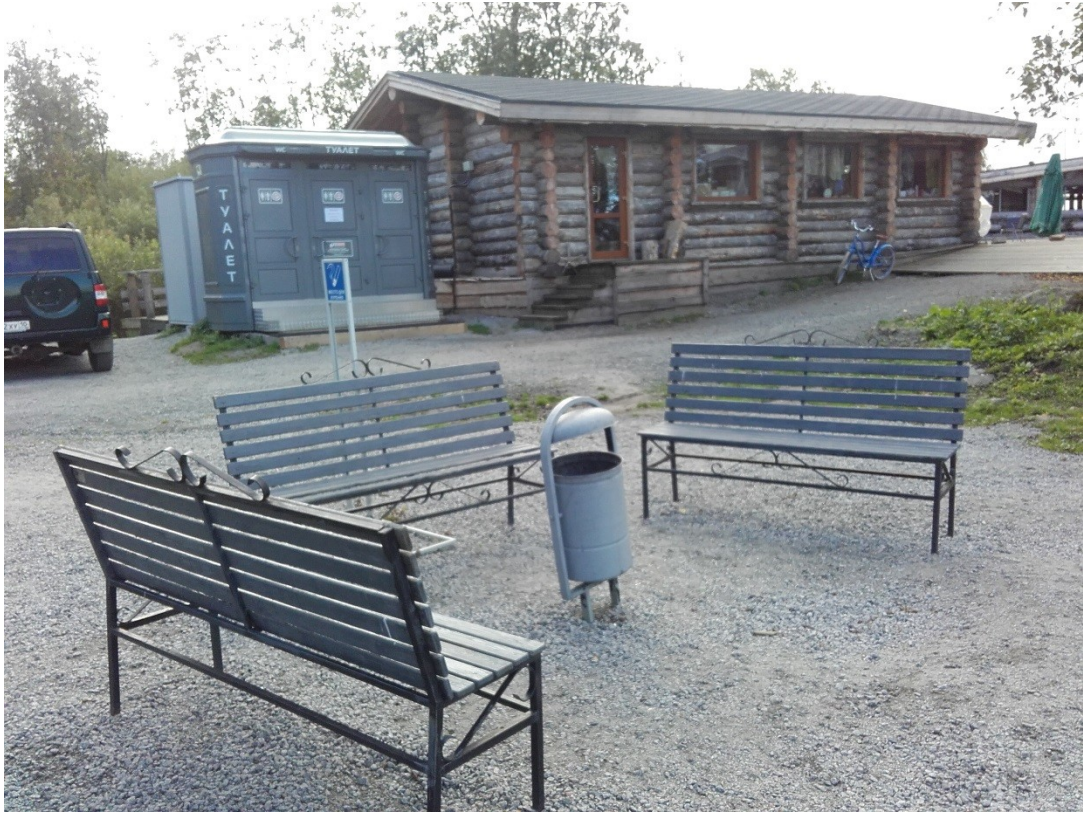
The smoking area by the entrance zone has been moved since last year, and is now in a much safer place, by the lake in a spot with little vegetation or flammable material.

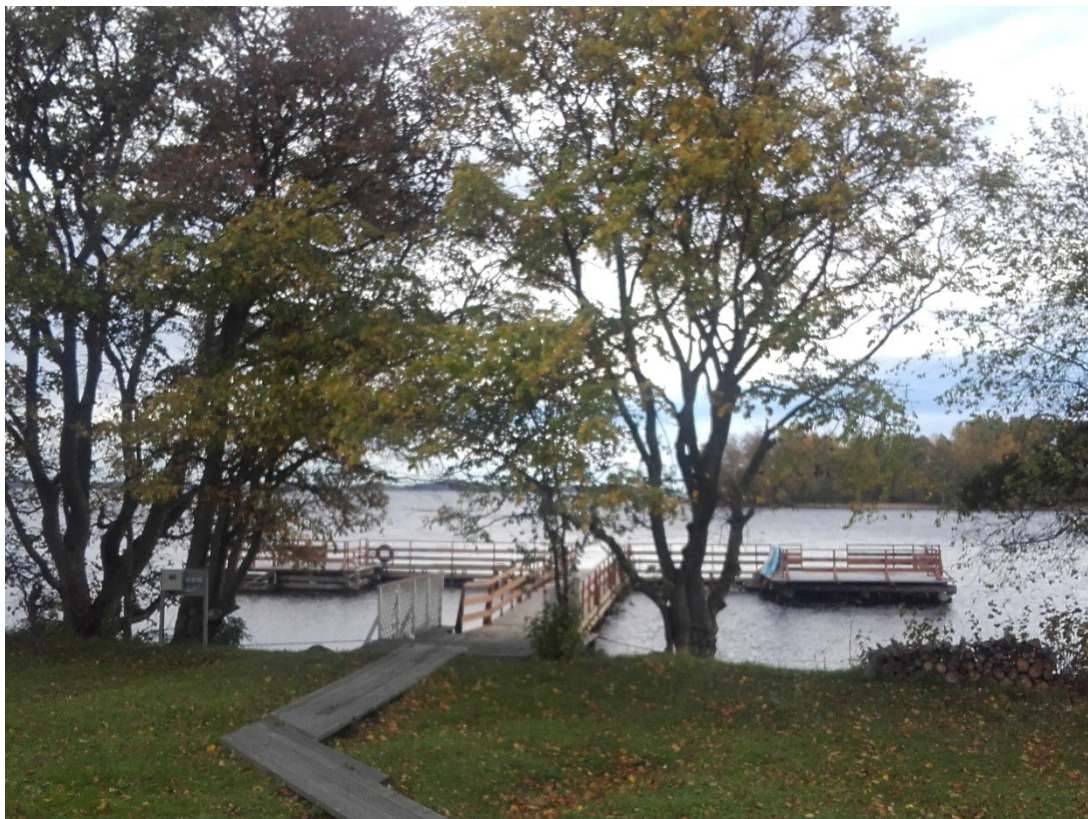
It has been a constant issue on almost every mission that changes are made on the island without being supported by a completed management plan. This mission also noticed some changes, and some of these changes both seem unnecessary and inconsiderate in relation to the museum monuments. The negative development observed since last year include a big floating pier outside the Gogolevsky guesthouse, and building of a piece of road from Yakovlev's house towards the Gogolevsky. The only purpose of the piece of road seems to be to make it possible to drive a little closer to the Gogolevsky house. The Gogolevsky guesthouse already has a pier for transport of goods and persons, and the purpose of the new floating pier is unknown.

The new pier on the eastern shore by the guest house.

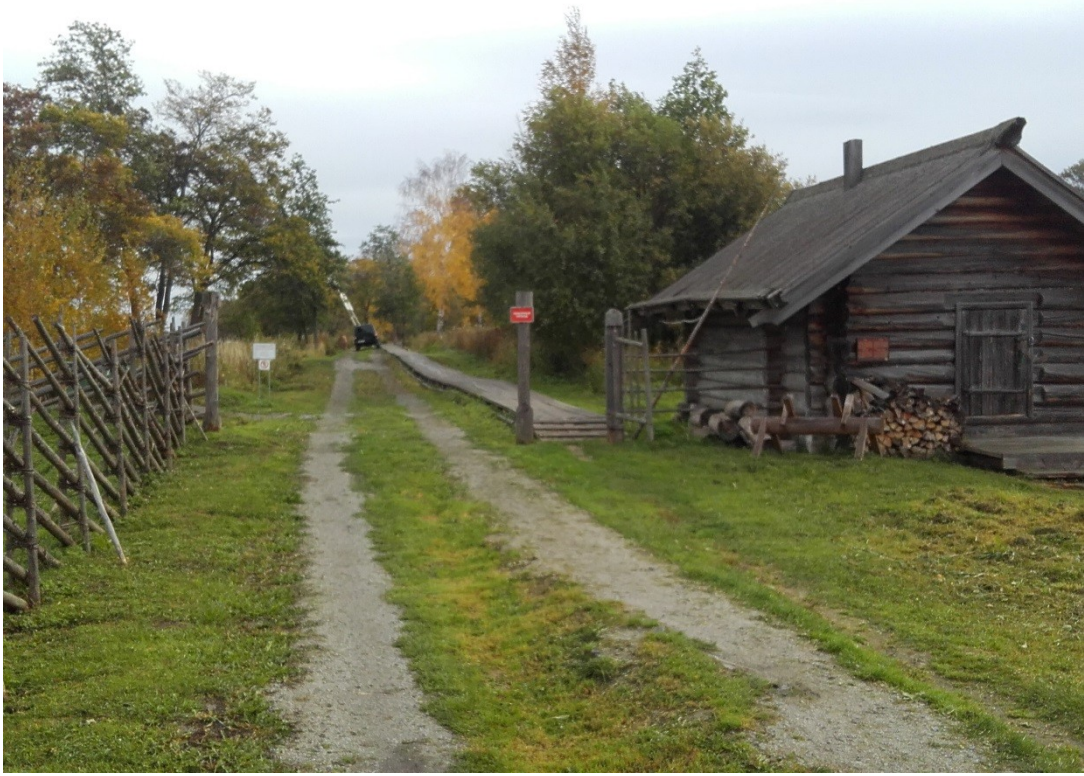
A piece of new road makes it possible to get closer to the guest house with a car.
